Ship: USS O'BRIEN (DD415)
Cause of Damage: Submarine Torpedo
Date: 15 September to 19 October 1942
Place: Solomon Islands
Class: DD 409
Standard Displacement: 1570 tons
Length Overall: 348' 3"
Extreme Beam: 36' 0"
Draft Before Damage: 11' 7"
Launched: 20 October 1939

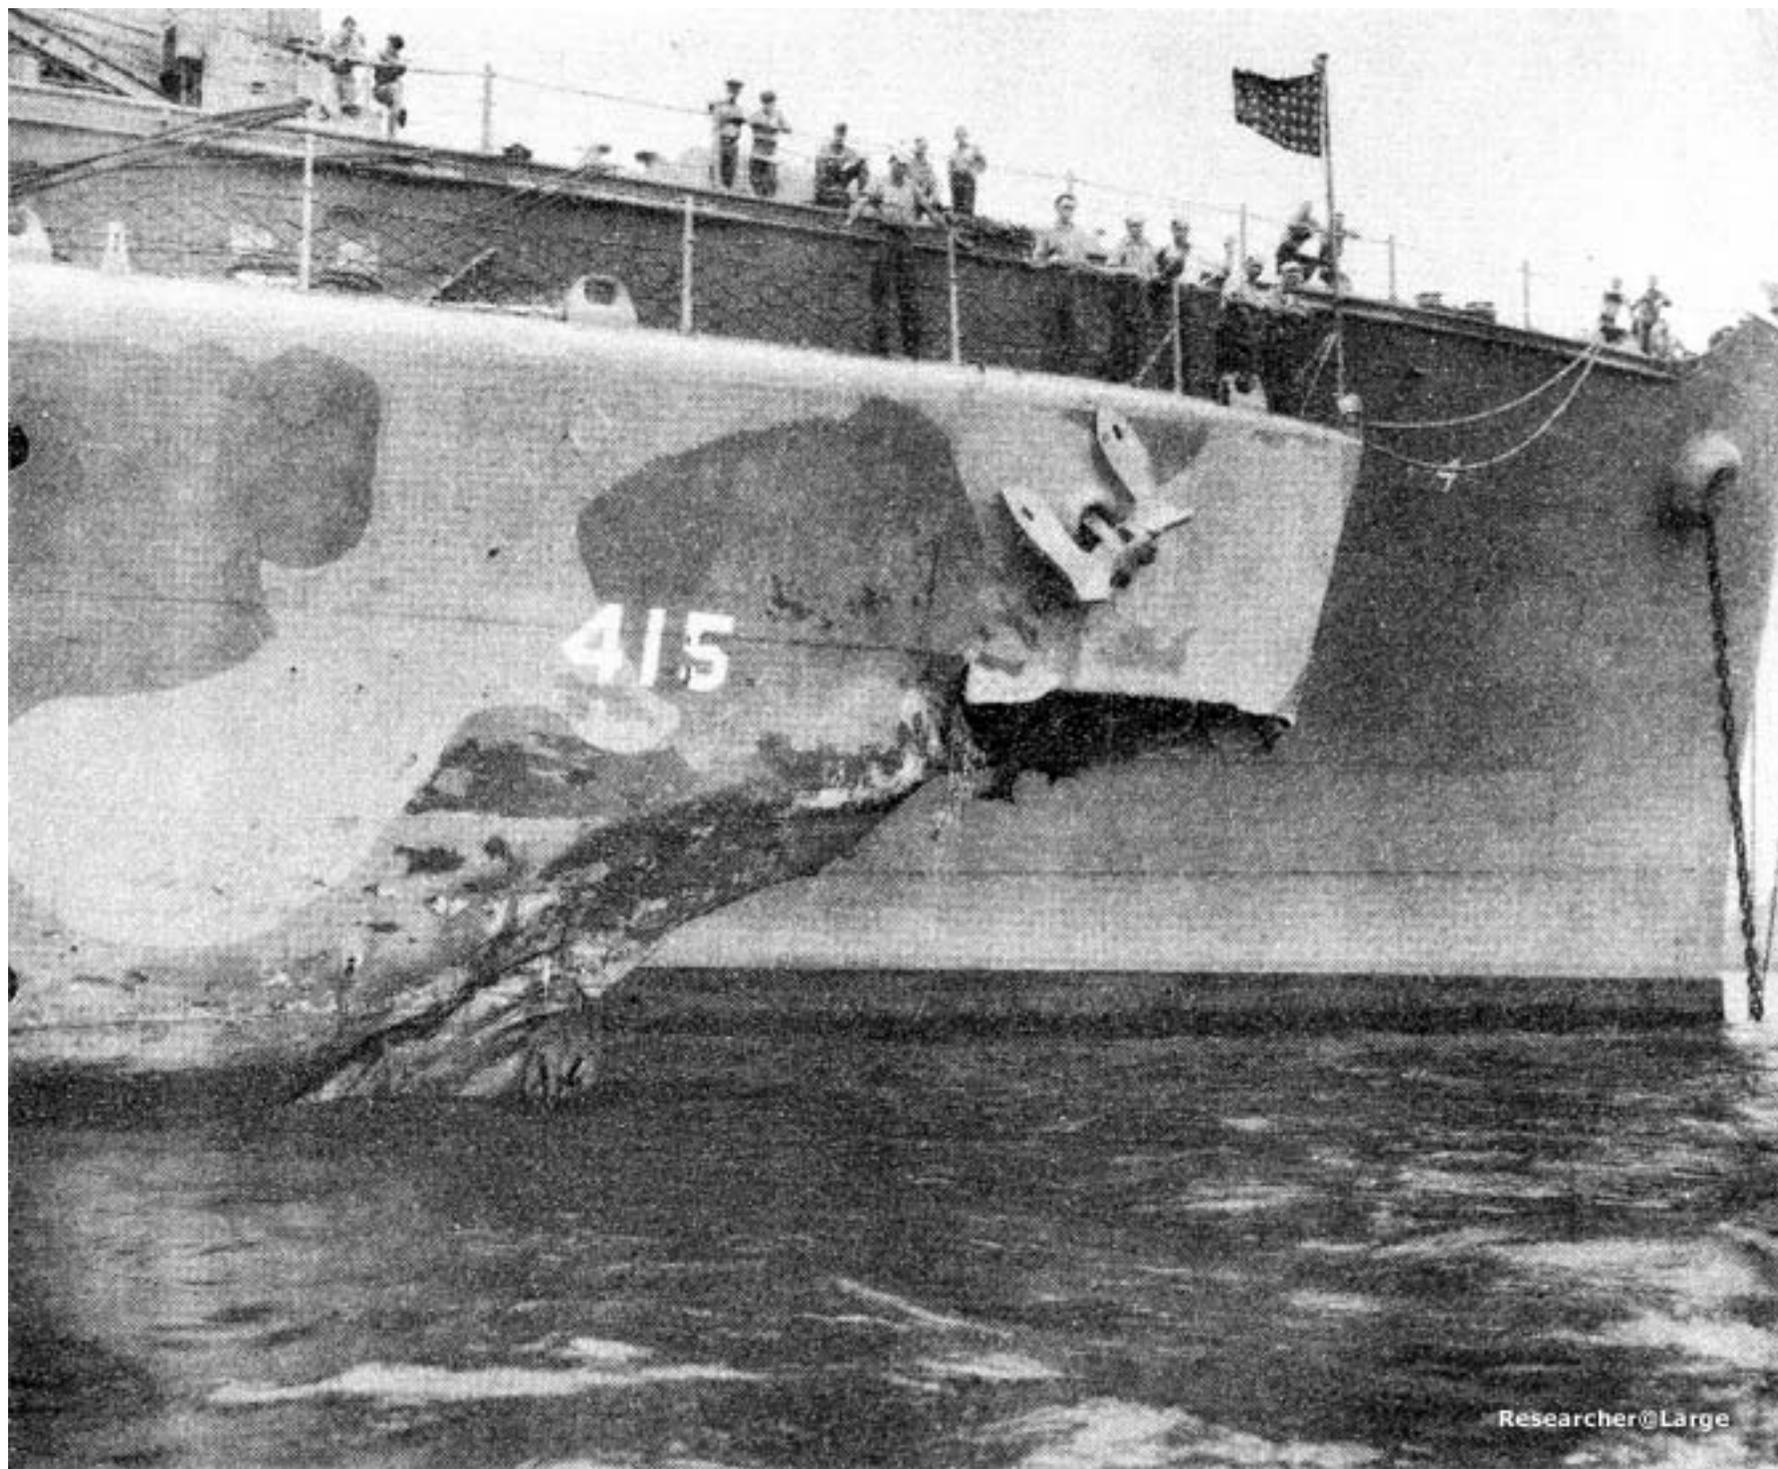
1. On 15 September 1942, a submarine torpedo detonated against the port side of O'BRIEN between the stem and frame 6 and about 10 feet below the waterline. The resulting local structural damage is shown in Photos 32 and 33 and Plate 17. The bow structure, below the main deck and aft to Frame 10 was blown away. Framing and plating were distorted back to frame 14. Free flooding occurred below the first platform between frames 10 and 22. As the bow plunged into sea, compartment A-202L on the first platform flooded slowly to a depth of 2 feet through ruptures in the first platform and bulkhead 14. Bulkhead 22 bulged aft but remained tight. Bulkhead 25 was not damaged. The draft forward, which was 11' 7" before damage, increased to 12' 2". This damage in itself was not serious and would not have placed the vessel in jeopardy.

Photo 32: O'BRIEN DD415 Damage to bow from torpedo hit.

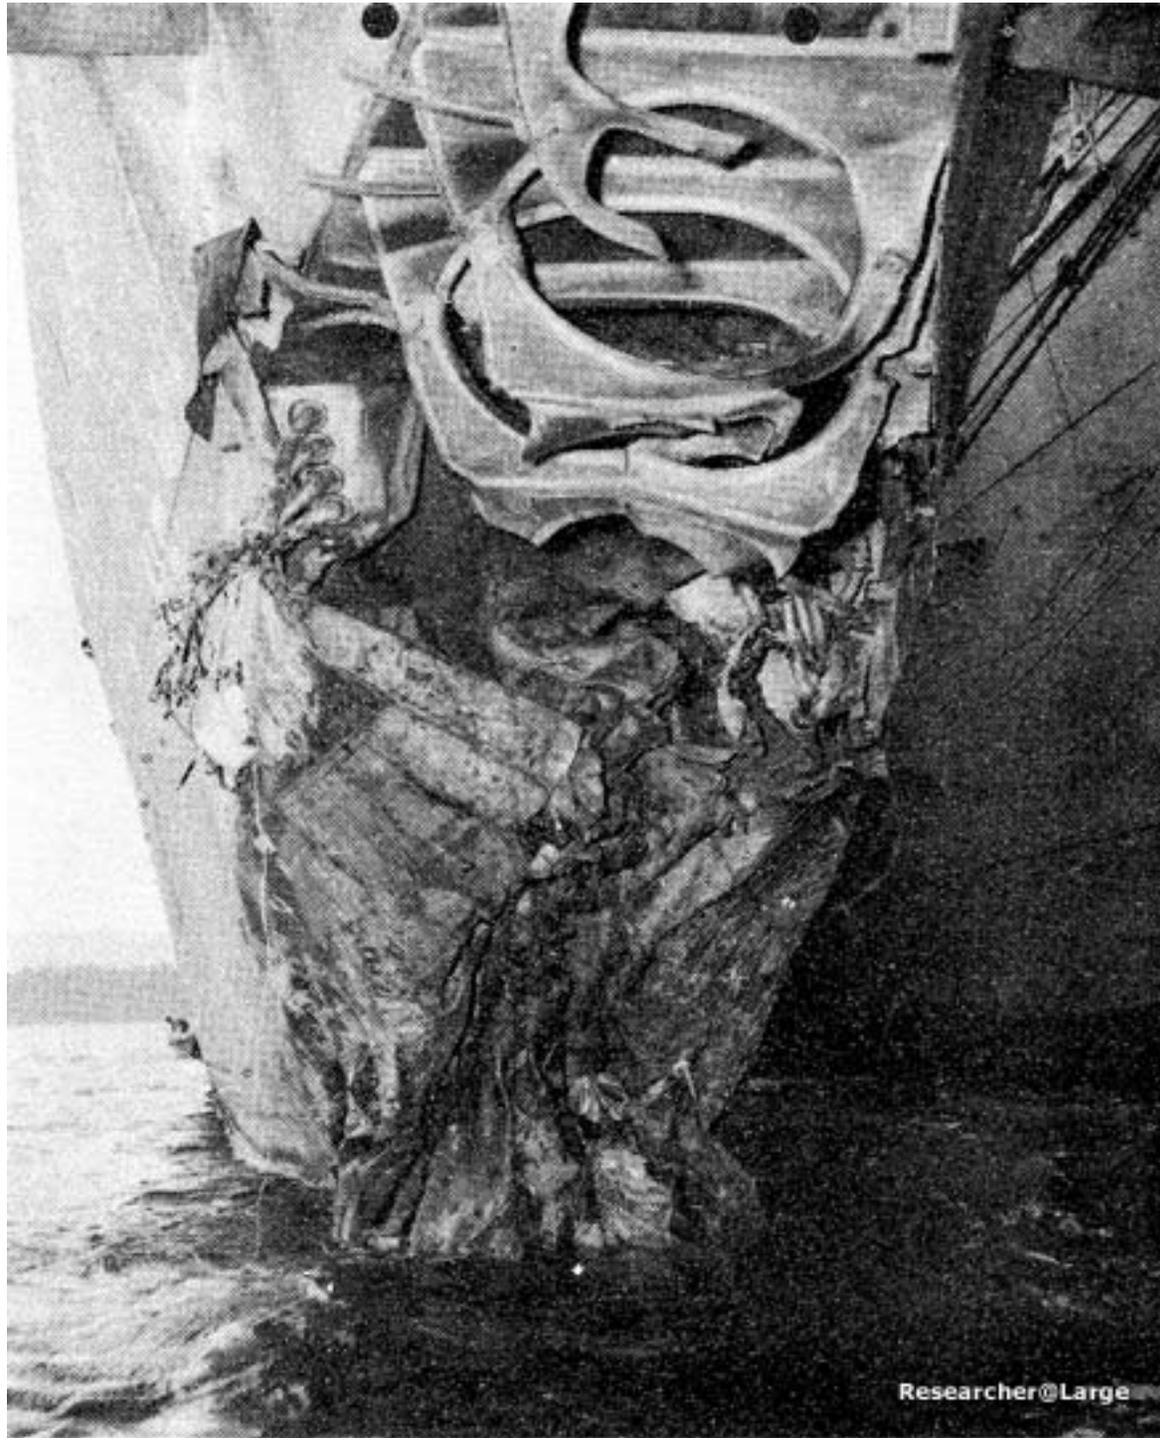
Photo 33: O'BRIEN DD415 Damage to bow from torpedo hit.

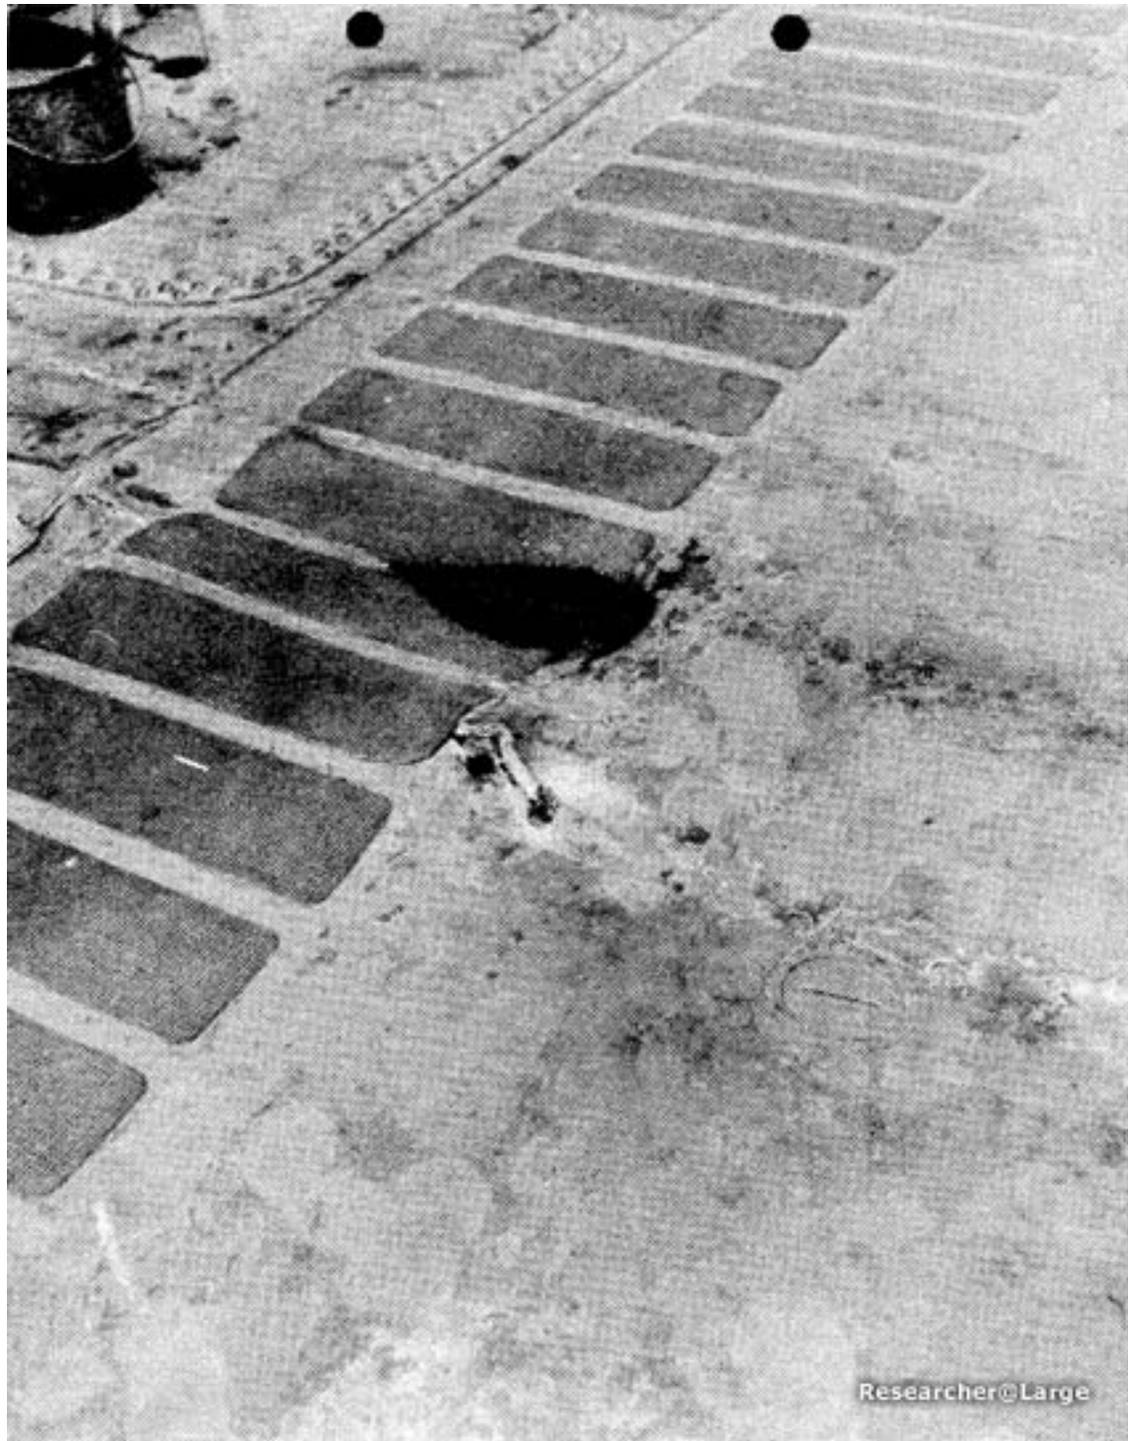
2. The explosion also caused severe flexural vibration of the hull girder. Photos 34 and 35 and Plate 17 show some of the moderate buckling of hull plating and longitudinals which resulted near frames 37, 78 and 123. The most serious failures were in the bottom structure between frames 104 and 108. Wrinkling and buckling of the shell and longitudinals extended from frame 104, starboard, across the bottom to frame 108, port. In this region the vertical keel, No. 2 and 6 deep longitudinals, several smaller longitudinals and shell plating all failed to some degree. Thus, the entire bottom flange of the ship girder was seriously damaged. In this area many rivets were loosened or sheared. There was considerable leakage through rivet holes and open seams into the forward engine room. Gun roller path data indicated that the after portion of the ship was twisted 1° to port.

Photo 34: O'BRIEN DD415 Crack and wrinkle in main deck plating frame 78, starboard, caused by flexural vibration resulting from torpedo detonation near the bow.

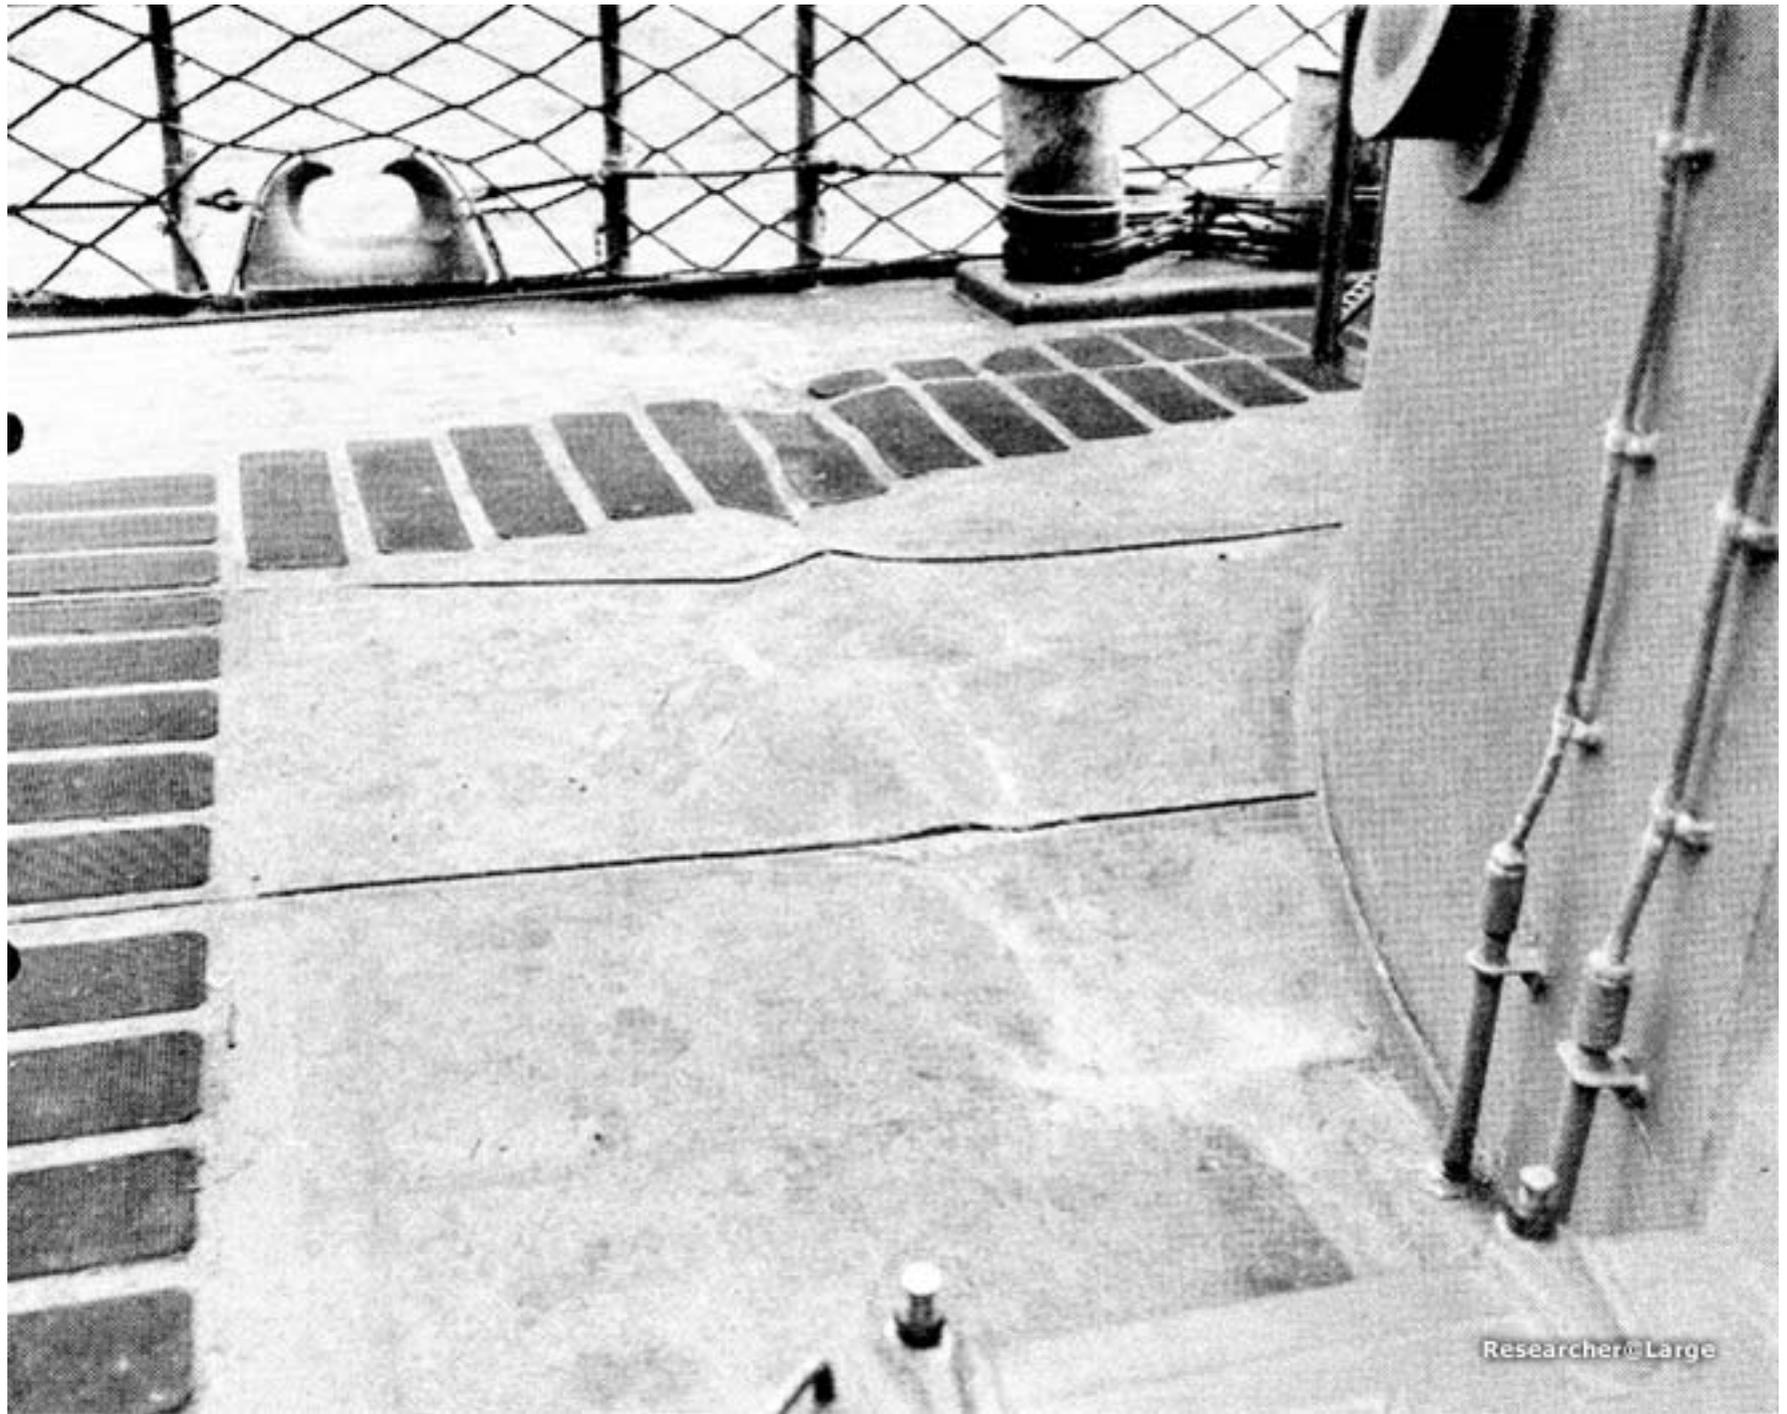
Photo 35: O'BRIEN DD415 Wrinkles in forecastle deck, frame 37, starboard, caused by flexural vibration resulting from torpedo detonation near the bow.

- A partial bow section extending about half way to the waterline was installed to protect against the force of the seas during pitching.
- At frame 37, starboard, four vertical flat bar longitudinal stiffeners were installed on the forecastle deck and two partial longitudinals were installed to reinforce the sheer strake.
- At frame 77, starboard, three new longitudinal sections were installed to replace fractured girders under the sheer strake. In addition, a

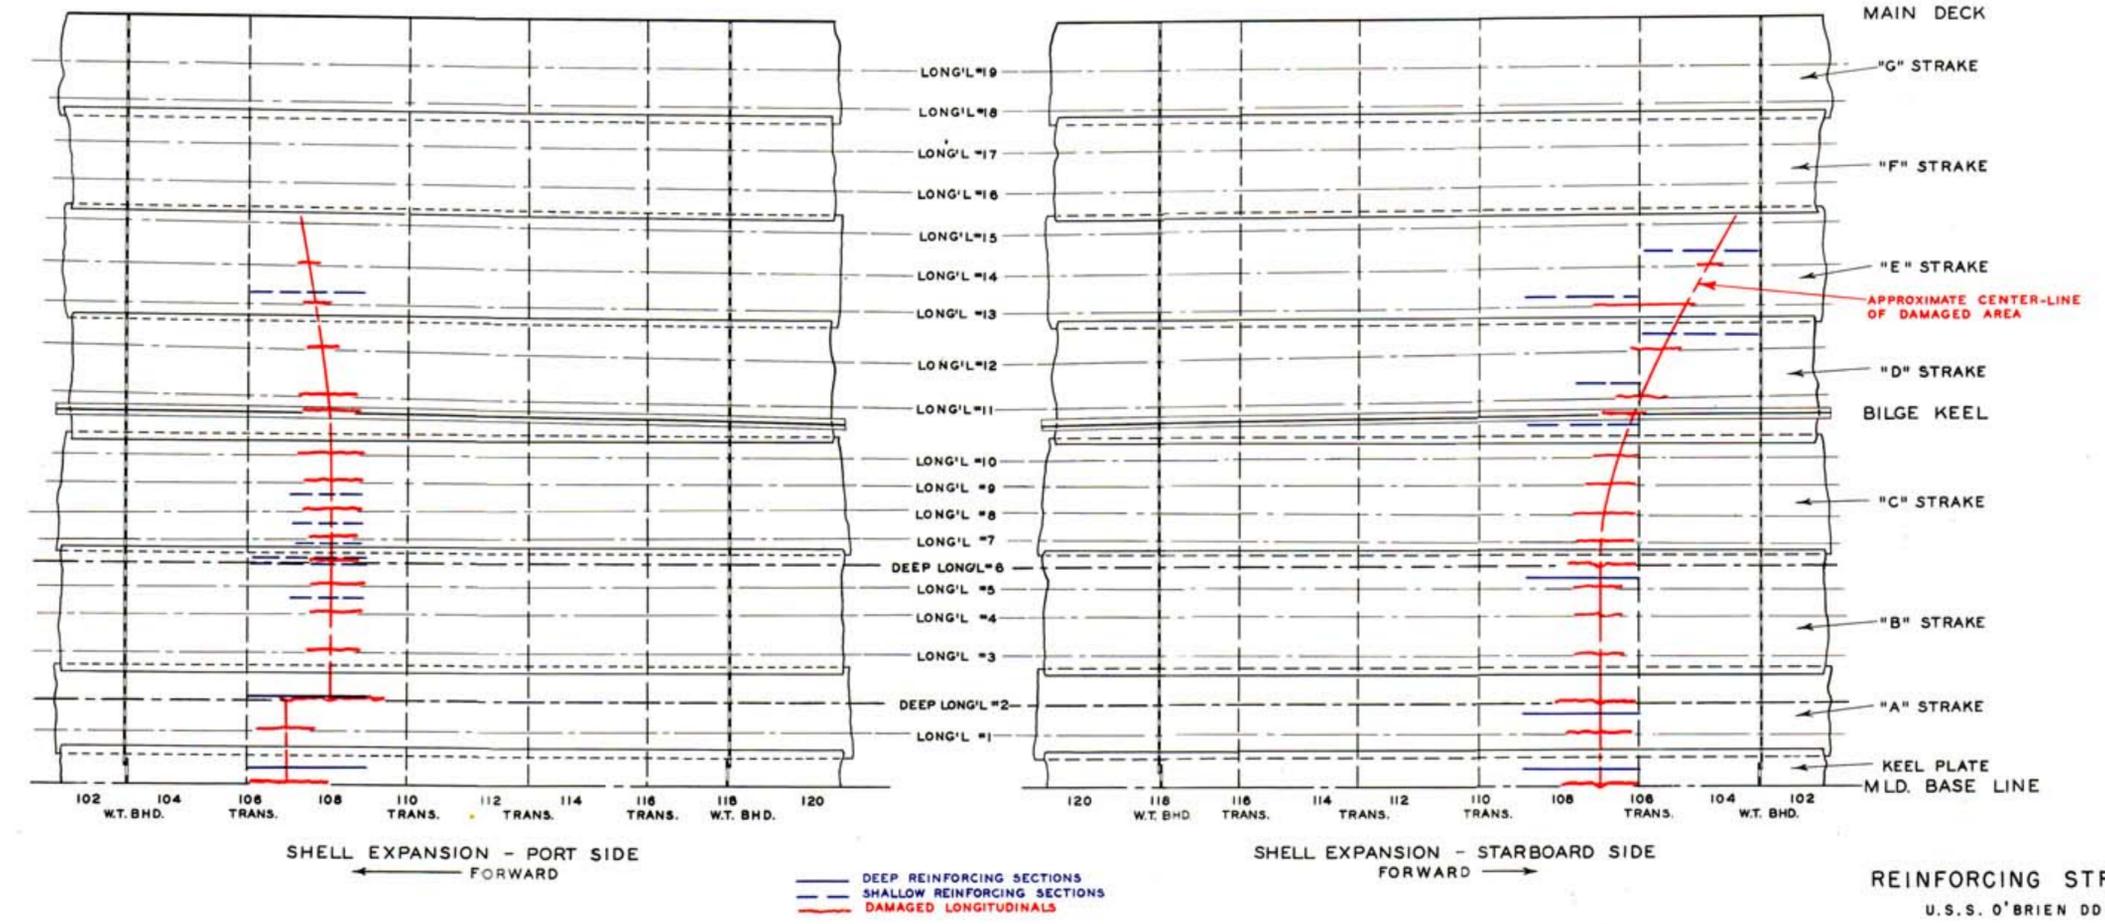
Plate 18: Reinforcing Structure, U.S.S. O'Brien DD415

12. O'BRIEN was lost because the repairs to the ship girder did not restore adequate longitudinal strength. Deficiencies in the repairs are:

- The damaged material was not replaced adequately. 260 square inches of material was damaged in some degree and only 100 square inches was replaced. It appears that the area lost due to wrinkled bottom plating was completely neglected. Medium steel was used to replace damaged high tensile steel without compensation for the difference in strength of the two materials.

- The replacement longitudinals were not of sufficient size and length, and were not properly located to distribute the loads properly. Since the longitudinals were only 63" long and the distance between web frames was 108", the longitudinals obviously were not long enough to convey the loading to intact structure and the ends could not have been adequately connected. The replacement longitudinals were not in line with the existing structure. This eccentric arrangement resulted in stress concentrations at the ends of both the replacement and the original longitudinals. The omission of additional plating or flanges on the lower end of the replacement longitudinals also served to increase the stress in these members.

- Details of repairs to the bottom structure, frames 103-109, in the forward engine room, are shown in Plate 18. Significant features of these repairs are:

- Deep sections were 21" x 10" x 3/8" welded T's, and extended over a length of 3 frame spaces (63"). Shallow sections were 4" x 3" x 12 1/2# welded T's and covered 2 to 3 frames. These scantlings were about the same or larger than those of the longitudinal which the temporary member was to reinforce.
- The reinforcing longitudinals were offset transversely from the damaged longitudinals they were meant to replace. The length of the new longitudinals was less than the distance between transverse web frames.
- No replacement was made for the loss of effective area of the hull girder resulting from damaged bottom plating.
