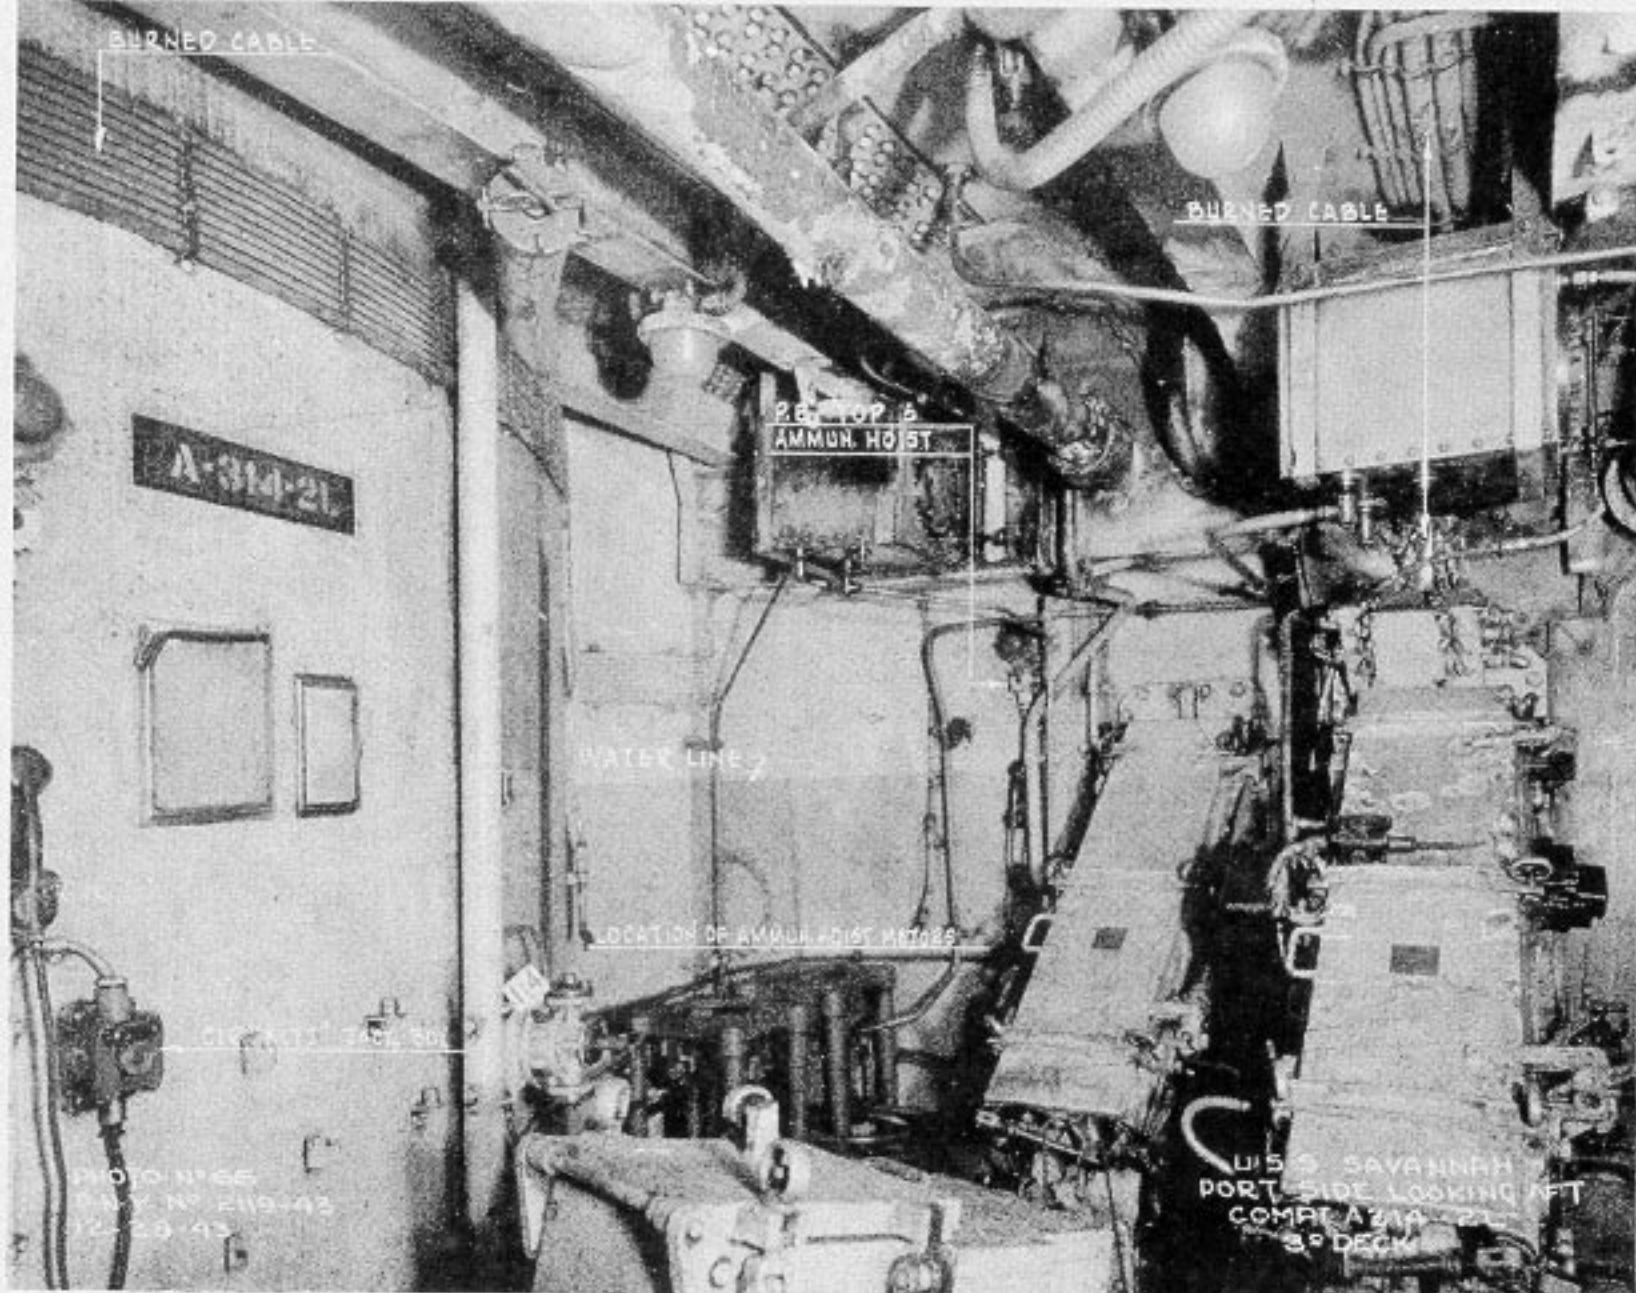
Photo 15: Compartment A-314-2L, third deck to starboard of No. 3 barbette. Note waterline and evidence of fire.

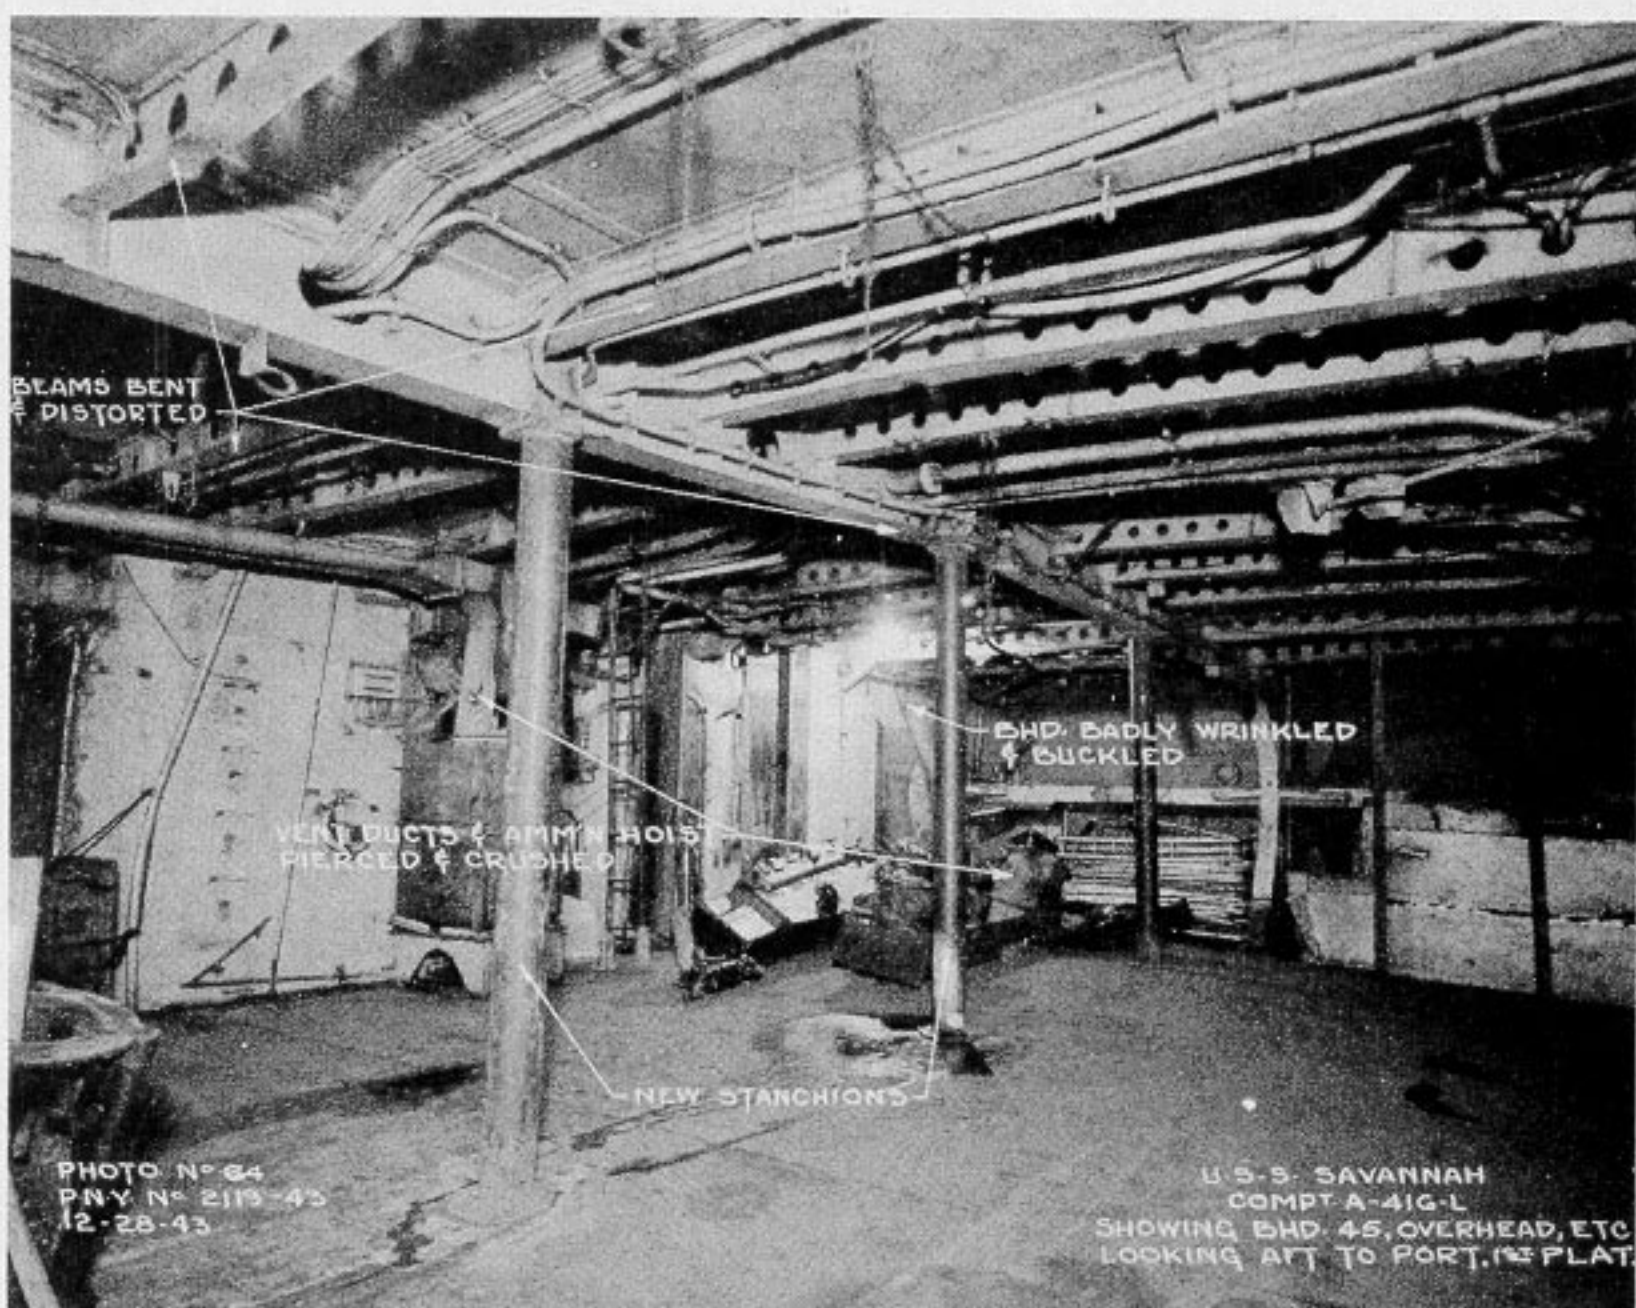
Photo 16: Compartment A-416-L, first platform, frames 39 to 45. Looking aft and across to port shell.

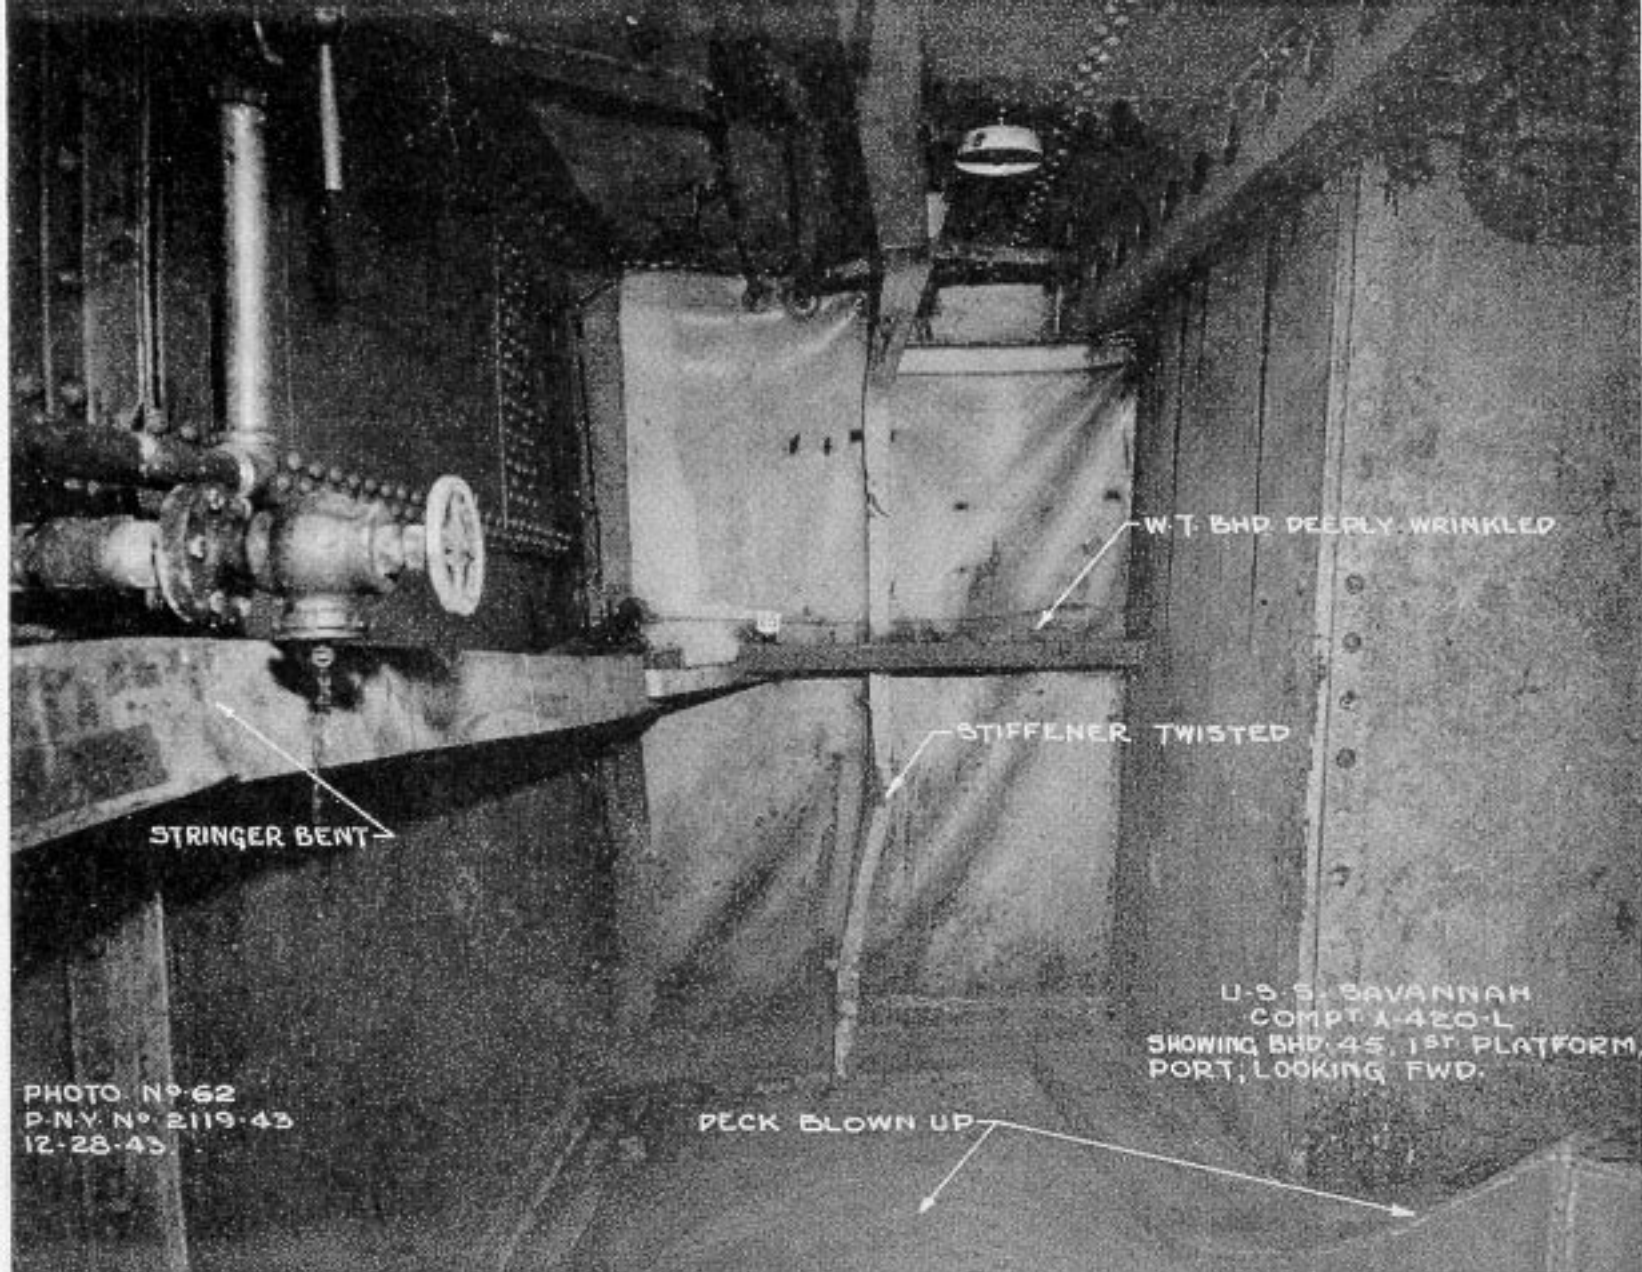
Photo 17: Compartment A-420-L, first platform, frames 45 to 49 port. Looking forward to bulkhead 45. Note excellent condition of armored trunk (1-1/2-inch STS) in right side. Lifting of armored deck (2-inch STS) extended to after edge of this trunk, see lower right corner.

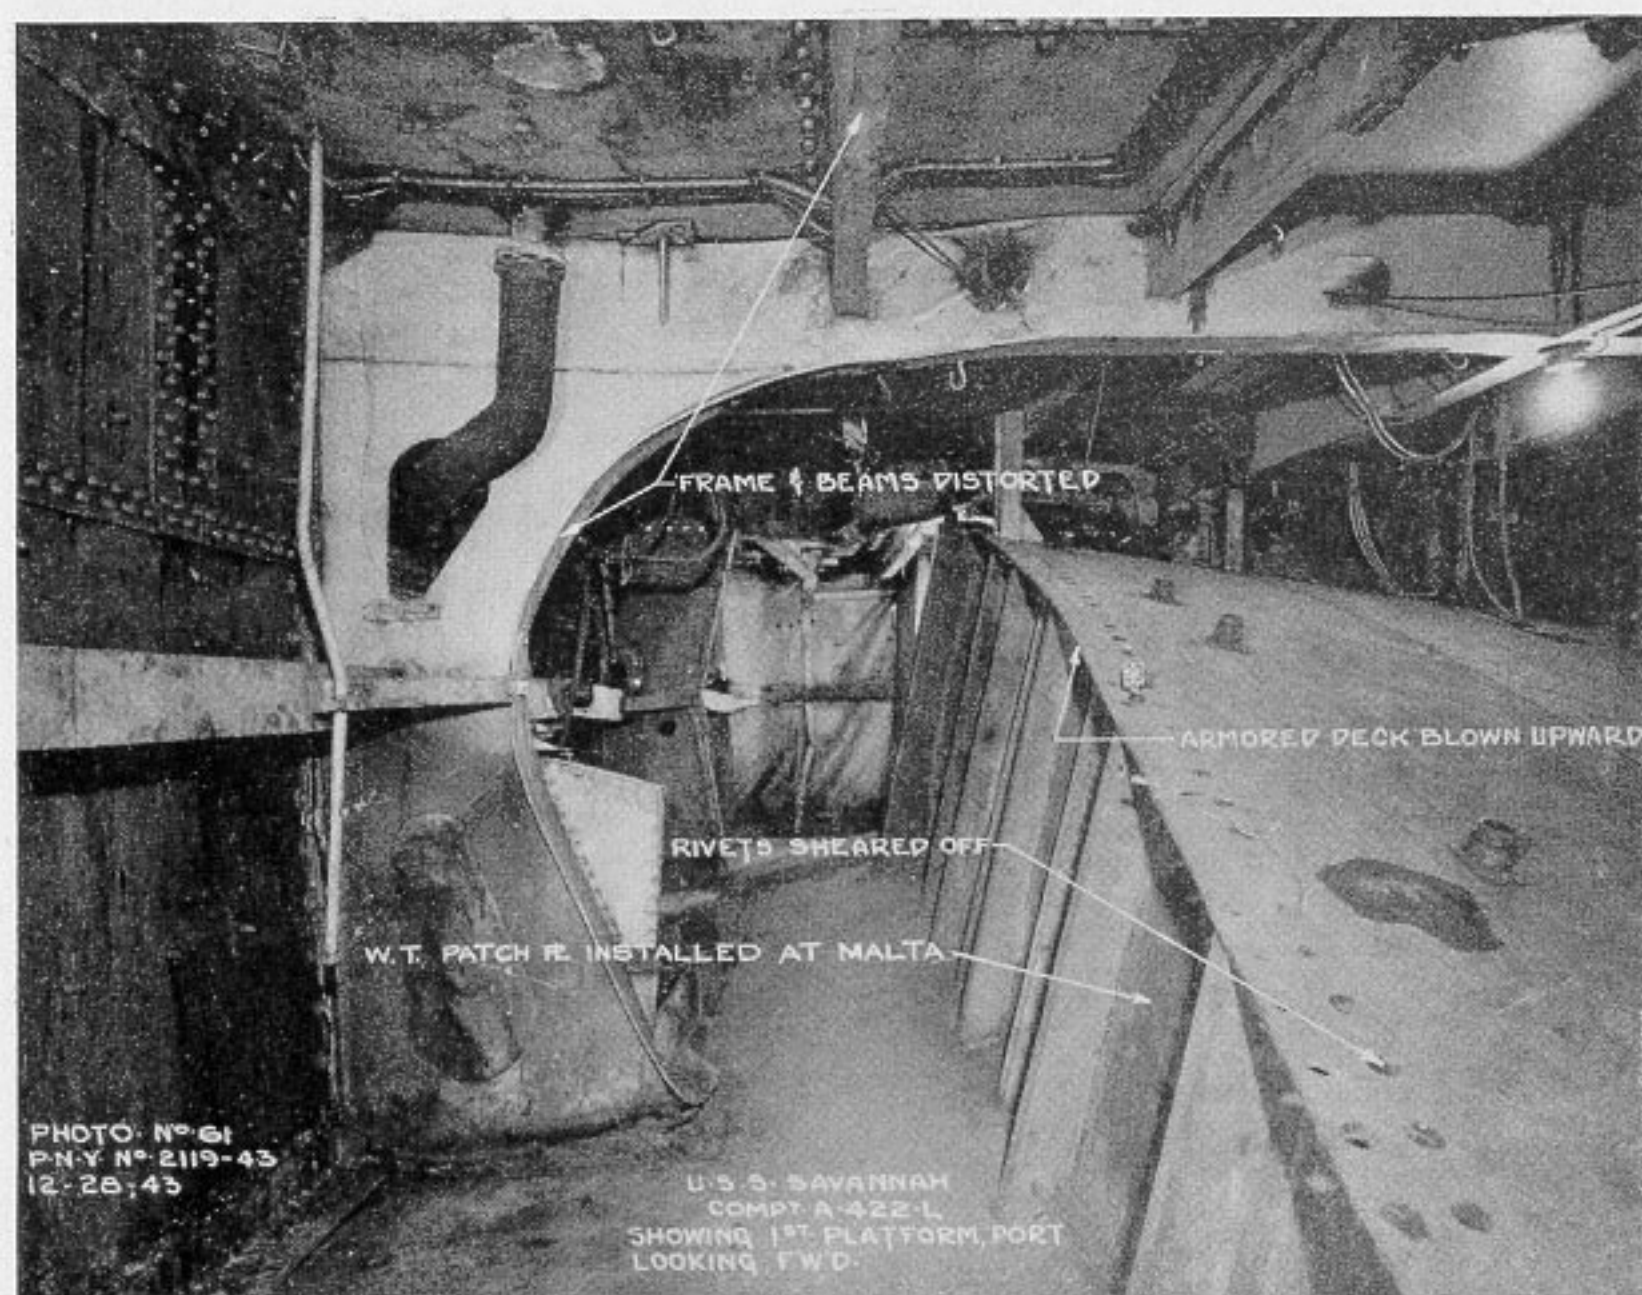
Photo 18: Compartment A-422-L, first platform, frames 49 to 56. Note temporary repairs which made this deck (2-inch STS) watertight for return to U.S.

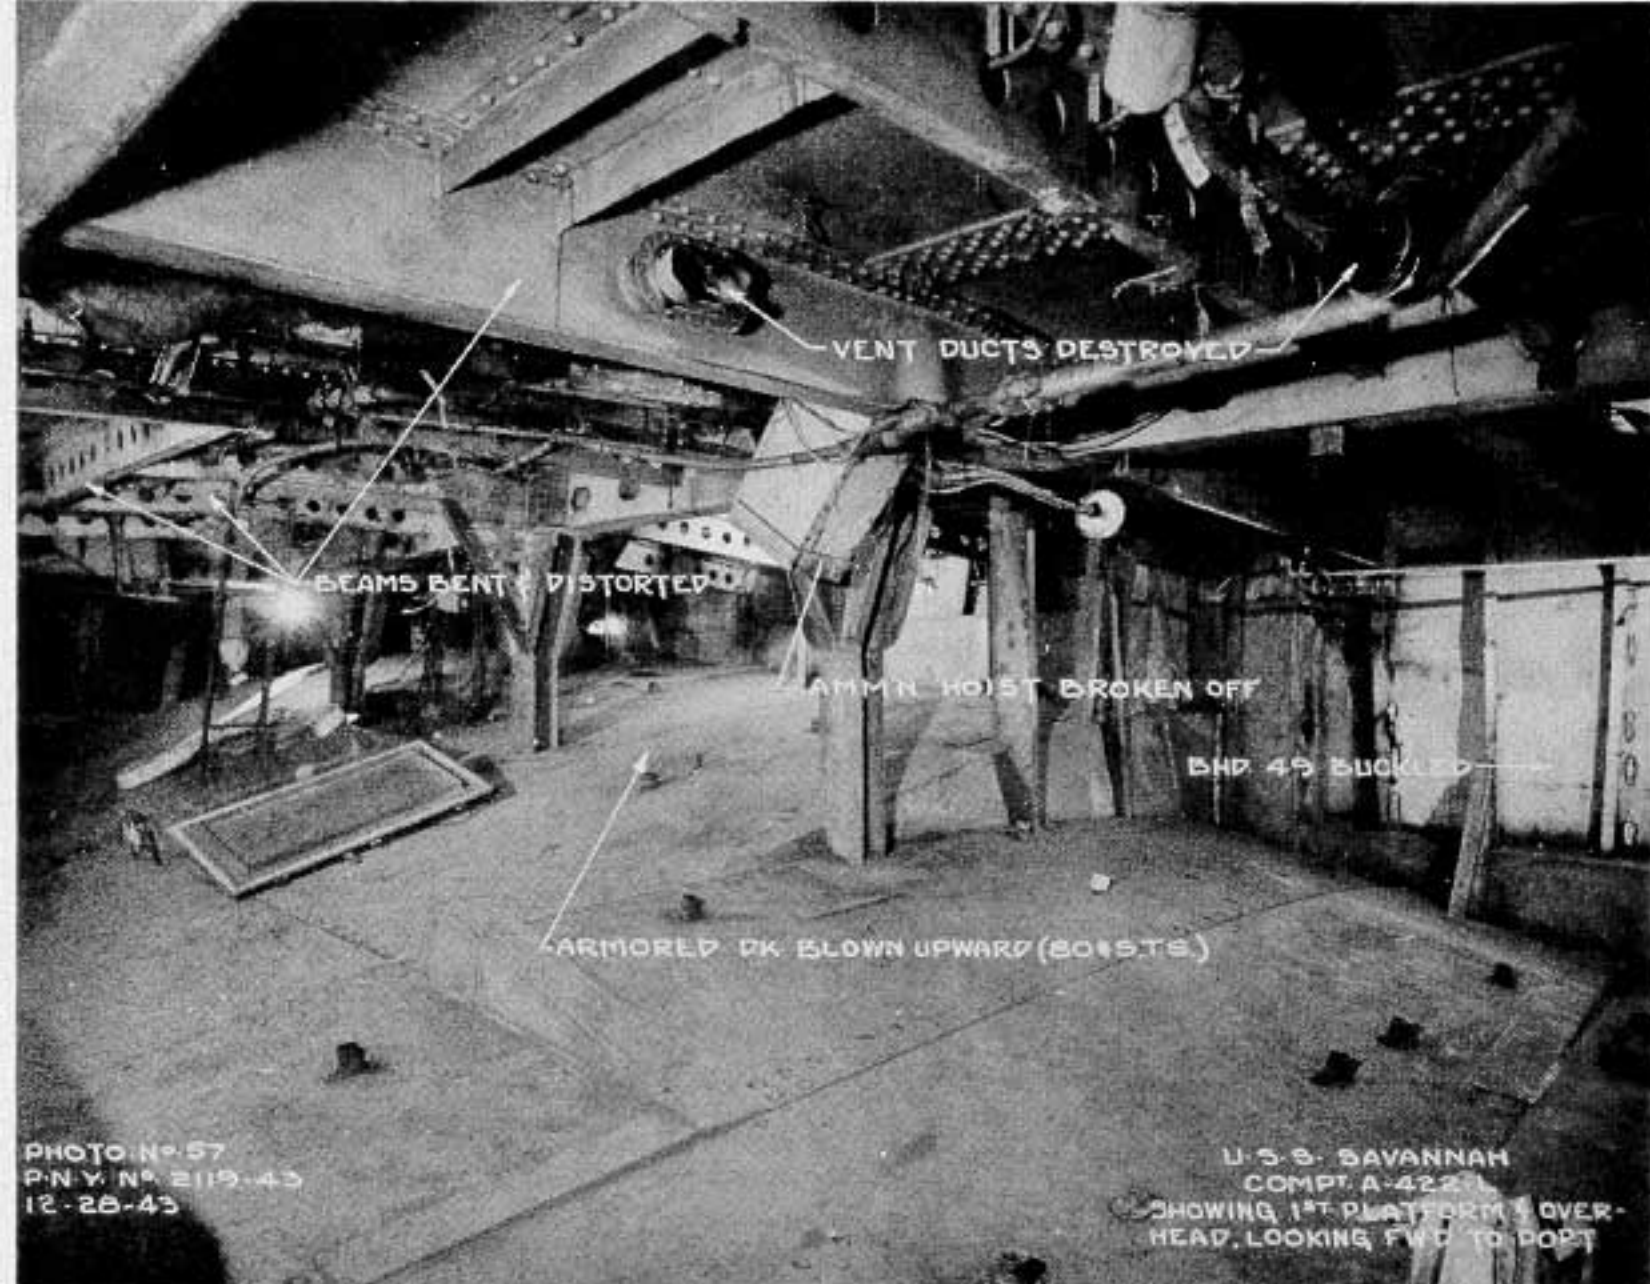
Photo 19: Compartment A-422-L, first platform, frames 49 to 56. Looking forward to bulkhead 49 and to port. The 2-inch STS deck effectively prevented major blast damage to the third deck above.

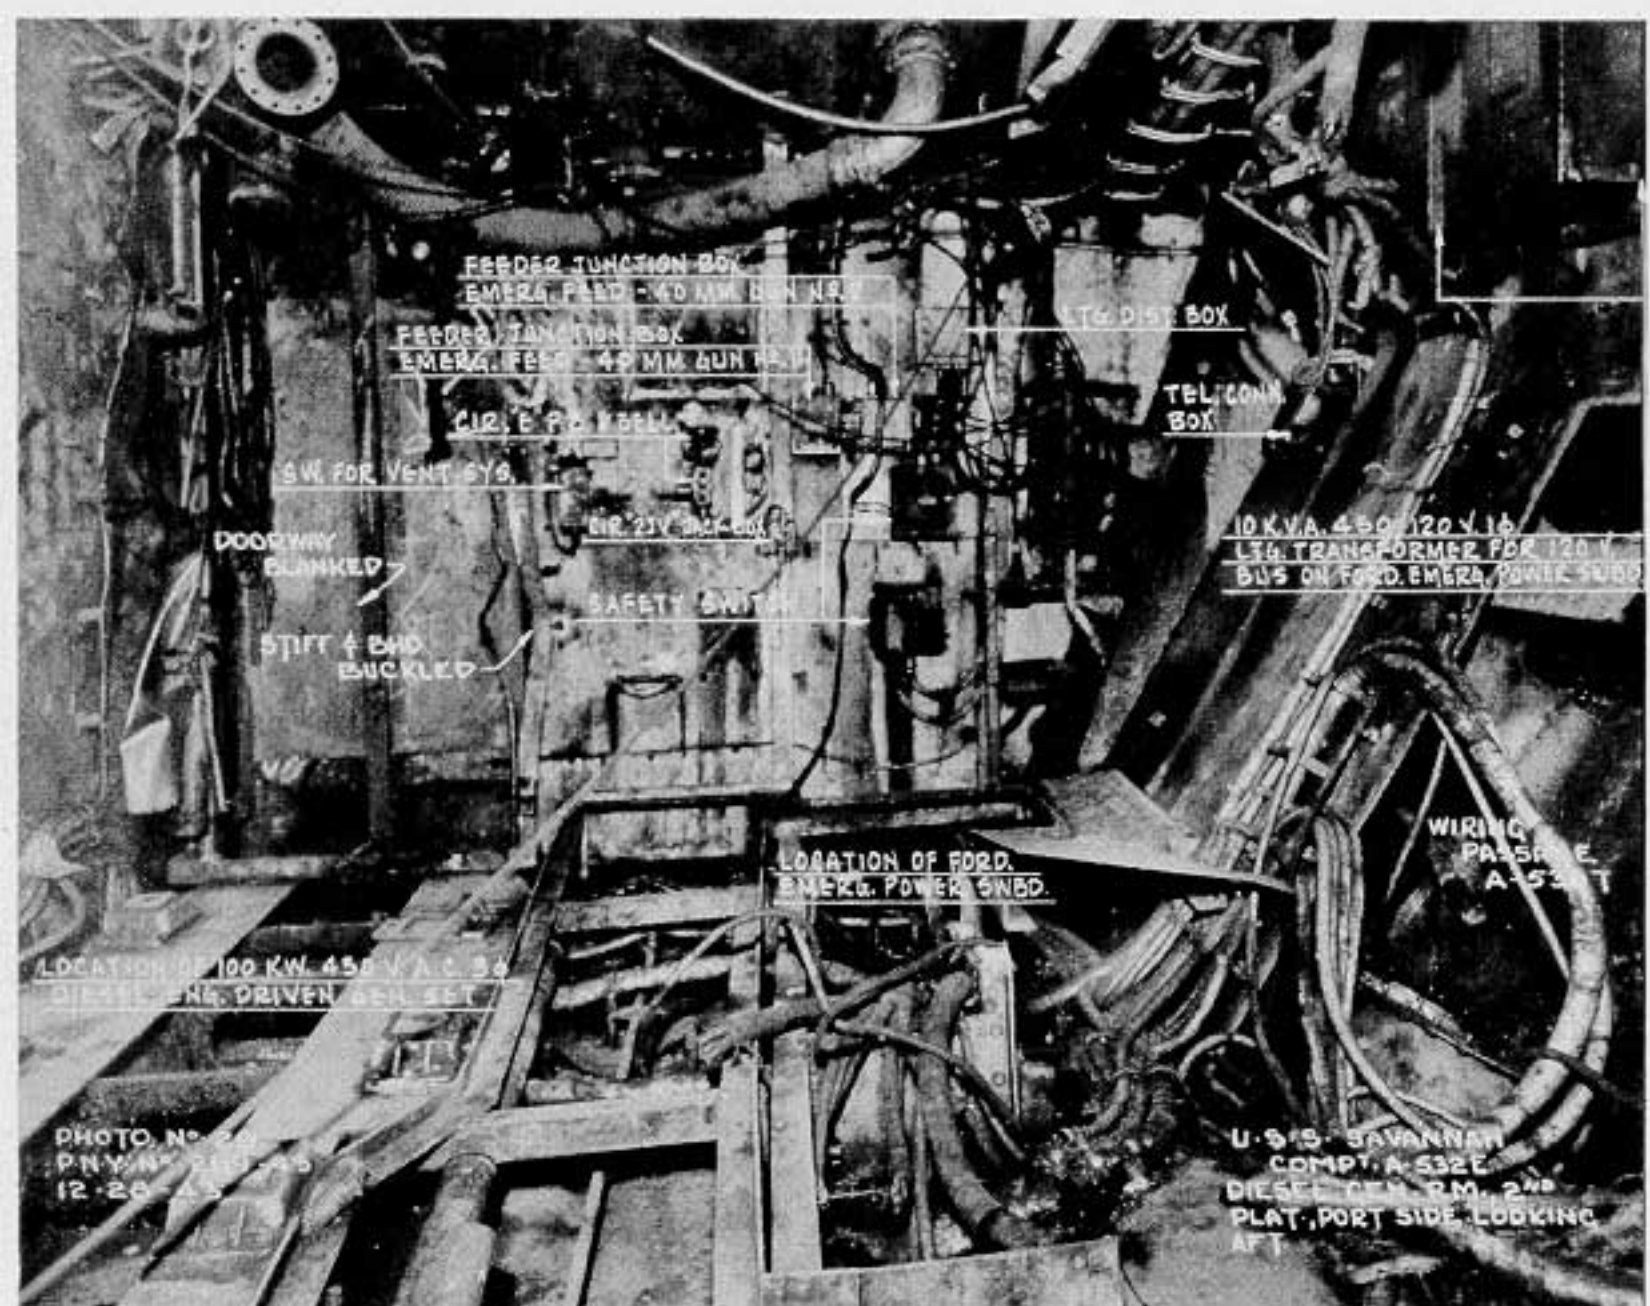
Photo 20: Diesel generator room A-532-E, second platform, frames 52 to 55-1/2 port. Looking aft.

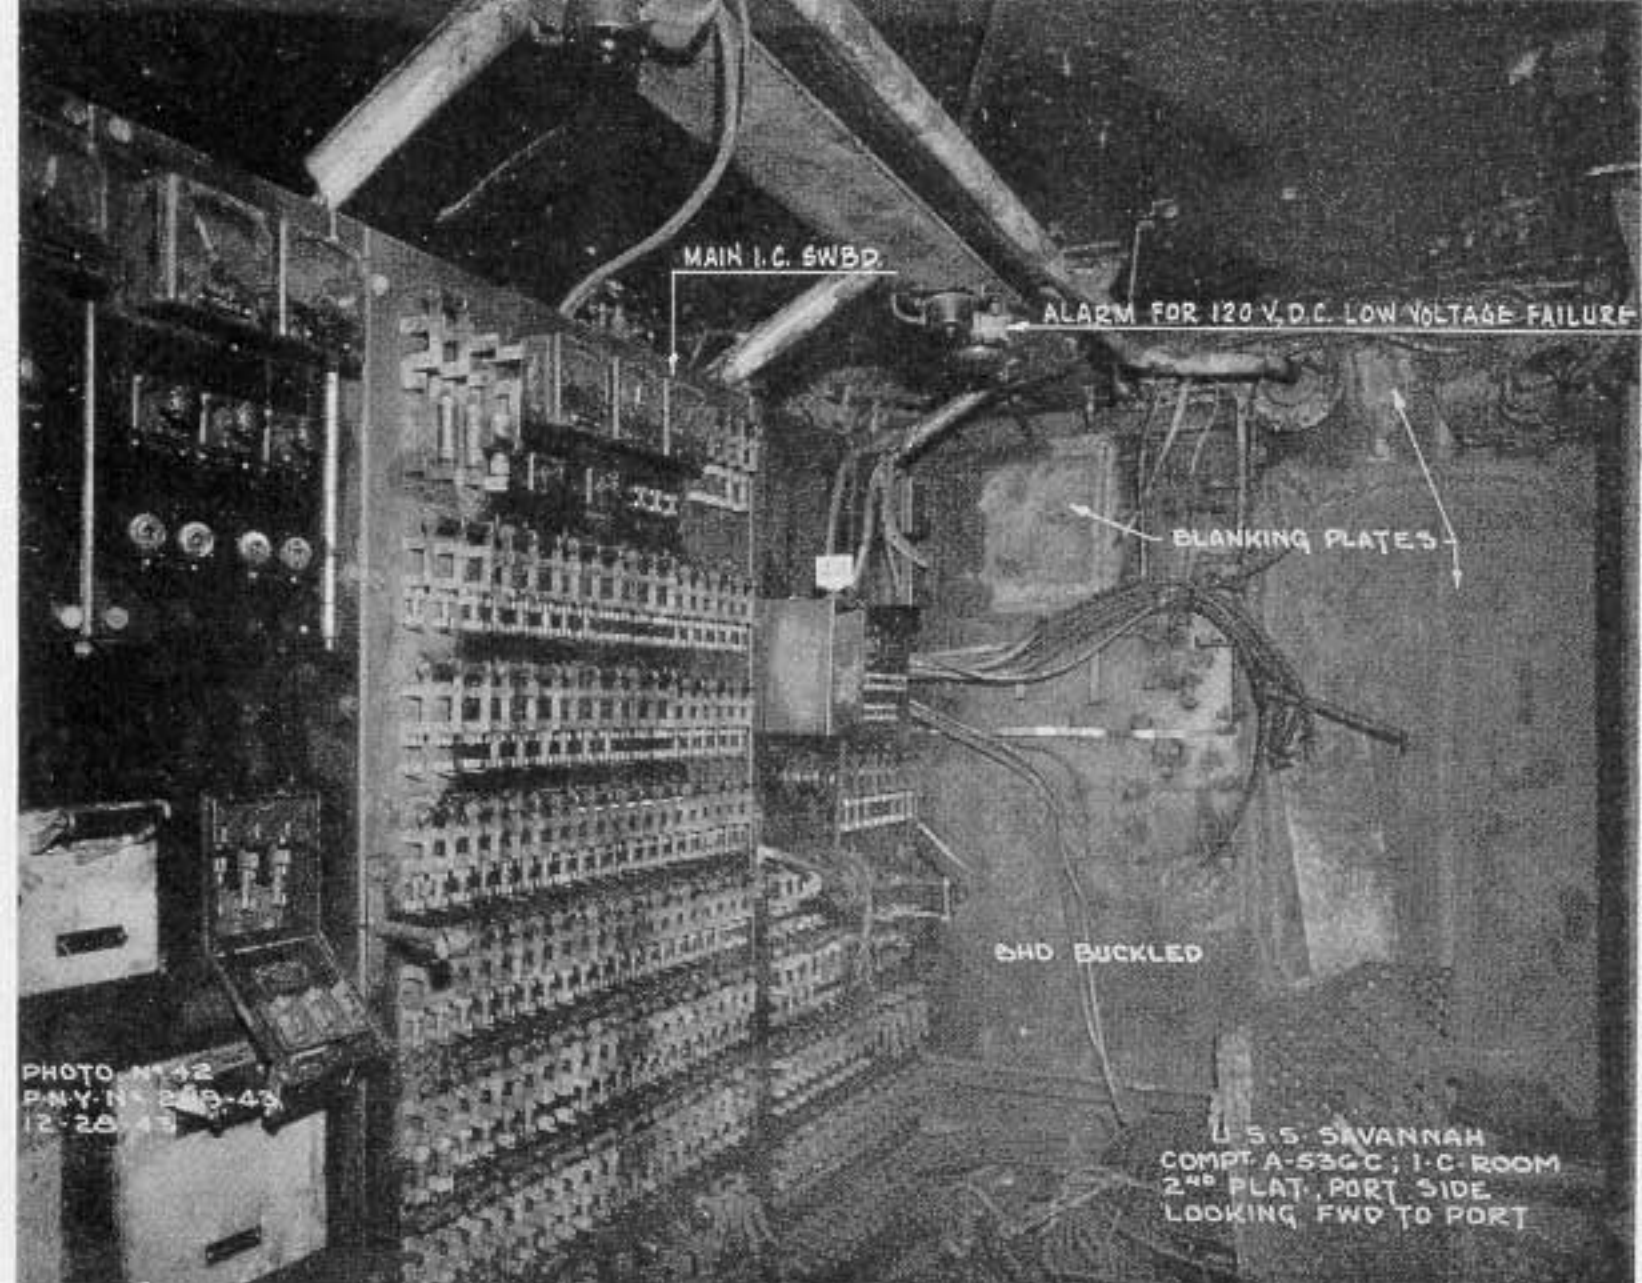
Photo 21: I.C. room A-536-C, second platform, frames 55-1/2 to 61, port. Looking forward to port. The door, which has been blanked, was in bulkhead 55-1/2 and was blown aft.

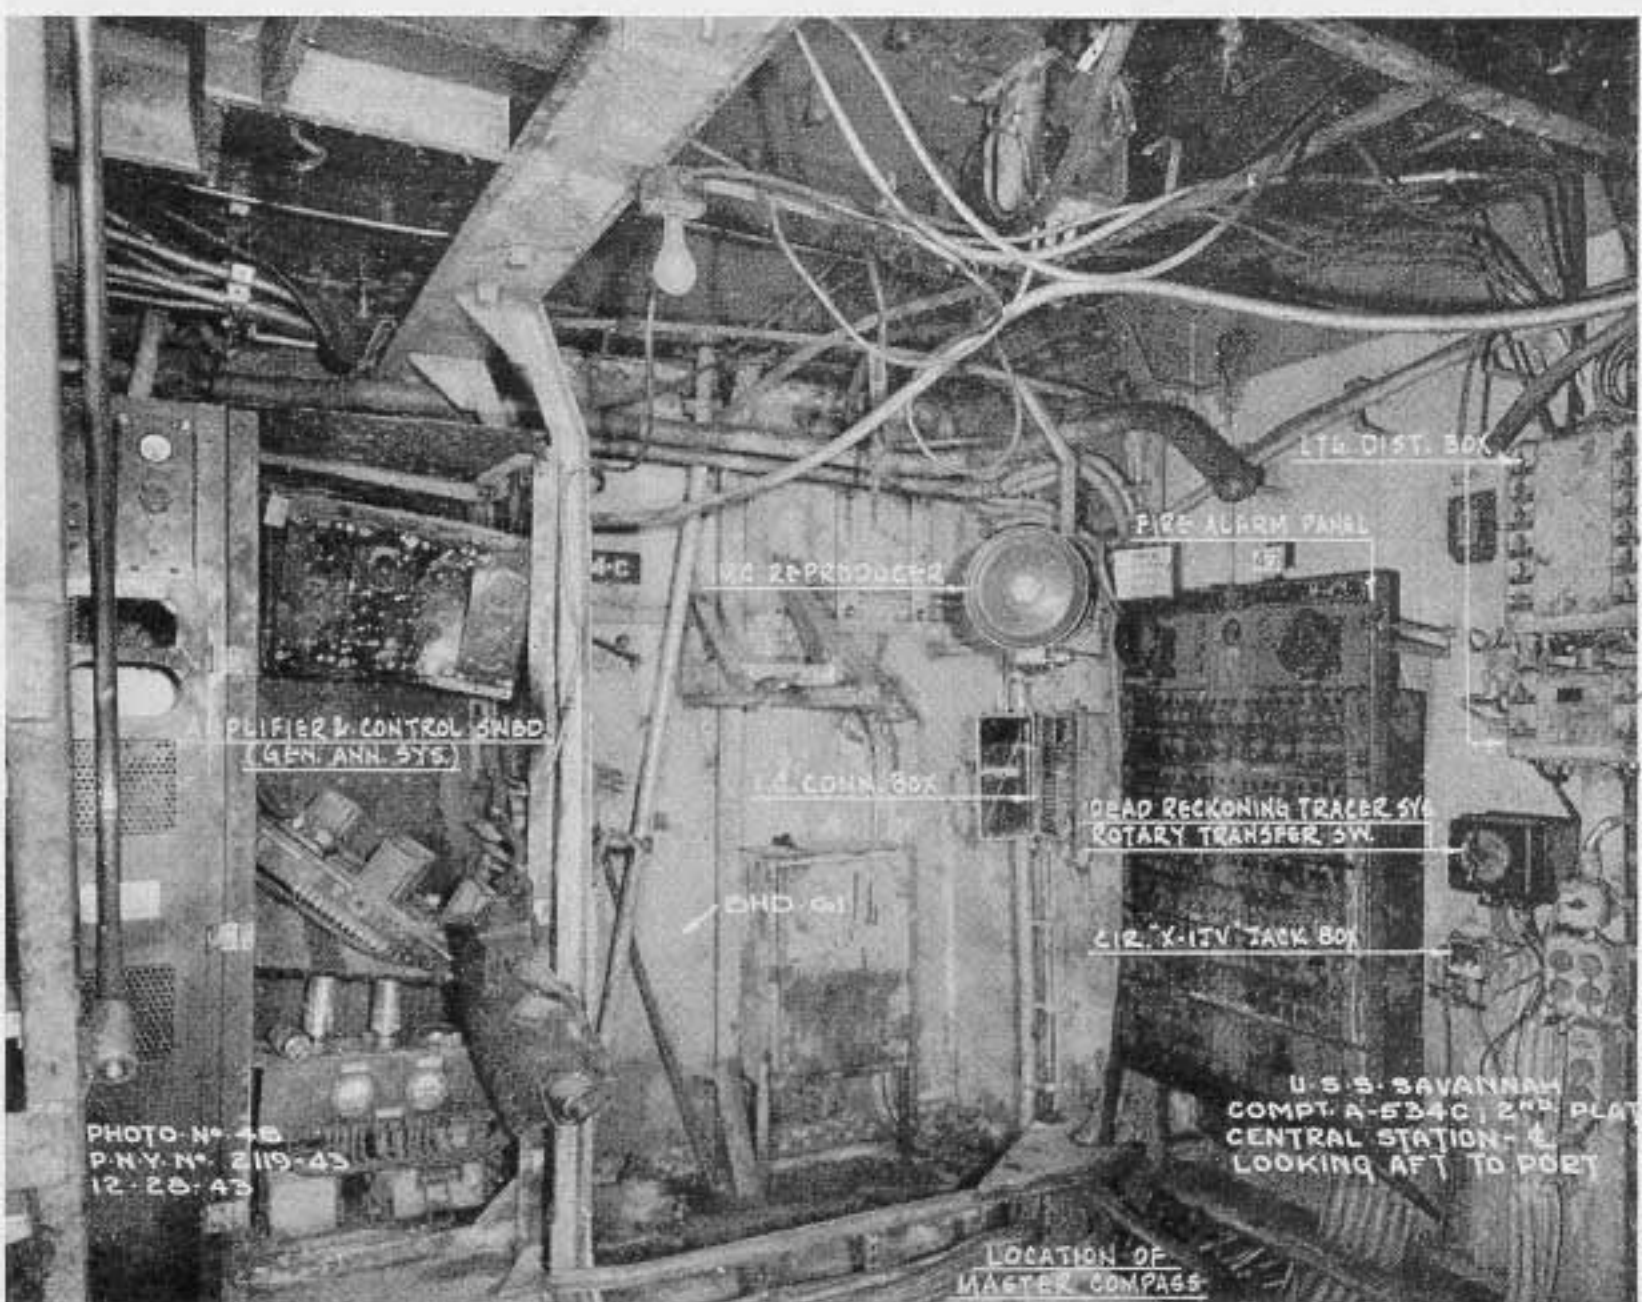
Photo 22: Central station A-534-C, second platform, frames 56 to 61, centerline. Looking aft and to port.
