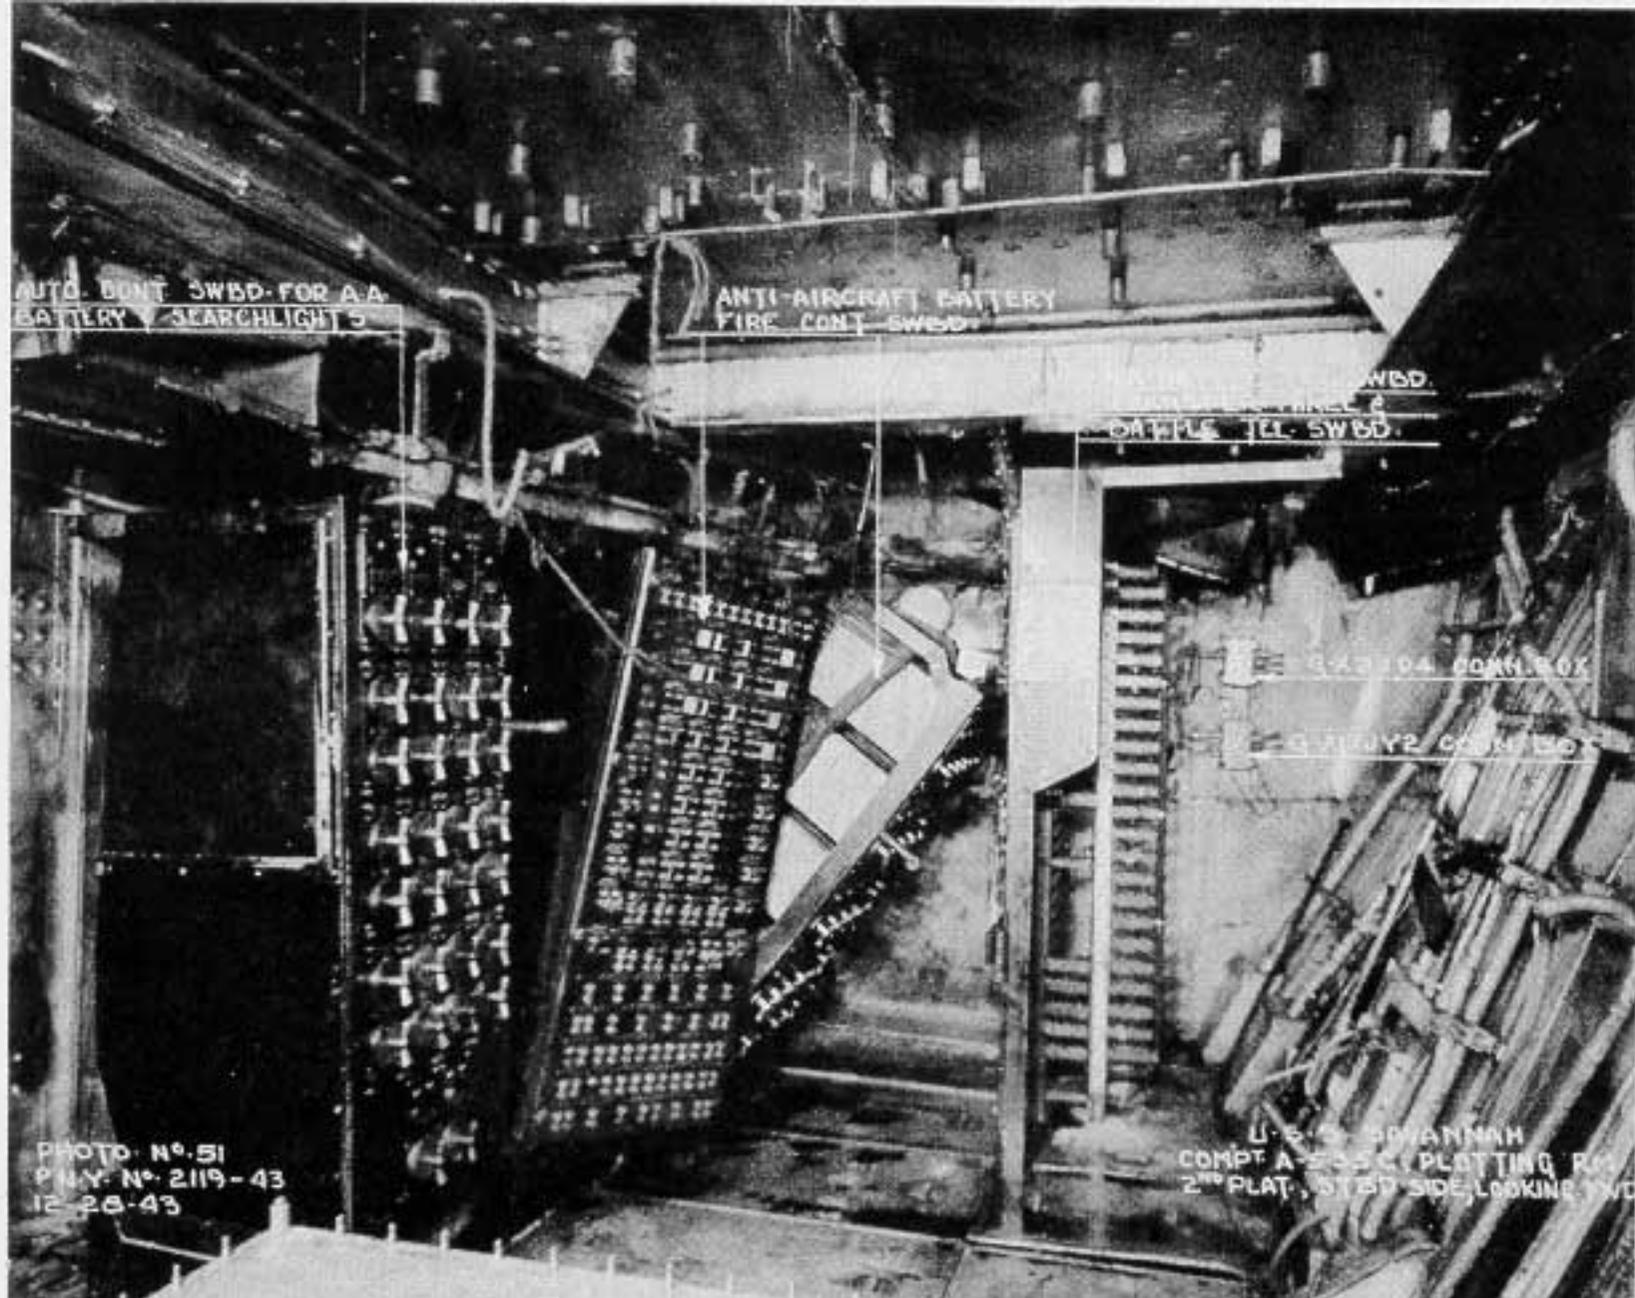
Photo 23: Plotting room A-535-C, second platform, frames 53 to 61, starboard. Looking forward to bulkhead 53. Bulkhead 53 and the inboard longitudinal bulkhead were intact except that bulkhead 53 was ripped loose at the top from the first platform.

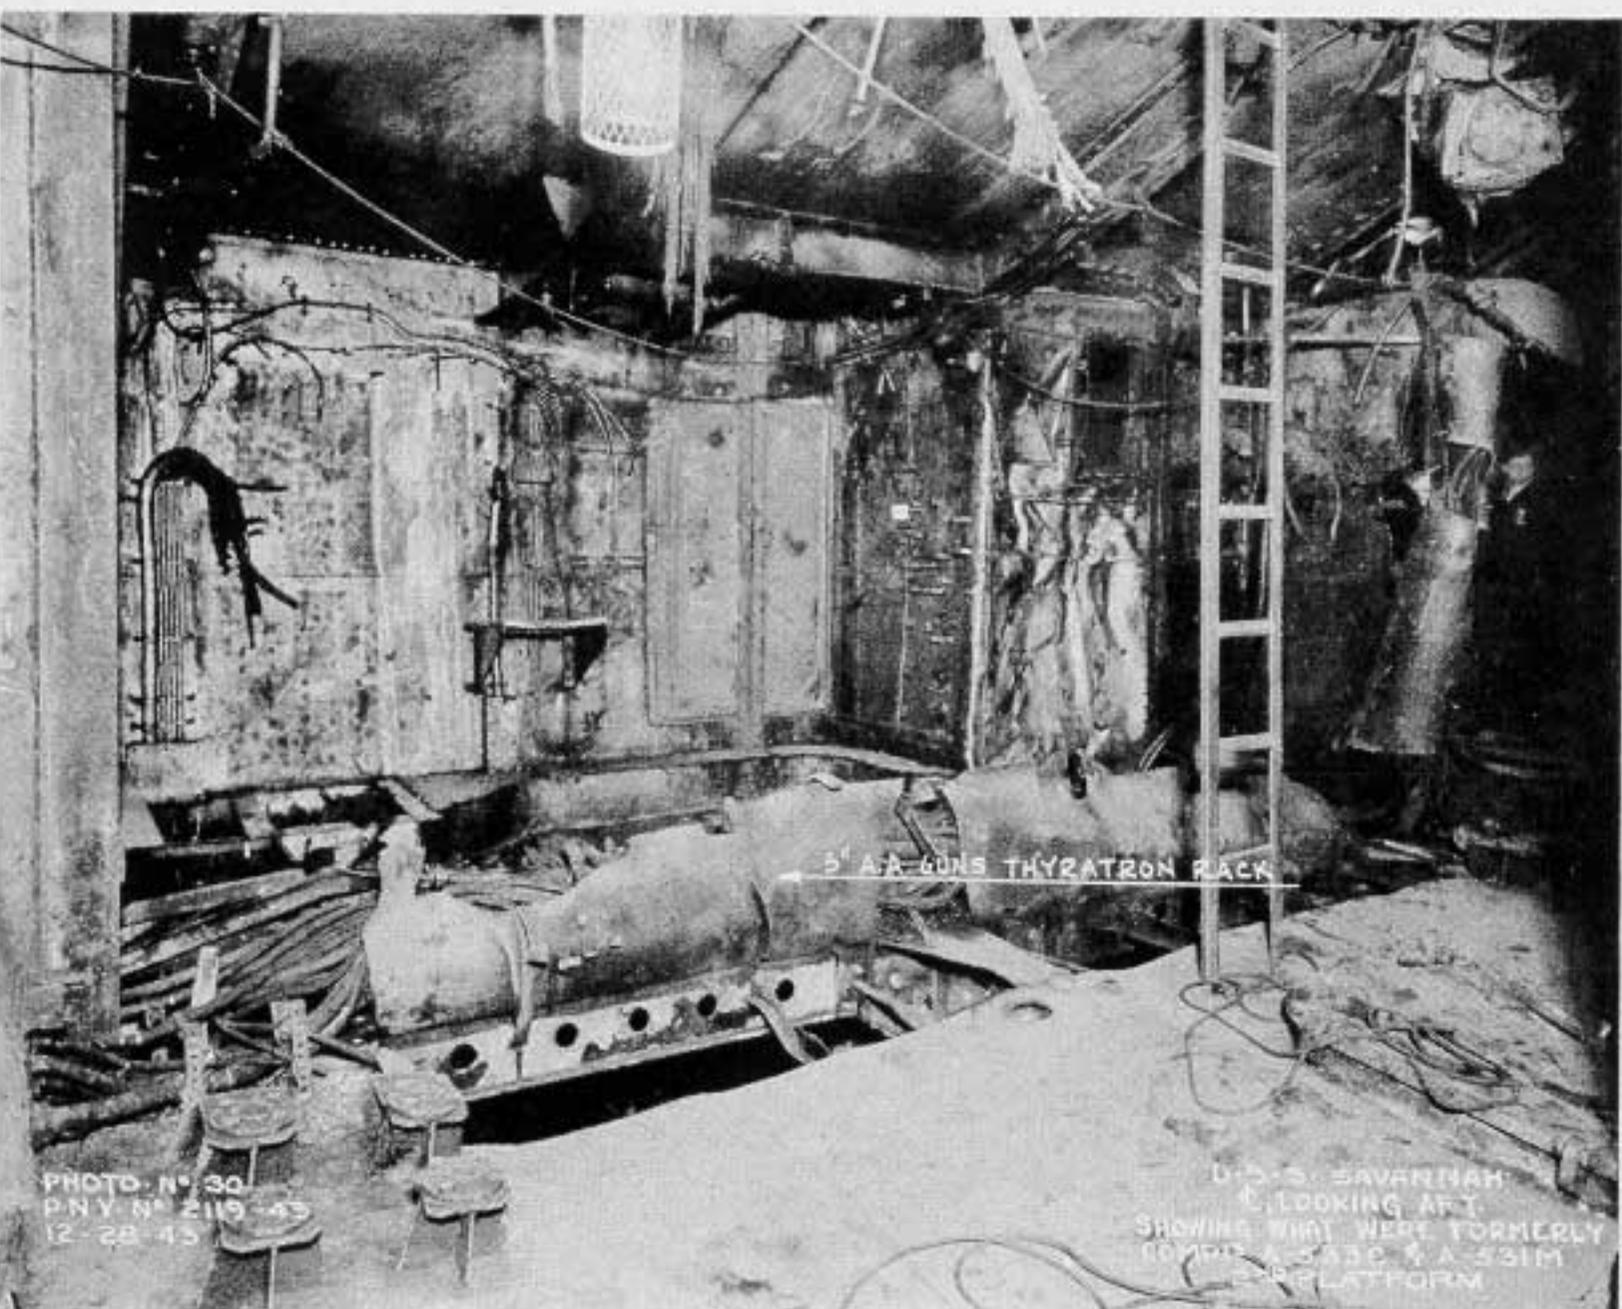
Photo 24: Showing remains of A-533-C and A-531-M, second platform, frames 49 to 56, centerline.

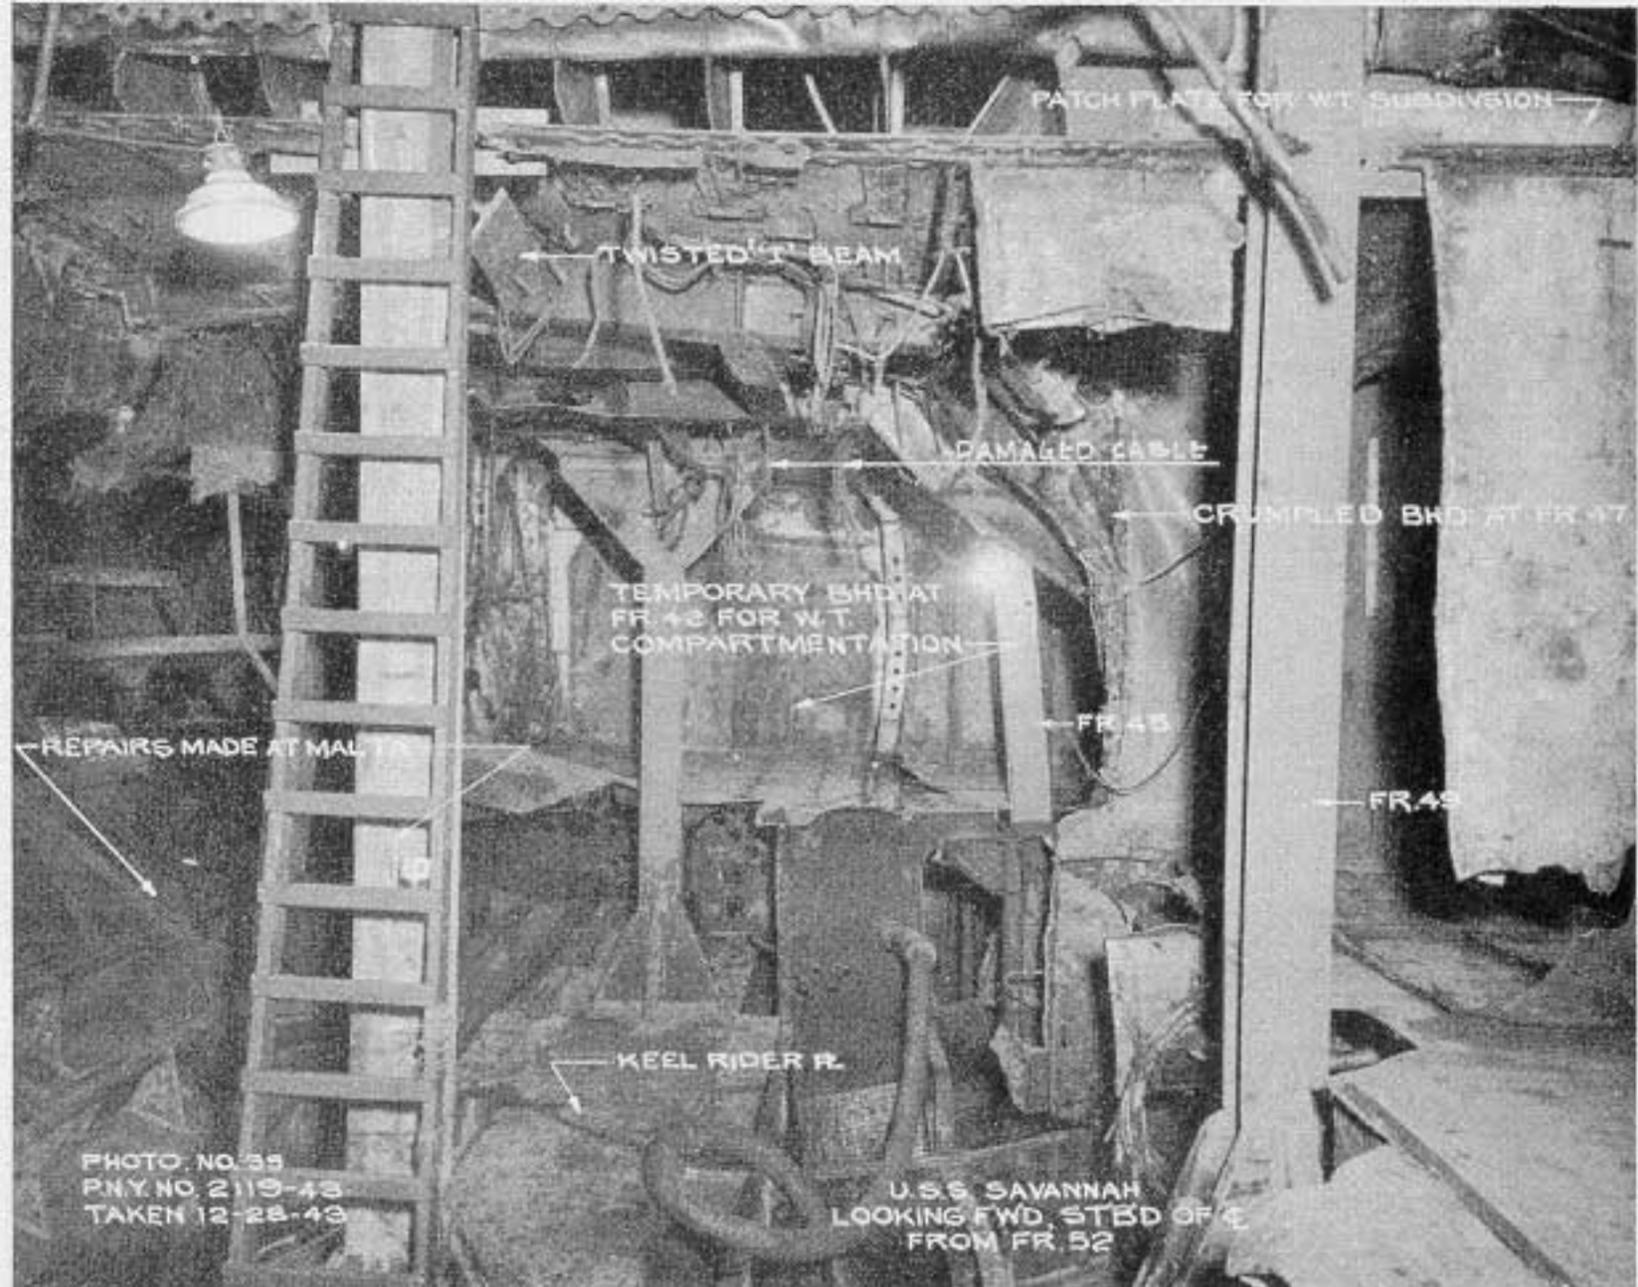
Photo 27: Looking forward from frame 52, second platform level, at remains of magazines A-527, 528 and 520-M.

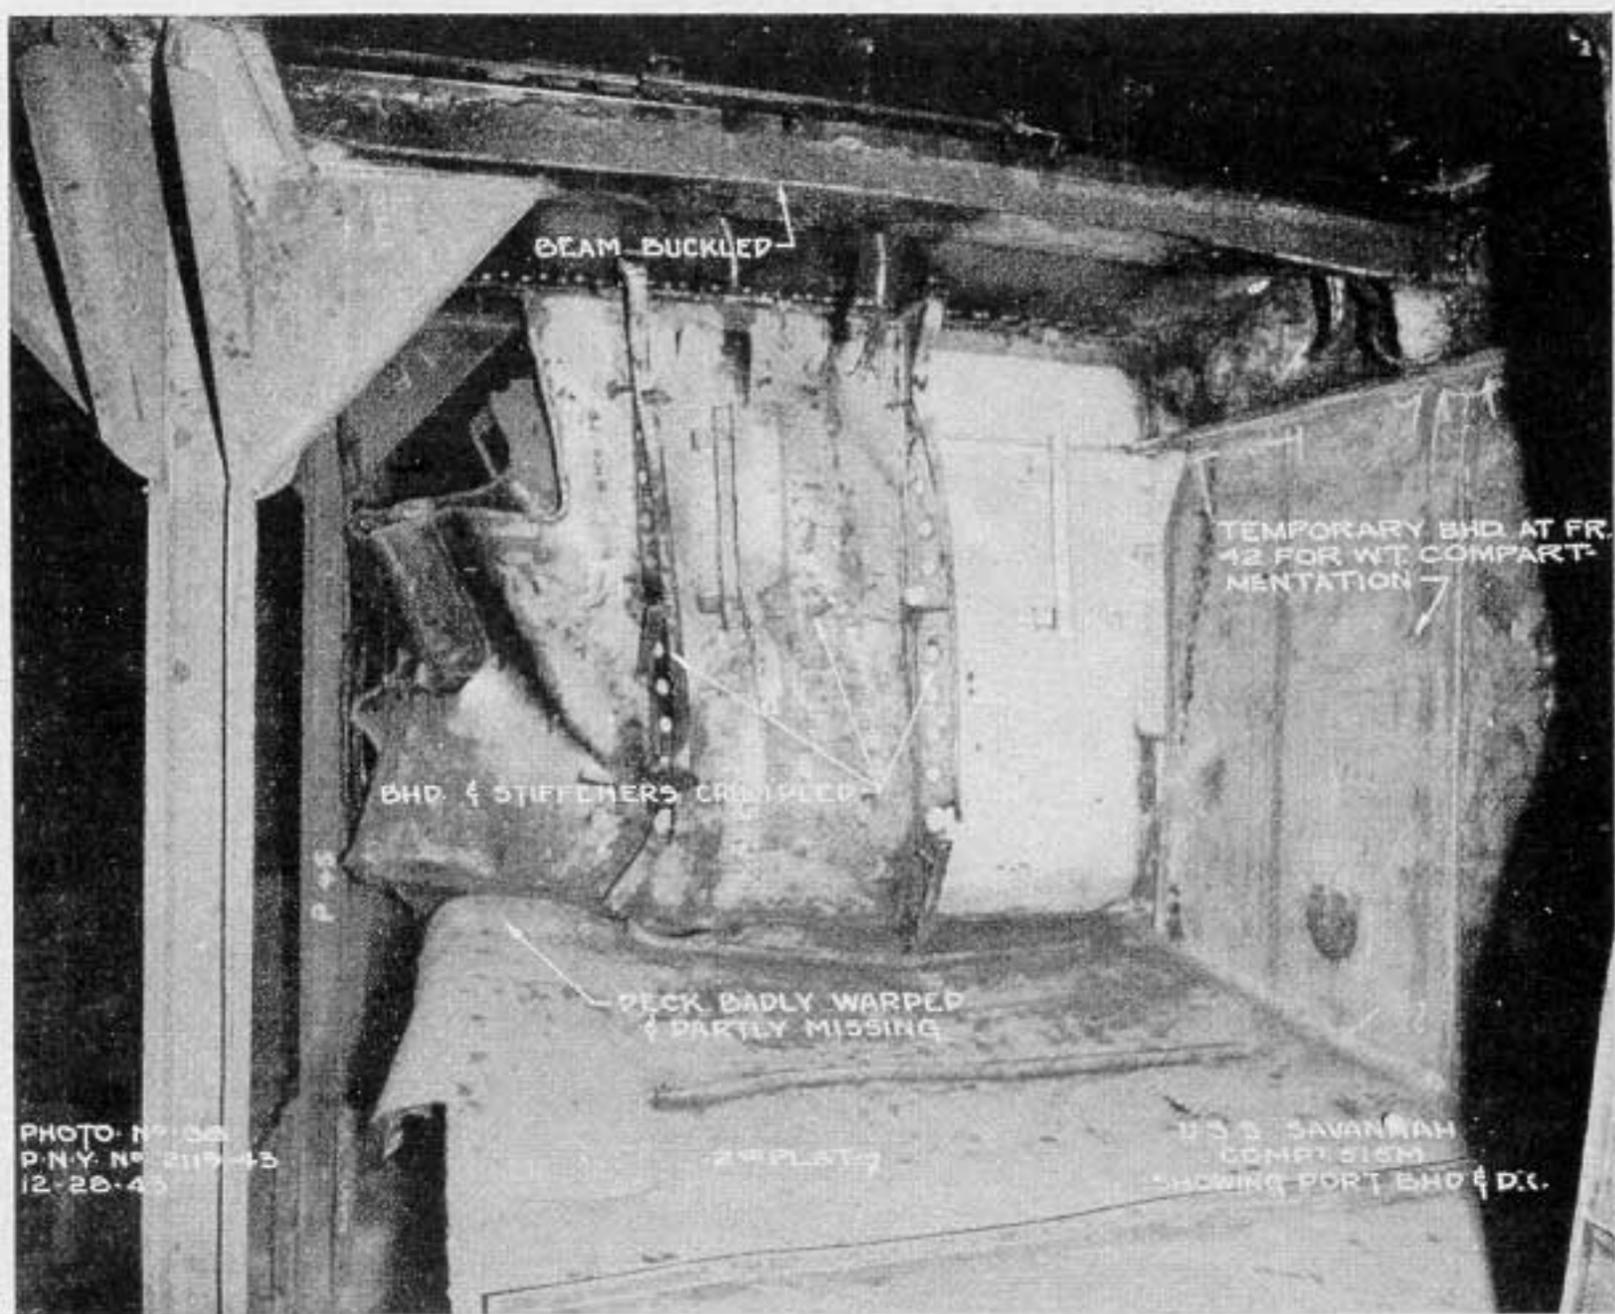
Photo 28: Looking to port and forward in A-515-M, 6-inch powder magazine, second platform frames 39 to 45, centerline. The bulkhead at frame 42 was temporary for the return trip.

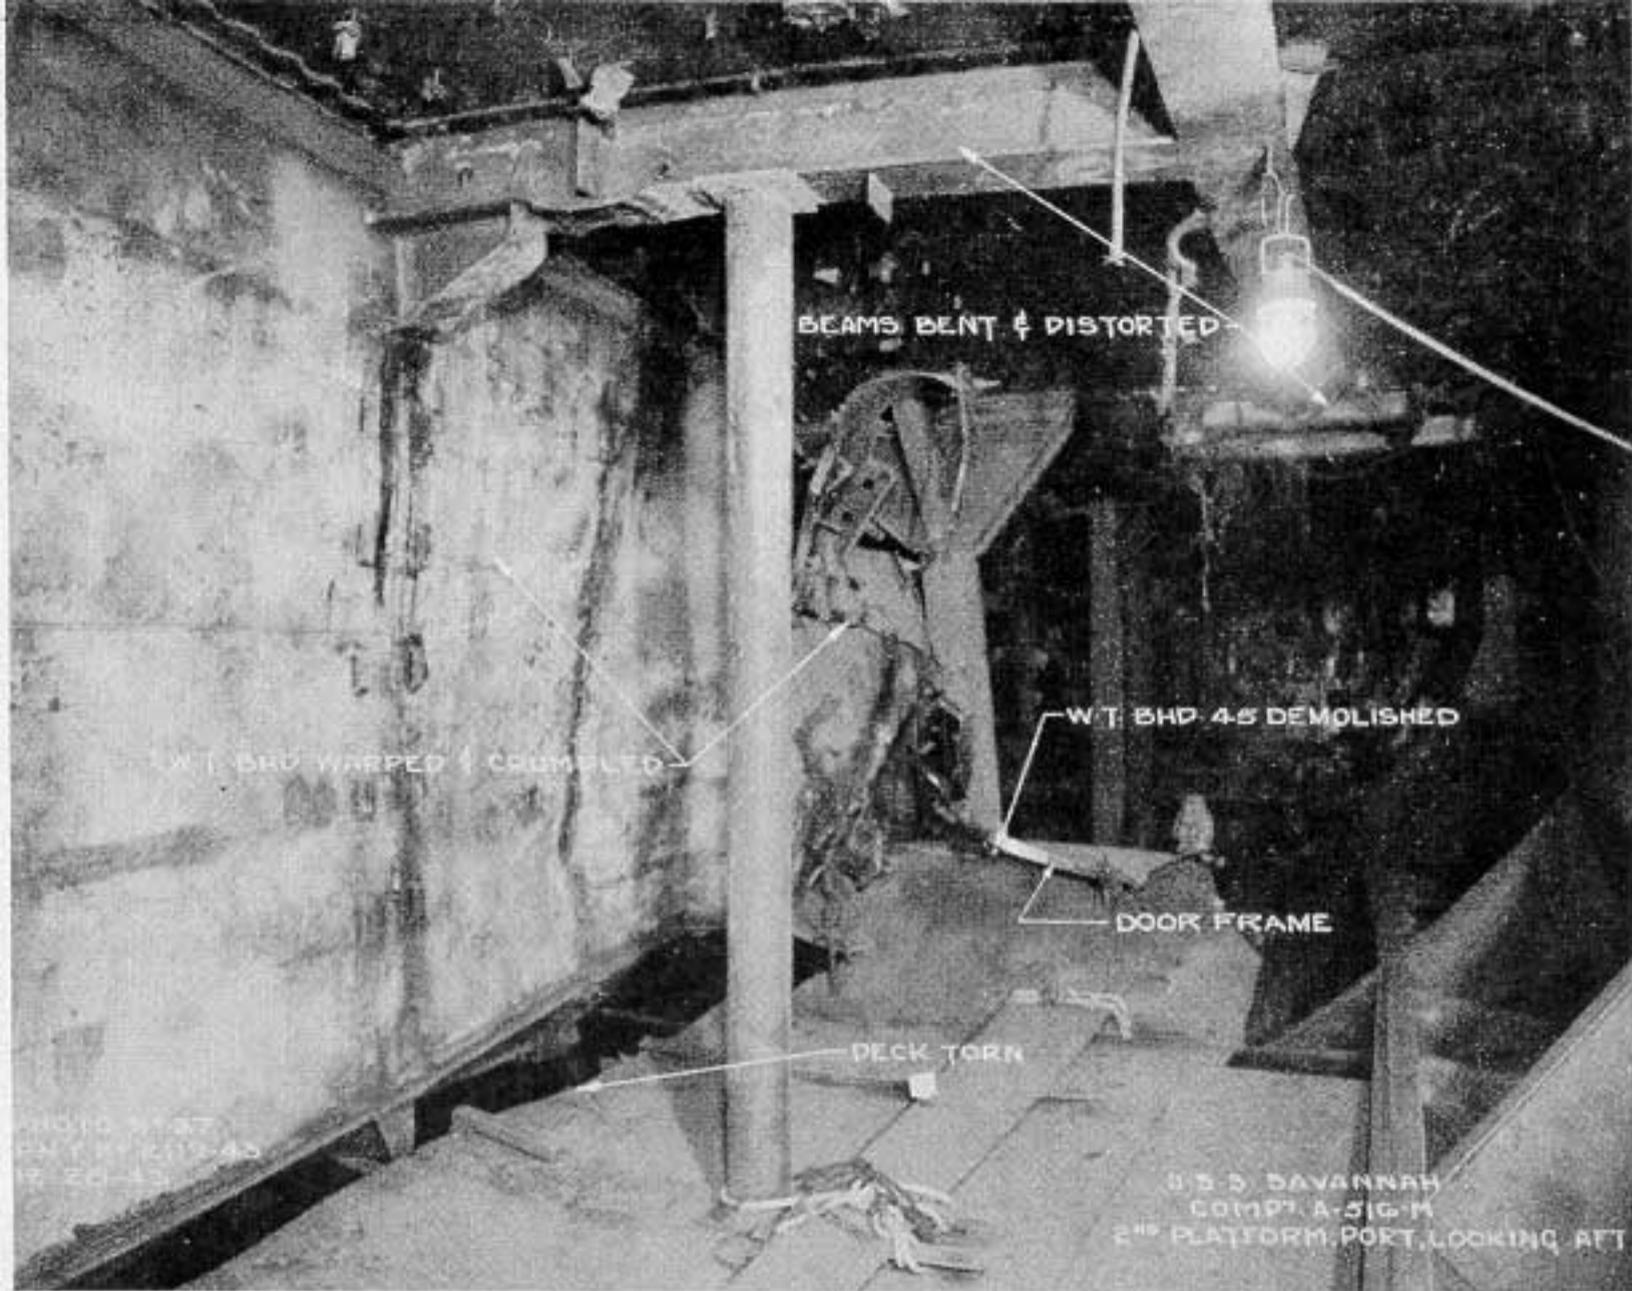
Photo 29: Compartment A-516-M, 5-inch 25 cal. ammunition magazine, second platform, frames 39 to 45, centerline. Looking aft. A visual inspection revealed some holes in the wreckage of the after part of the longitudinal bulkhead which could have been caused by fragments.

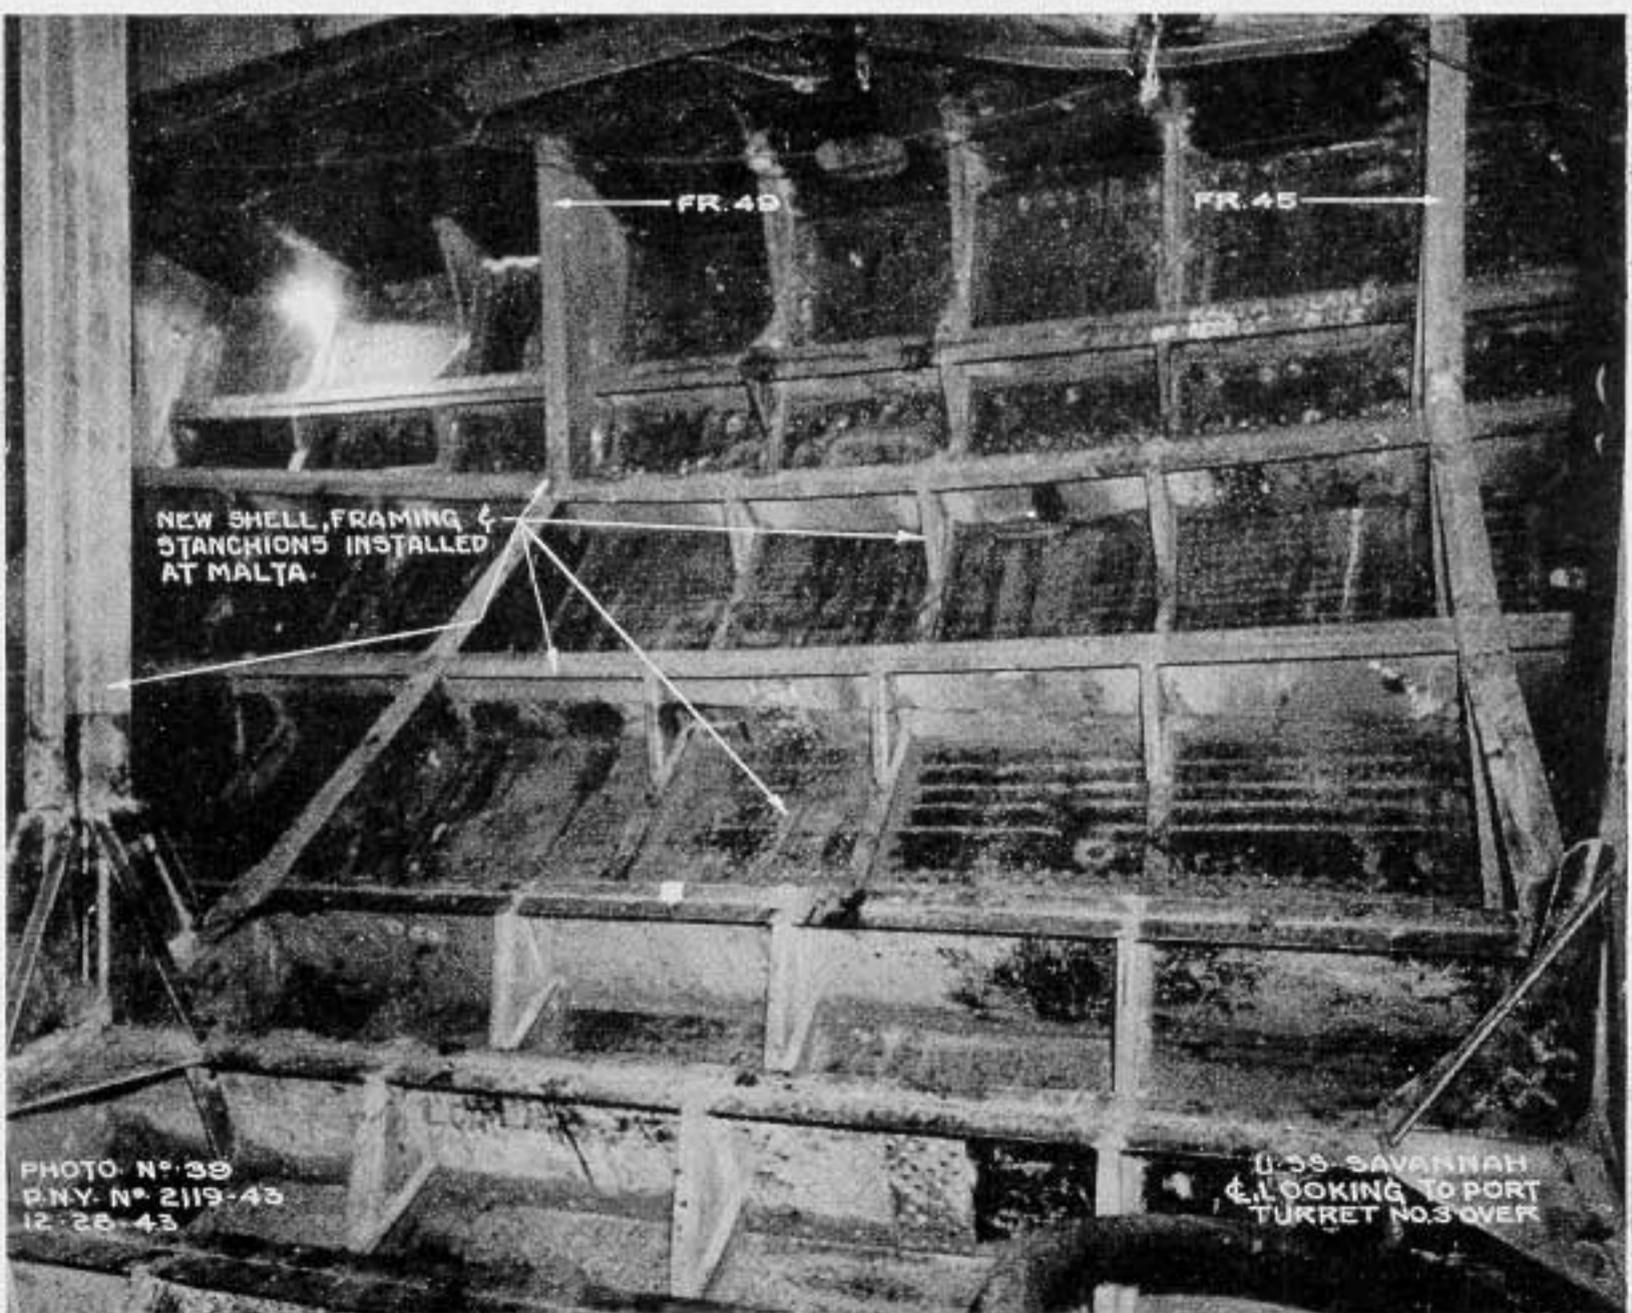
Photo 30: General view of temporary framing and shell plating installed at Malta.
