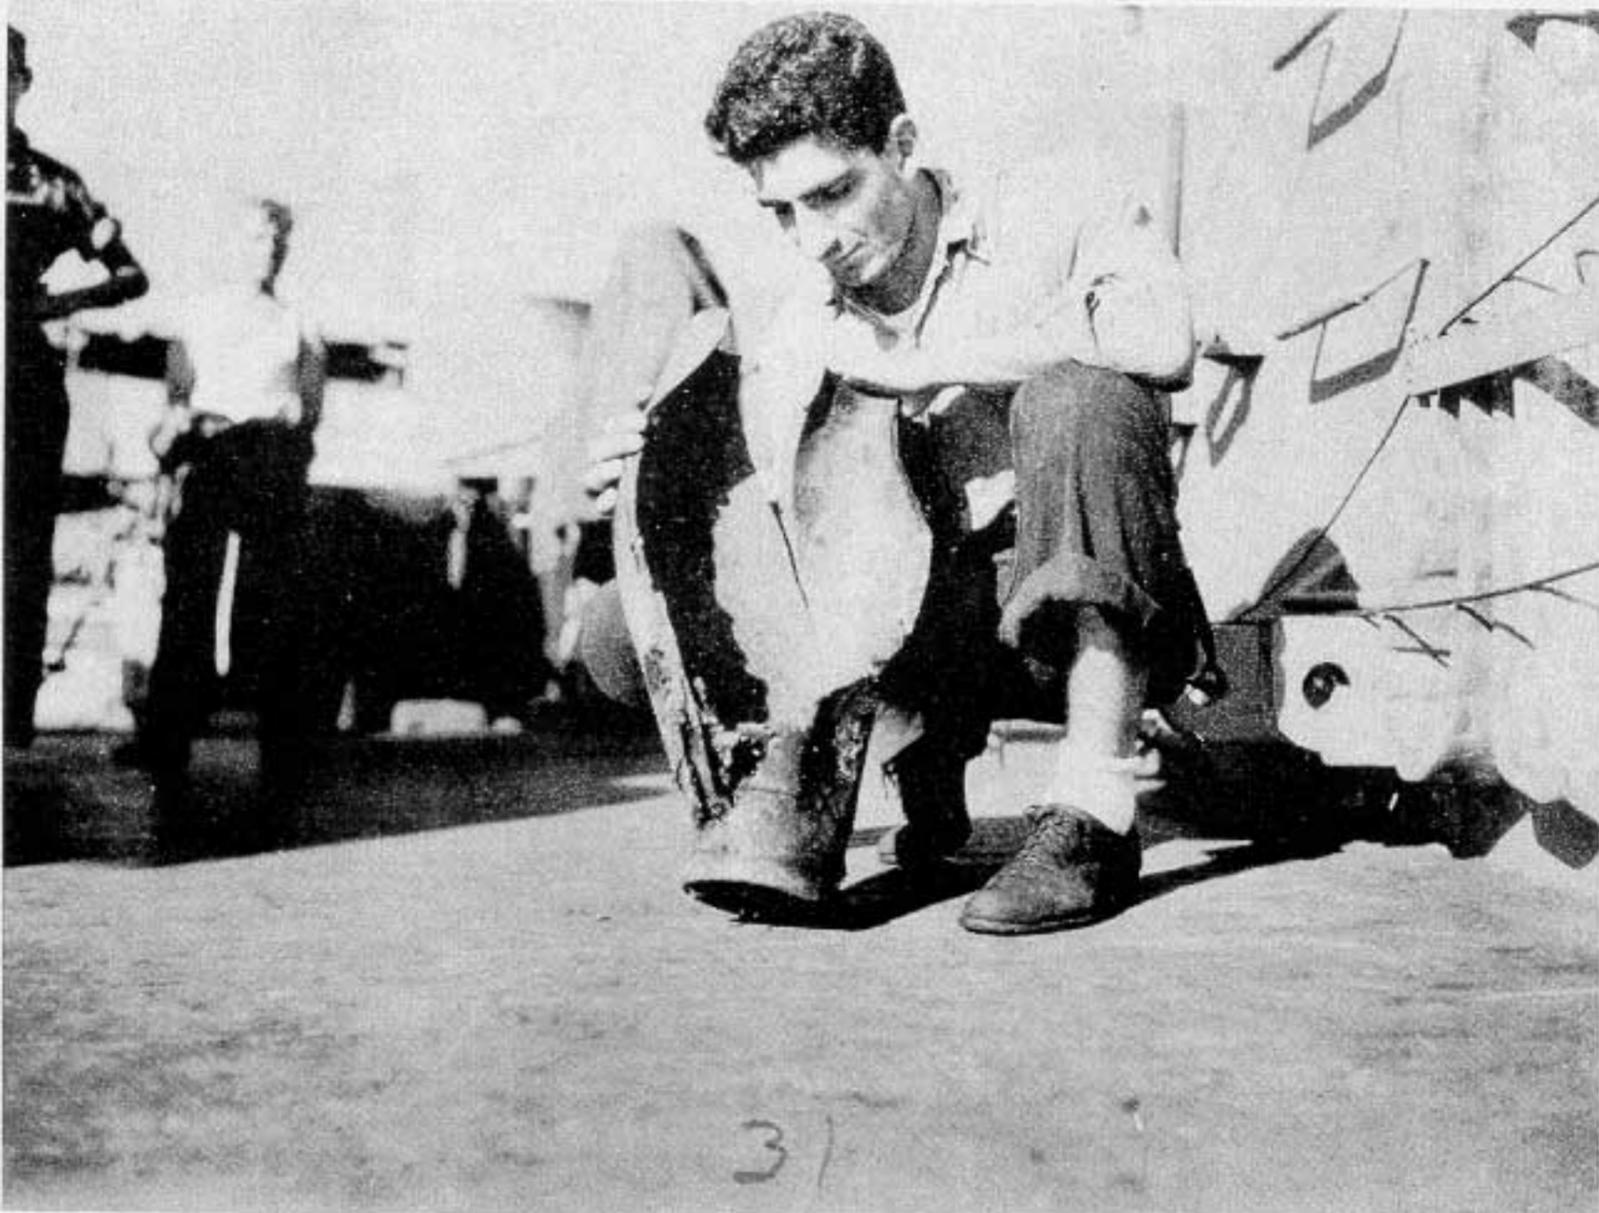
Photo 31: One of two 6-inch/47 H.C. projectiles — that detonated in the gun room of No. 3 turret. Both are believed to have been stowed in the left projectile rack, 30 inches below the roof. Both went off 24 minutes after the bomb hit, during which time there was a fire in the gun room. Detonations were apparently low order. The left side plate of the turret was bulged outward in way of the stowage to a depth of 4 inches.

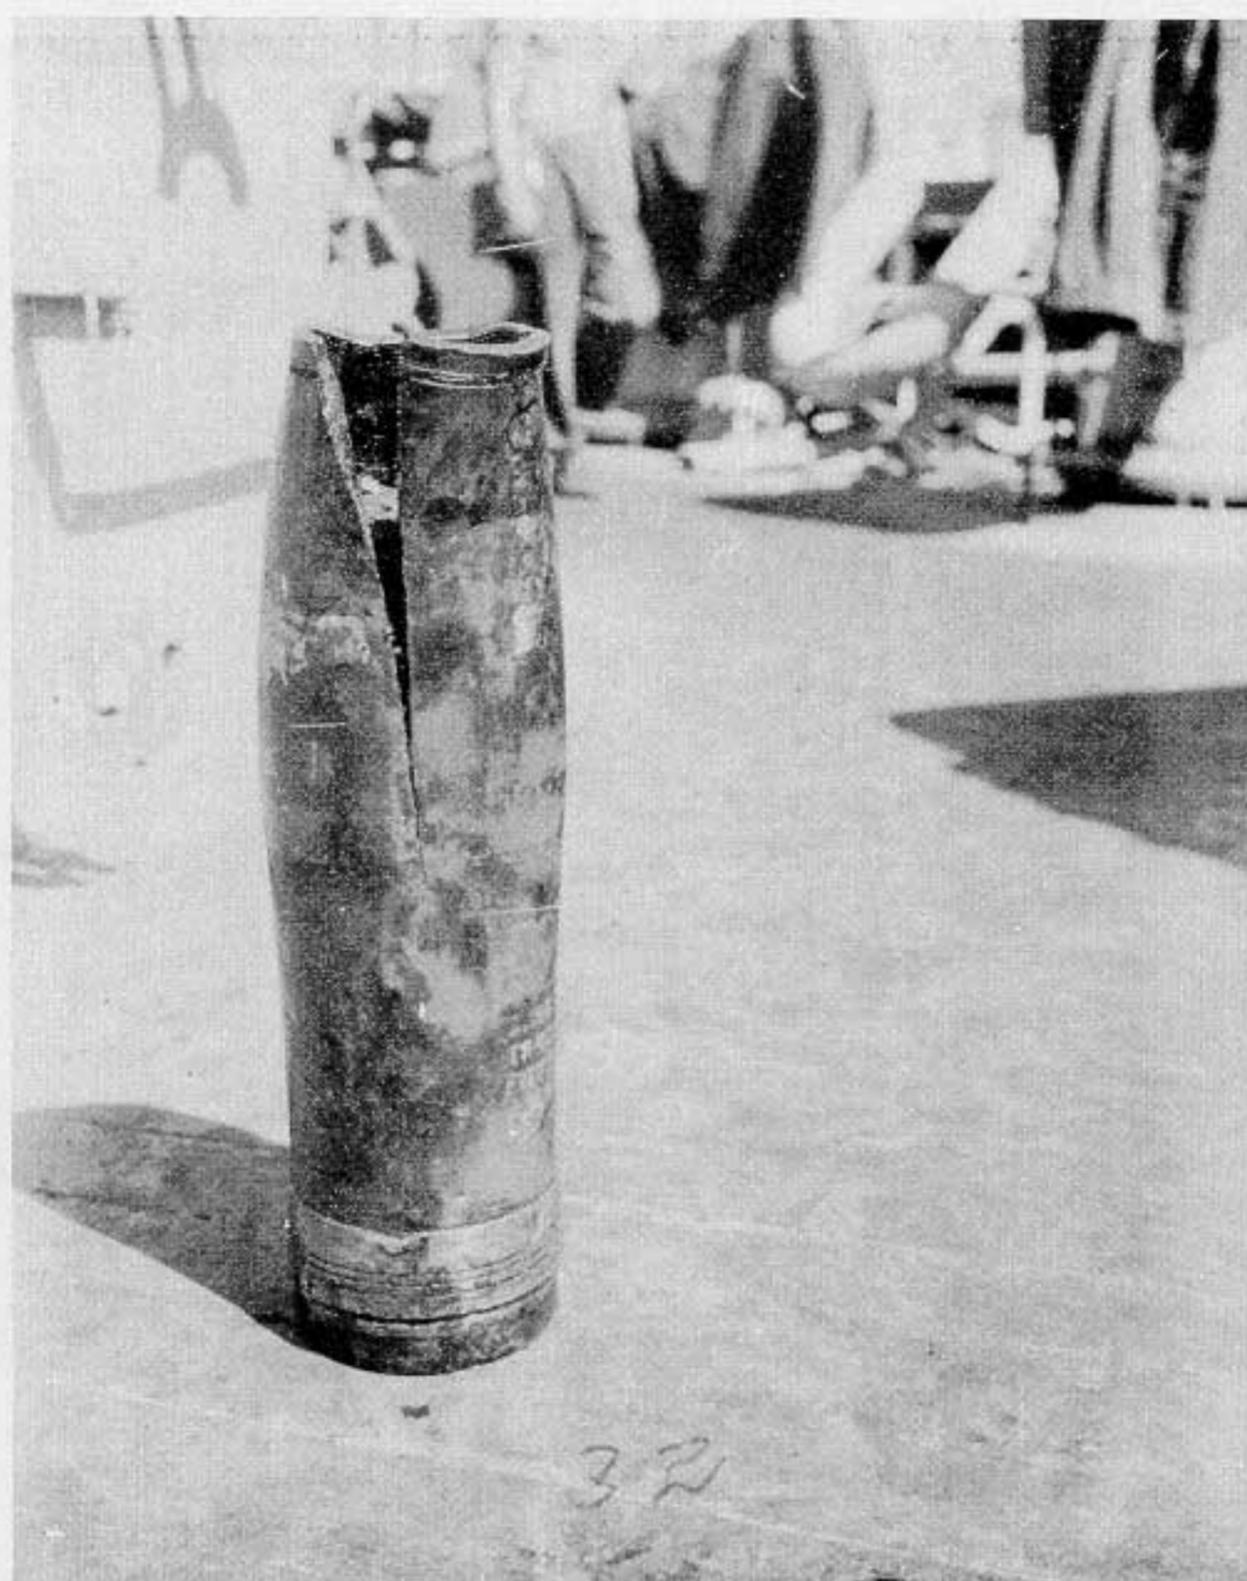
Photo 32: A 6-inch/47 H.C. projectile split open by impact. The filler did not detonate or burn. Recovered from the gun room of No. 3 turret.

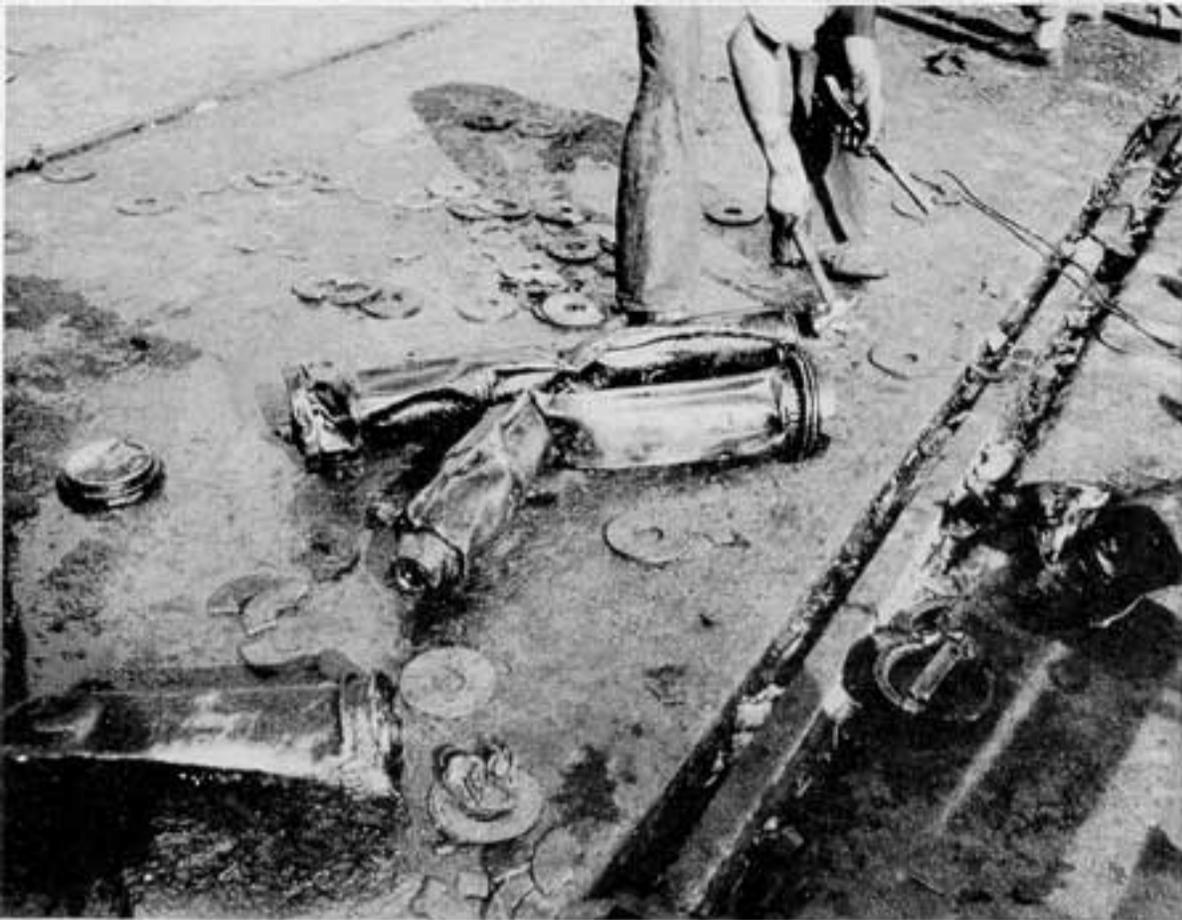
Photo 33: 5-inch/25 ammunition recovered from wrecked magazines.

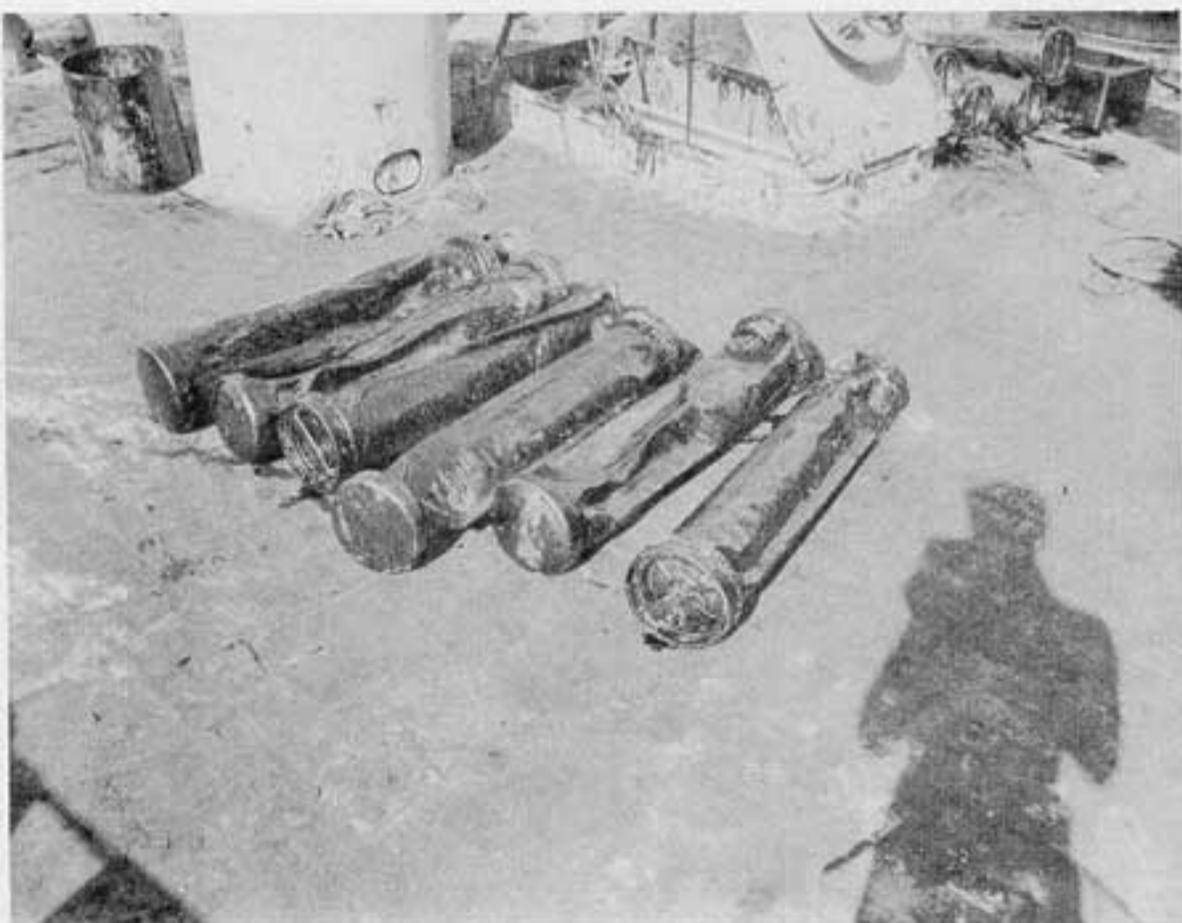
Photo 34: 6-inch/47 powder charges and cartridge tanks recovered from forward end of A-515-M. This picture is typical of all 6-inch powder recovered from A-515-M, A-507-M, A-511-M and A-512-M.

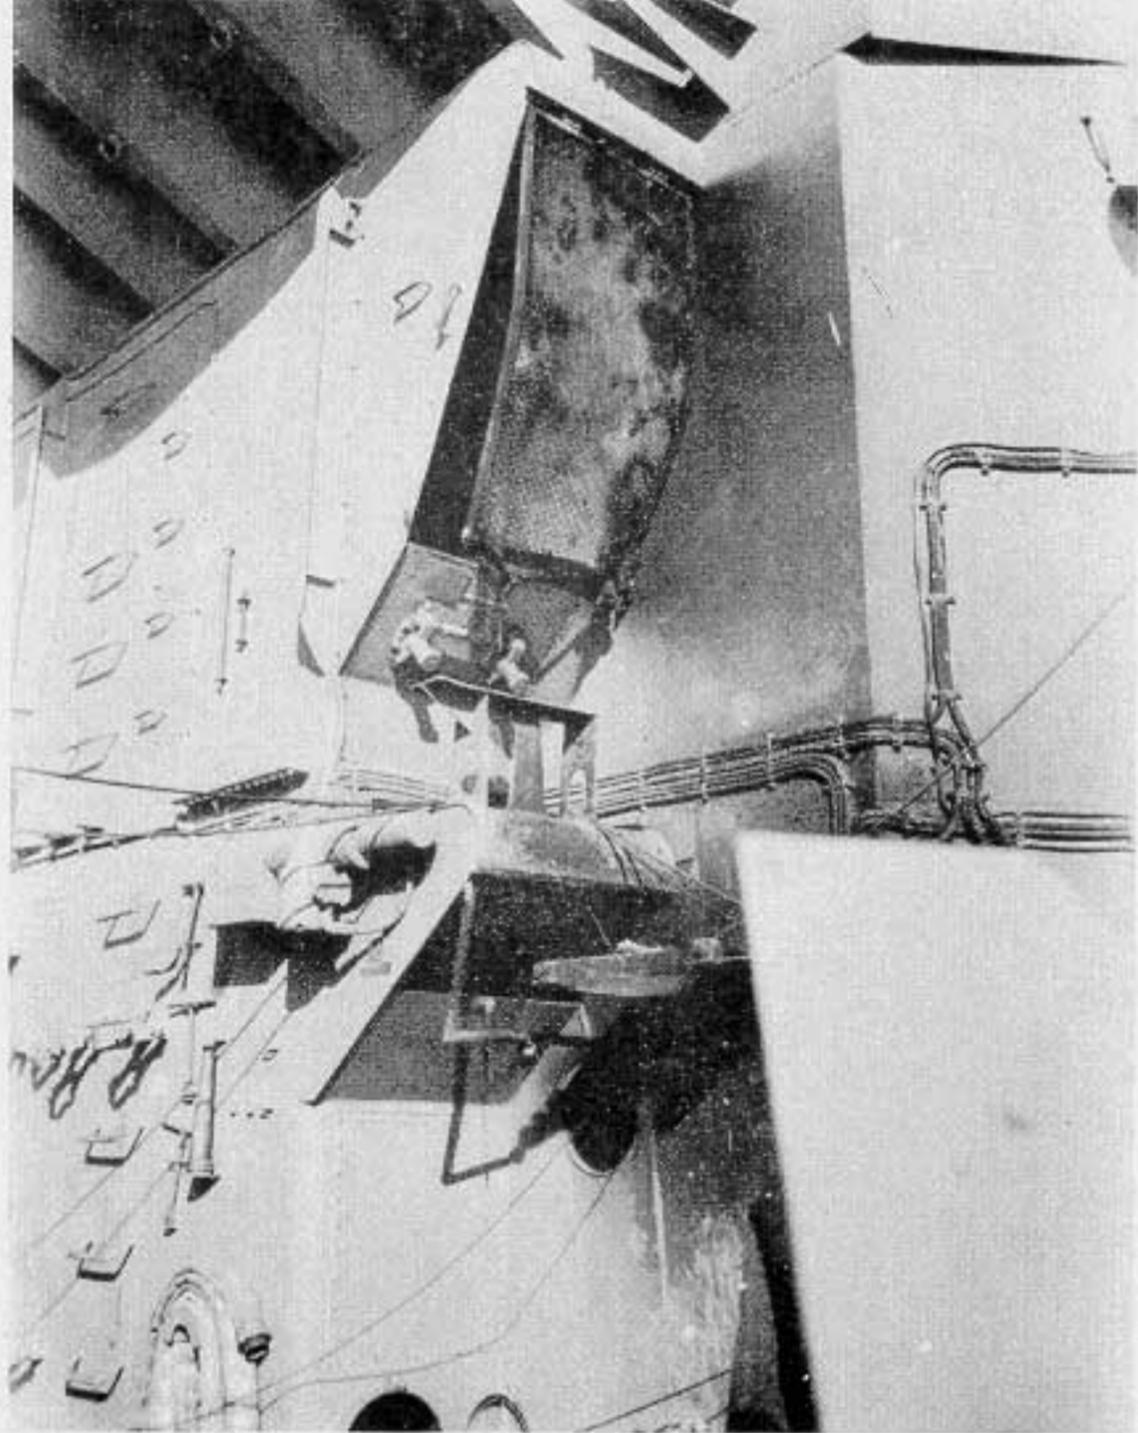
Photo 35: Blast effect to screen on vent trunk terminating at frame 55, above main deck. The lower vent trunk supplied air to A-533-C, second platform, demolished by the detonation.

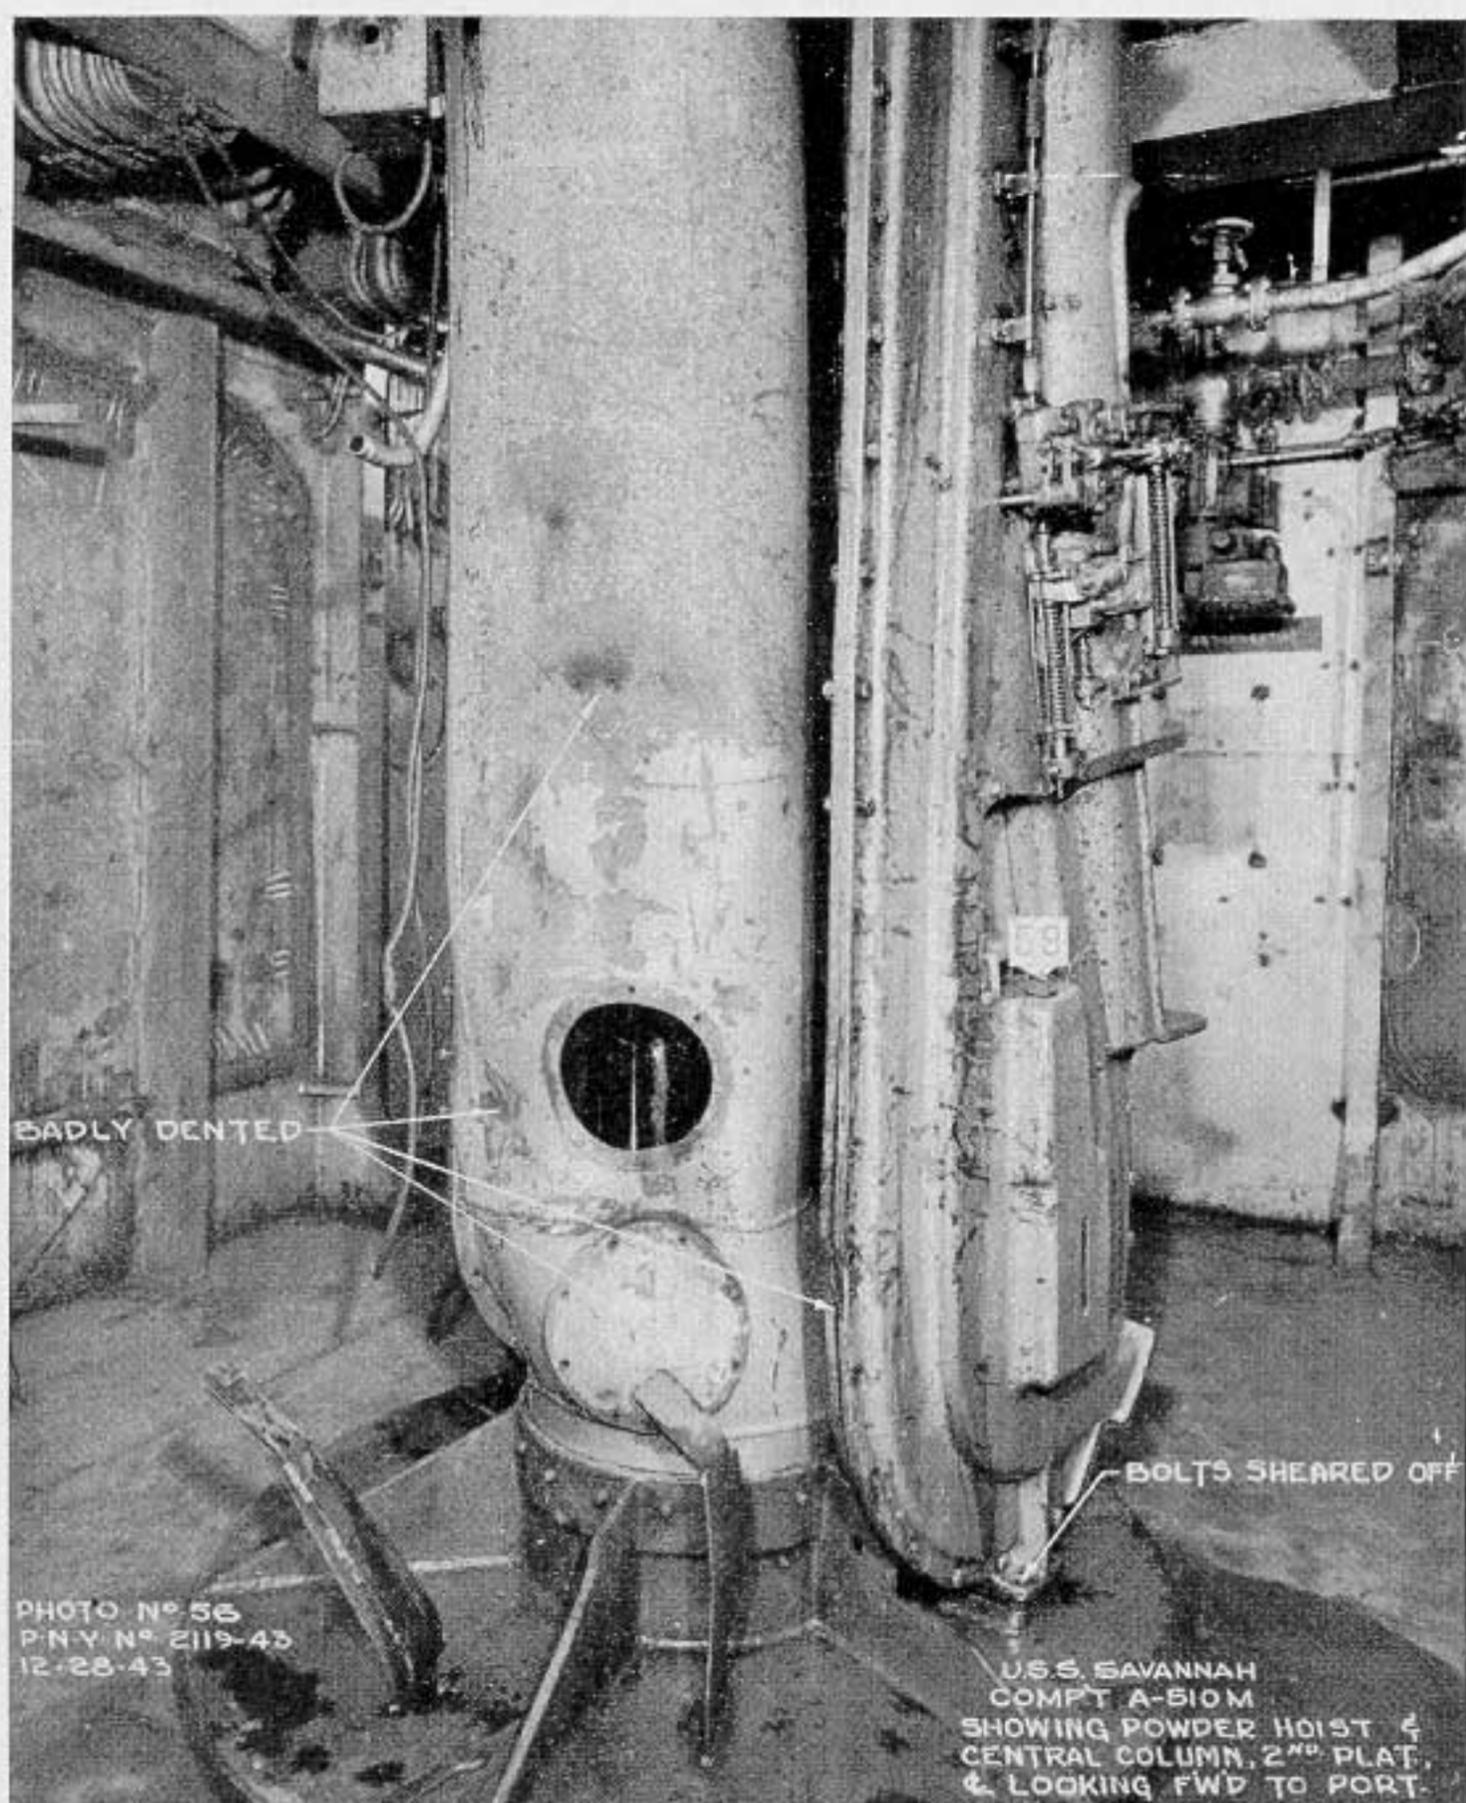
Photo 36: Results of fragment attack and blast on central column for No. 2 turret, in lower handling room A-510-M.

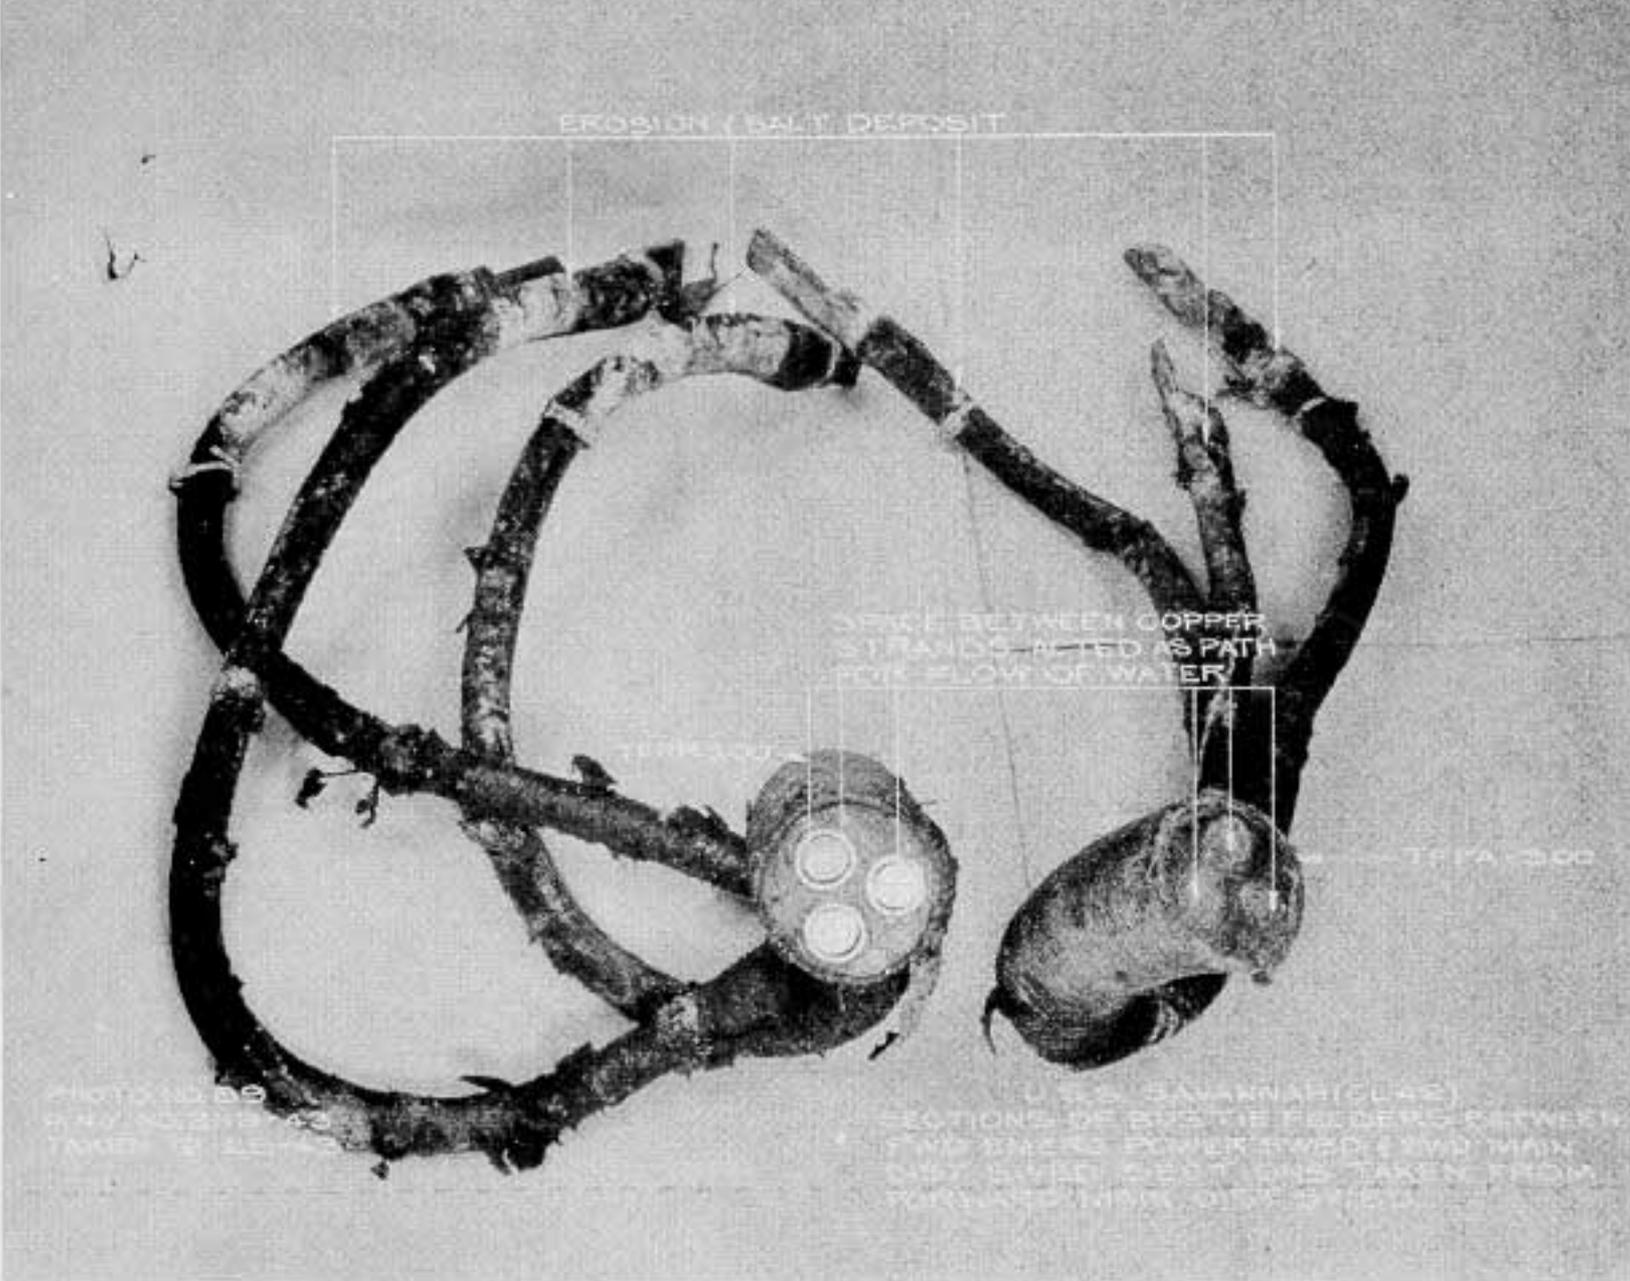
Photo 37: Electrical cables which permitted water to pass from forward emergency power switchboard (in A-532-E) to forward main distribution board (in forward engine room).
