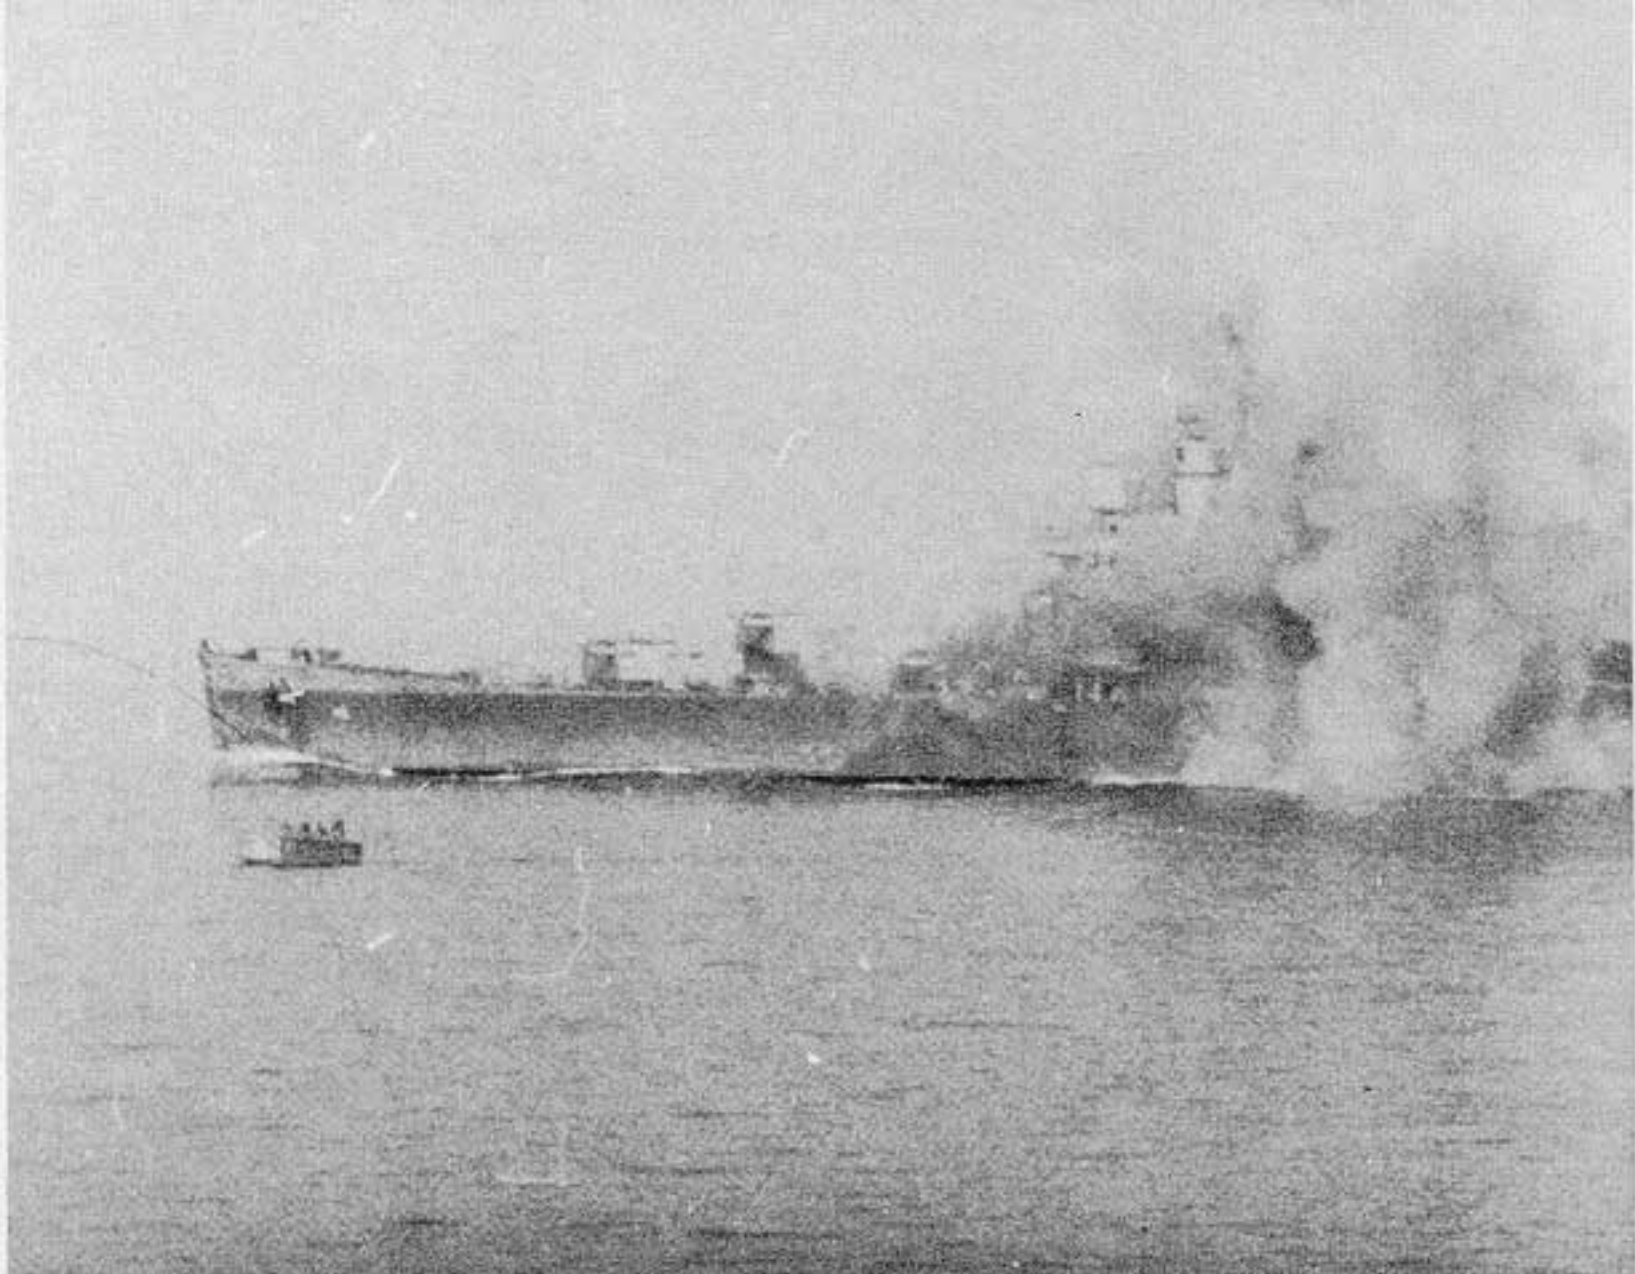
Photo 3: SAVANNAH four seconds after photo 1.
