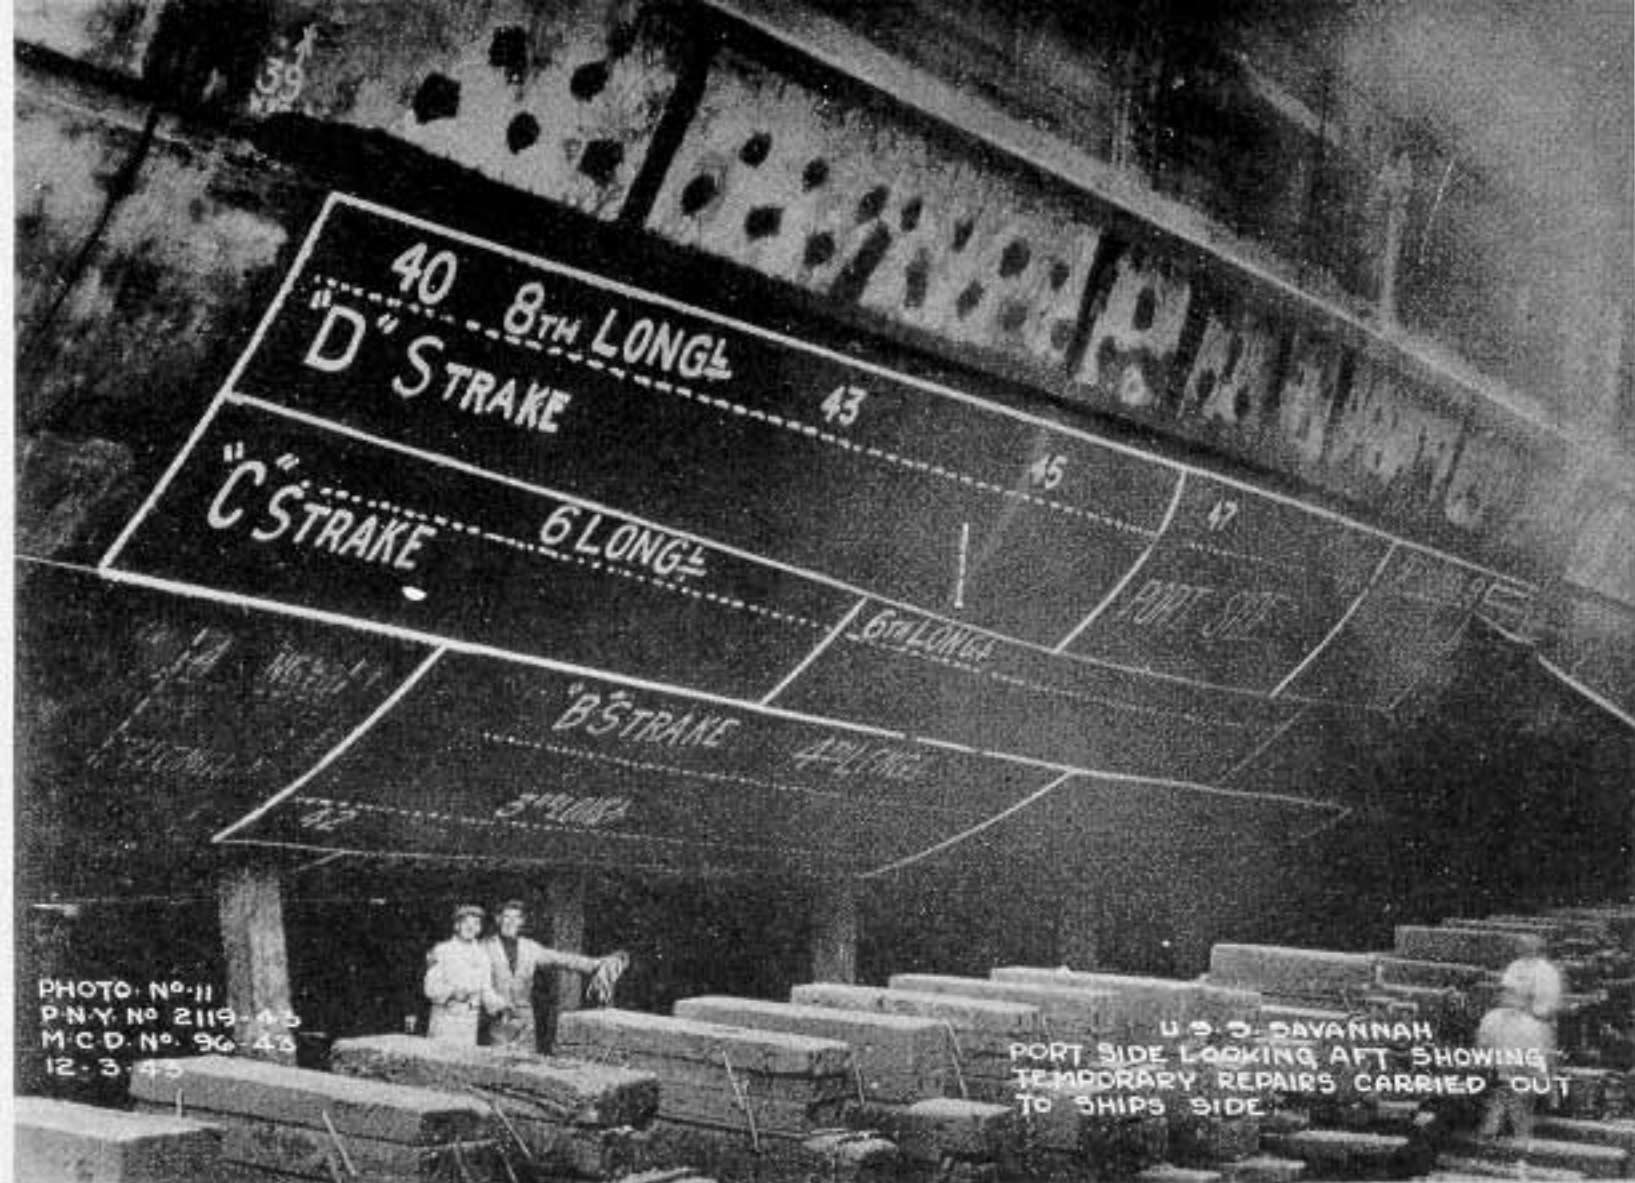
Photo 9: In drydock at Malta, 3 December, 1943.
Temporary repairs to port shell completed.

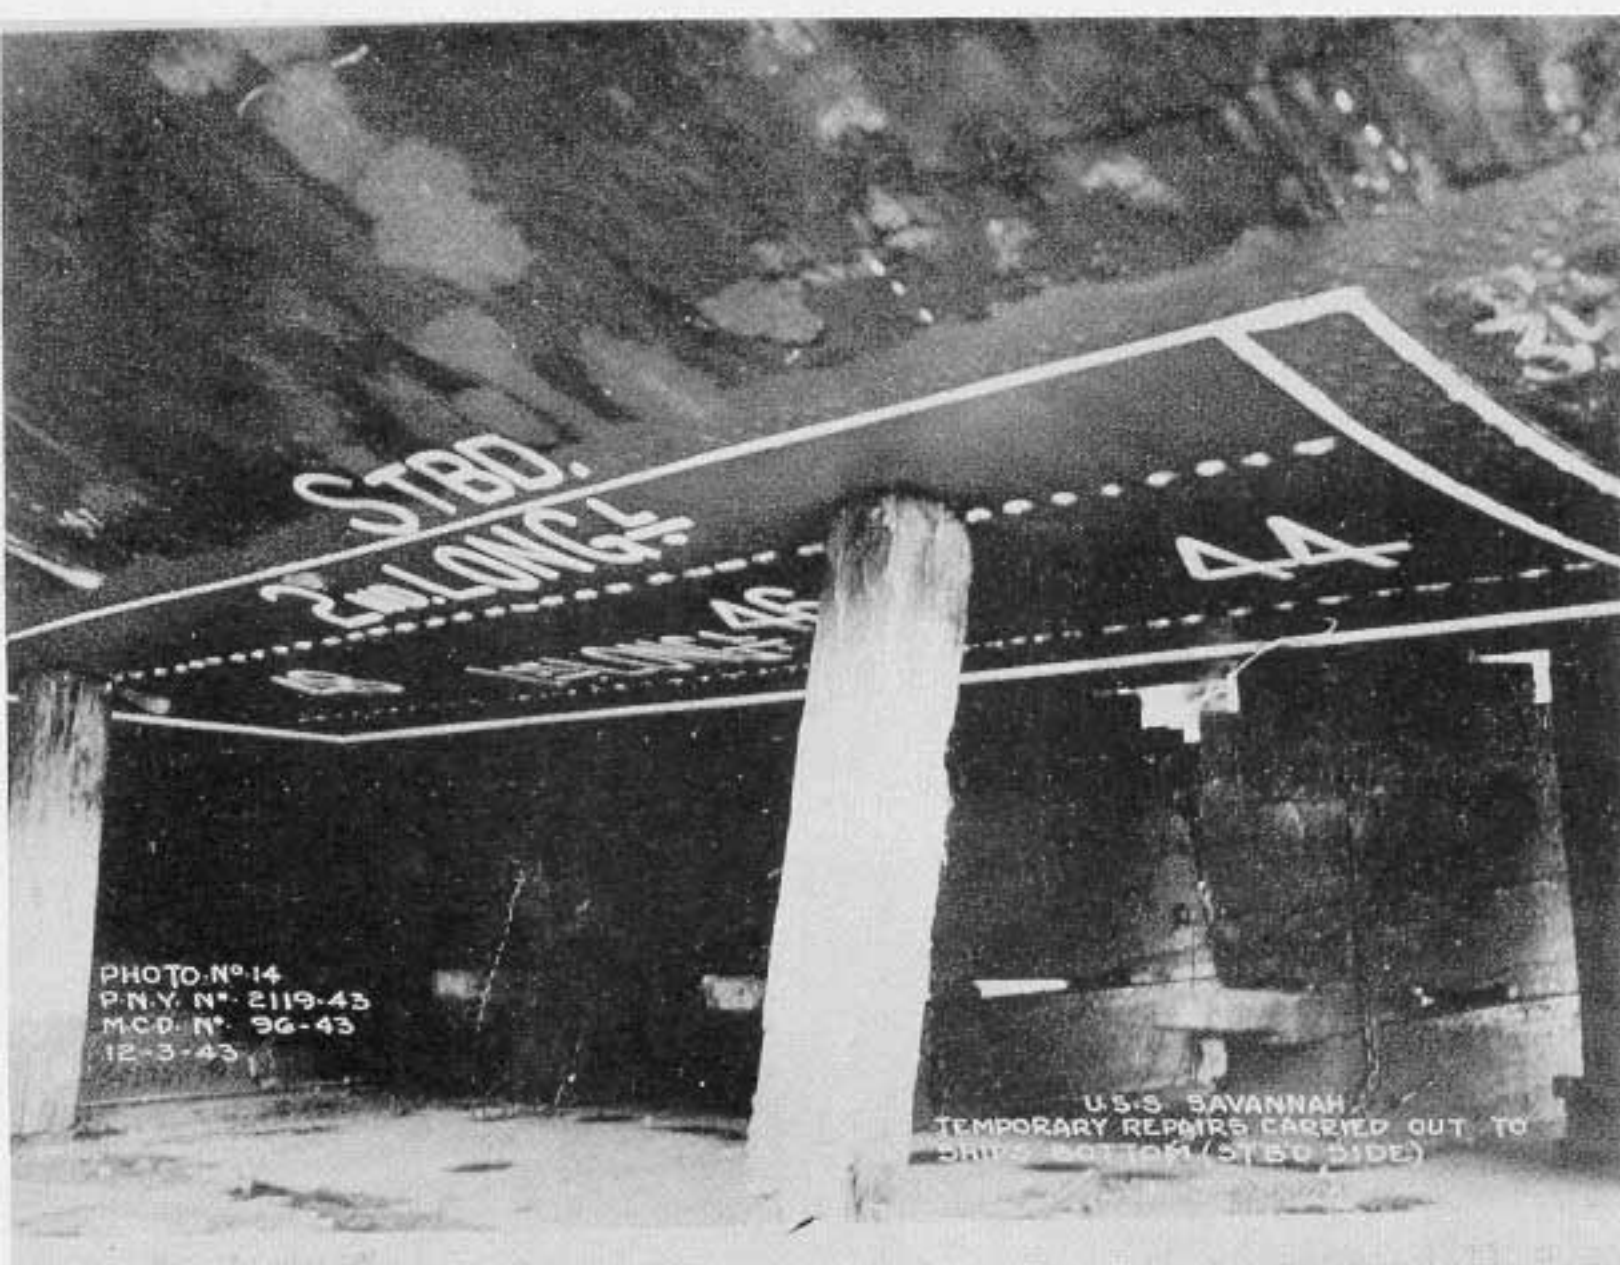
Photo 10: In drydock at Malta, 3 December, 1943.
Temporary repairs to starboard shell completed.

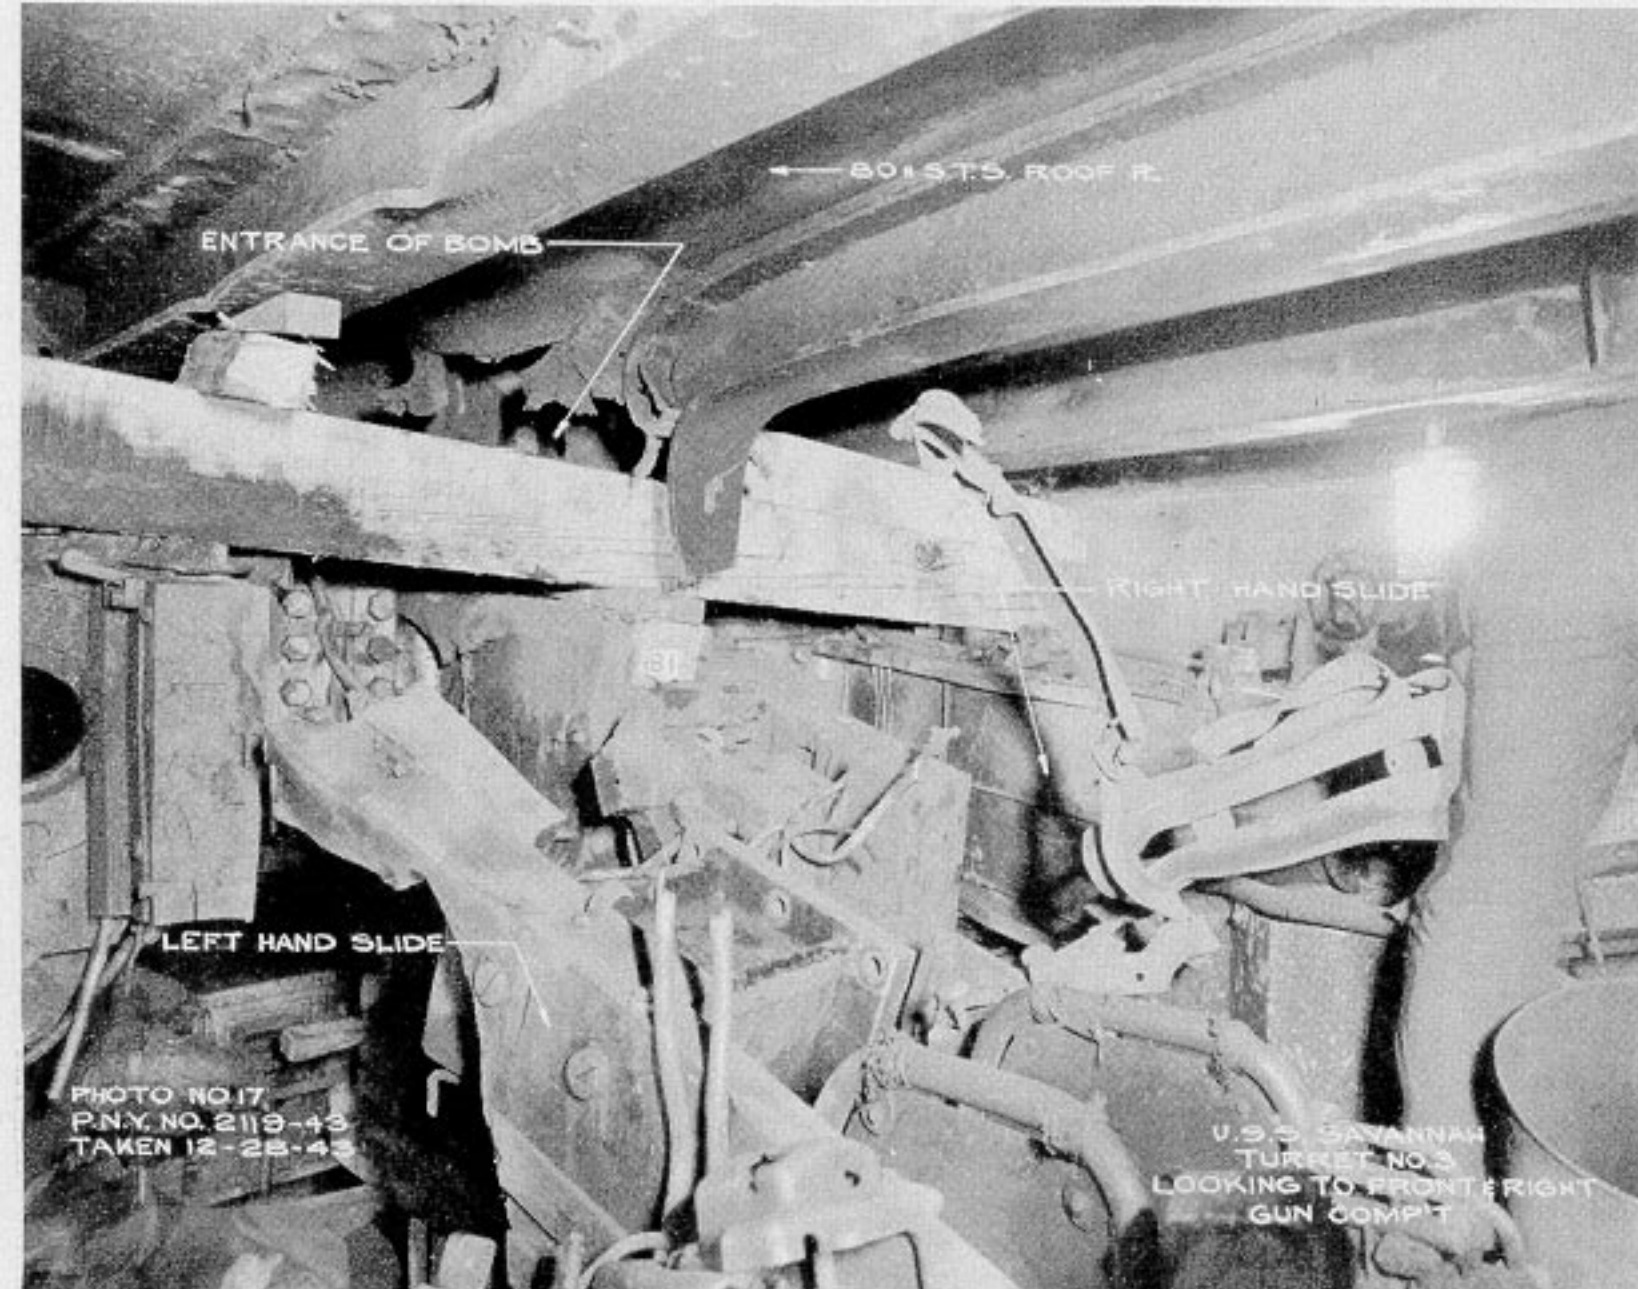
Photo 11: No. 3 turret gun room - looking forward and to the right.

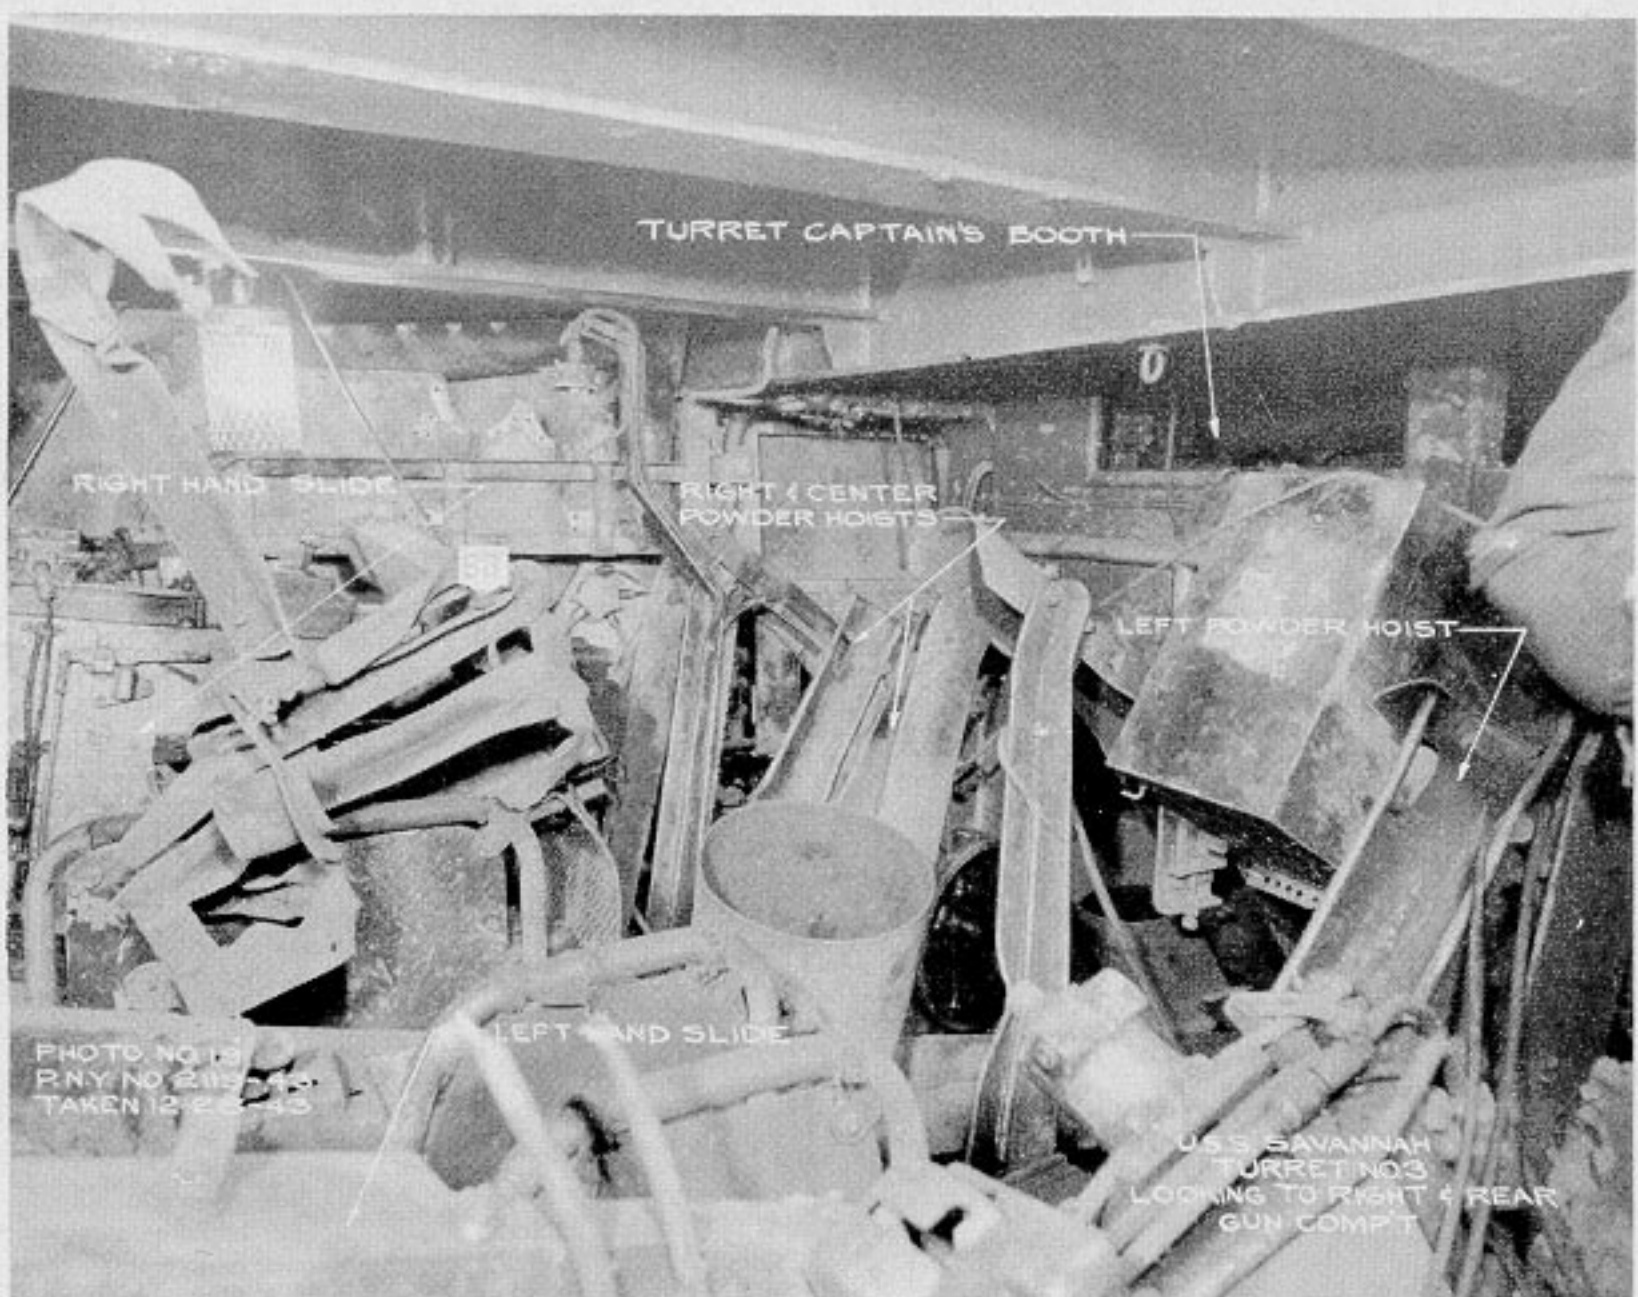
Photo 12: No. 3 turret gun room - looking aft and to the right.

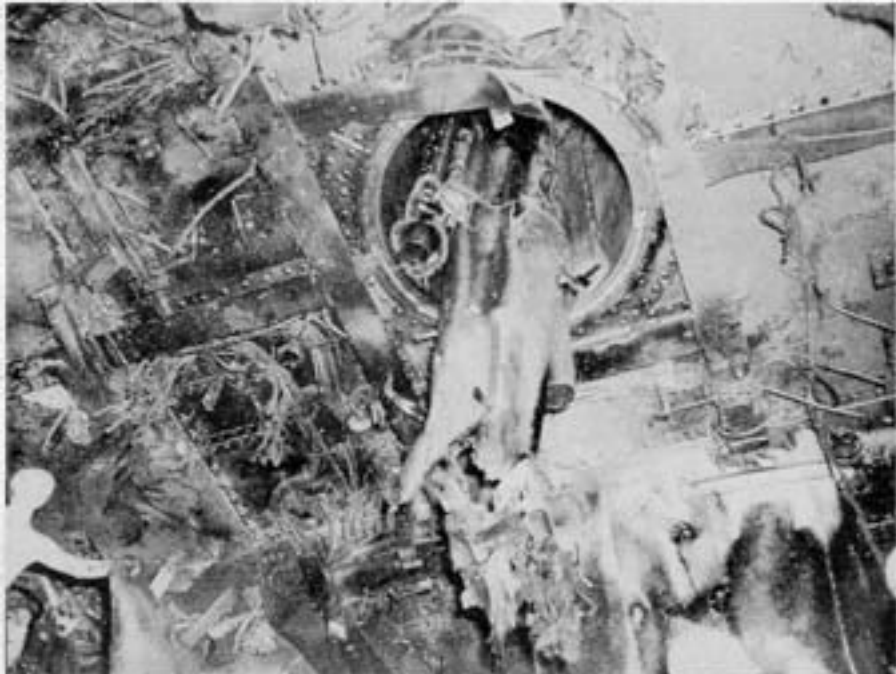
Photo 13: Looking up to the overhead (first platform level) in the lower handling room A-520-M for No. 3 turret. Note the broken powder hoists. The bulkheads and deck (second platform) were obliterated.

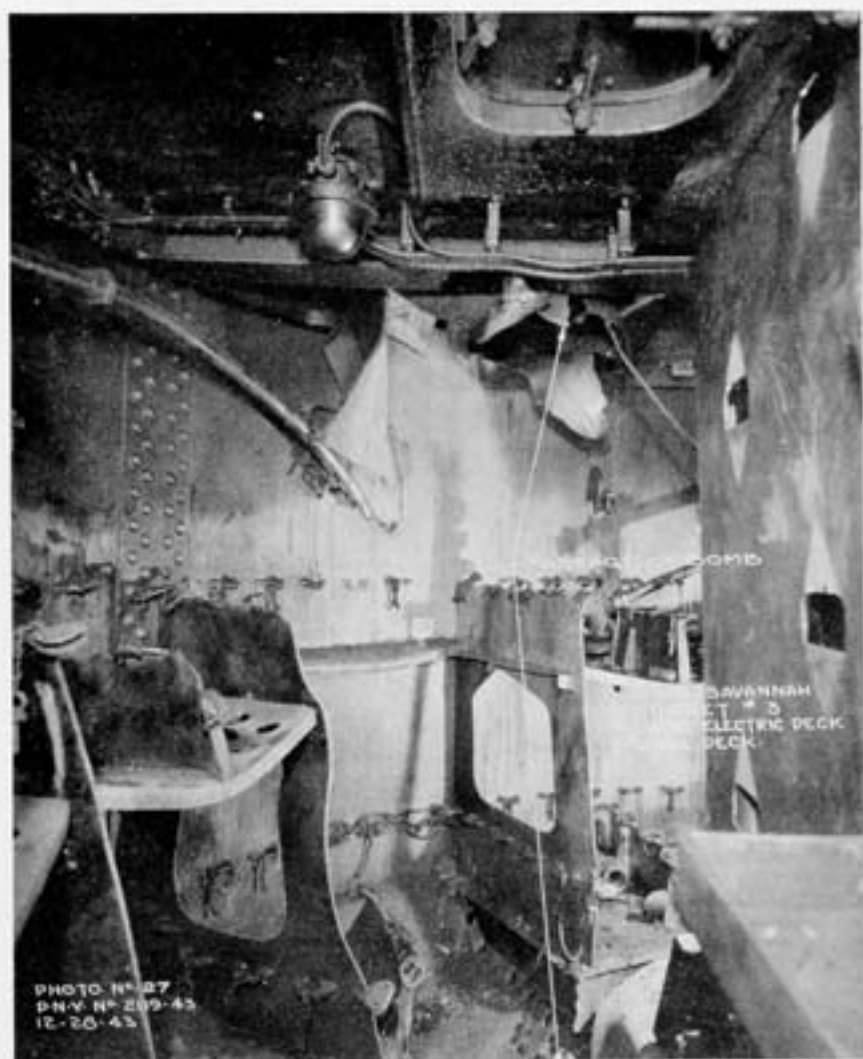
Photo 14: Electric and shell deck, No. 3 turret, showing path of bomb.
