Notes on a Meeting held at R.A.F. Station, Polebrook, on 14/8/41,
to consider present and future developments with regard to
B.17.C. Aircraft.

REPORT ON WEIGHING OF BOEING B17-C AIRPLANE NO. AN536 (COMBAT CONDITION) AT BOSCOMBE DOWN ON AUGUST 26th, 1941.

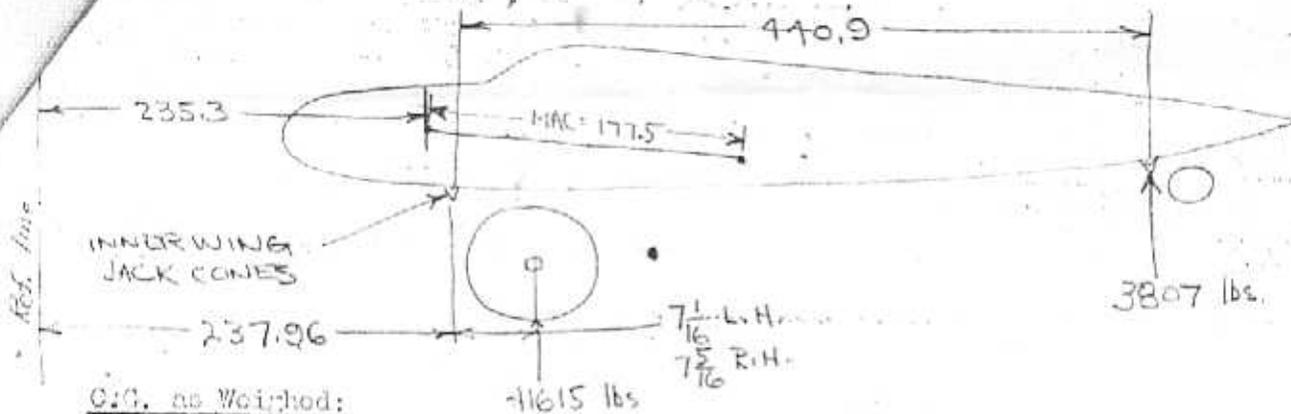
C.G. as Weighed:

Gross 18-11-2-7

The recommended maximum aft position of the centre of gravity,
 from structural and aerodynamic stability standpoints, is 26% M.A.C.
