“Normal Requirement”

The Navy’s Worst Ever Aircraft Accident

By David Trojan, USN Retired

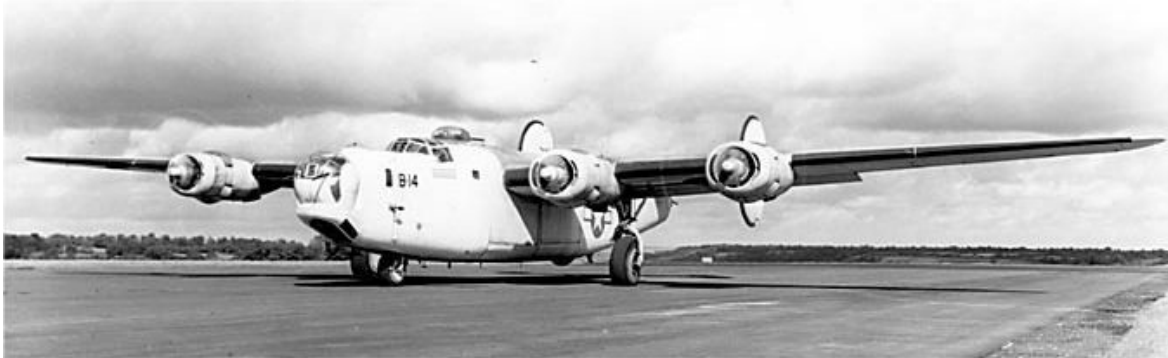
Navy PB4Y-1 taxi for take off

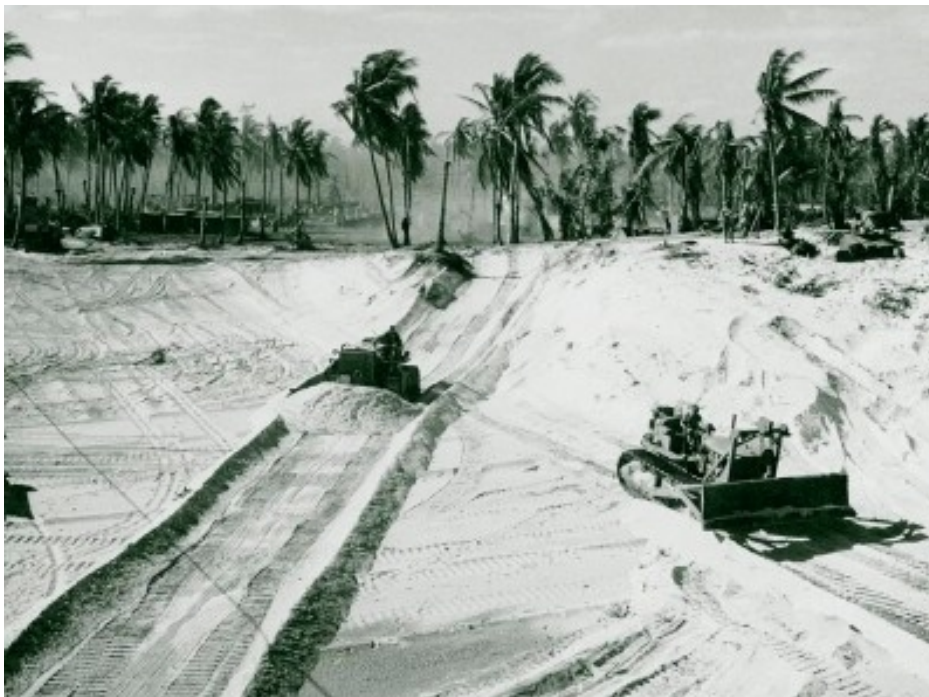
Bulldozer operators carve out an airstrip on Eniwetok following the island's seizure.

Eniwetok Island was built into a major staging area. On 11 March 1944, less than one month after Eniwetok Island was captured, the first plane landed and on 5 April 1944, the first mission by permanently based bomber squadrons was flown from Stickell Field. The completed field, 6,800 feet long and 400 feet wide, had two taxiways, facilities for major engine-overhaul, and housing for aviation personnel in Quonset huts. A tank farm of twelve 1,000-barrel tanks,

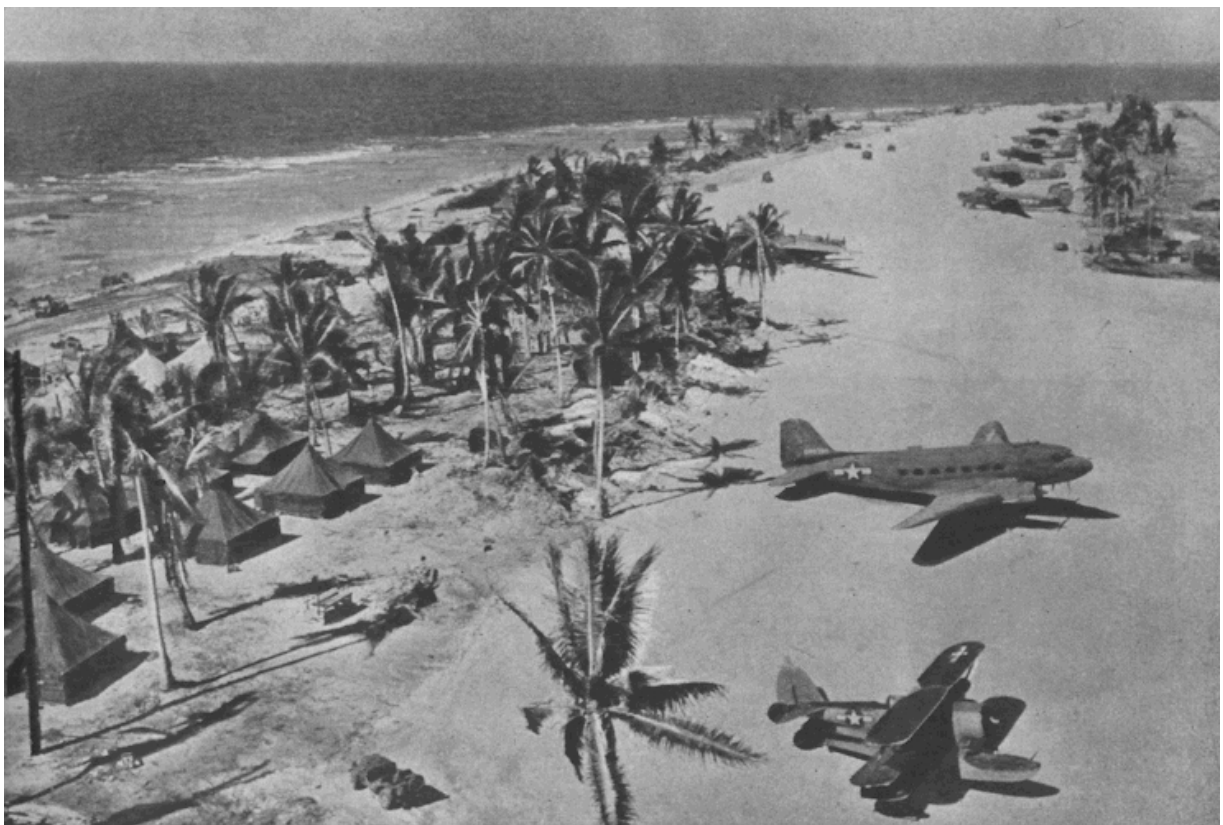
Stickell Field, Eniwetok Island in 1944

with piping, a floating pipe-line 1,200 feet long, and a tanker mooring, was completed for aviation gasoline on Eniwetok Island by May 1944. Completion had been delayed by the explosion of an LCT in March, which reduced the status of completion of the tank farm from 80 to 30 percent. Eniwetok served as a rear anchorage and repair base and kept tabs on the by-passed Japanese island bases in the area. The airfield was often used as a ferry strip for B-24 and B-25 on missions to Truk and other targets. Eniwetok's airfield allowed the Marshall Islands to be dominated by air. One Navy Officer described the place in July 1944 as "A place of desolation. A flat barren stretch of sand with a long airstrip and one big canteen operated by the Army, was all there was. There were as many B-24s and B-25s as could be handled on that long spit of land."

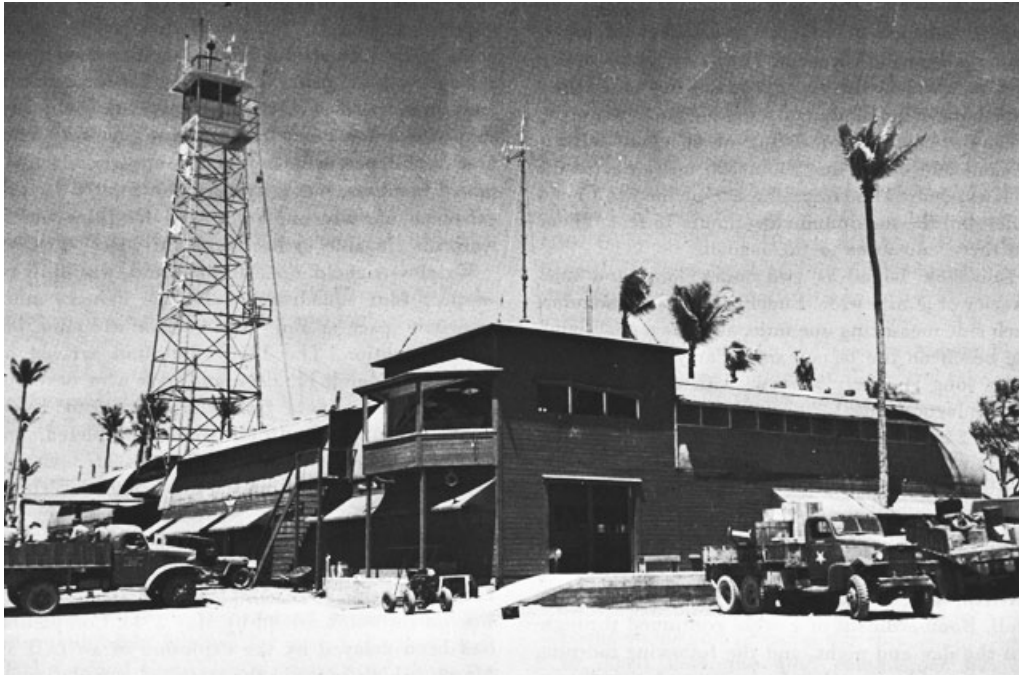
Quonset hut Operations building variation at Eniwetok showing Quonset huts erected atop one-story buildings.

As activities increased, the land area became insufficient to support these activities properly. To overcome this difficulty, Quonset huts were erected atop one-story buildings in order to save space, a measure which proved very practical.

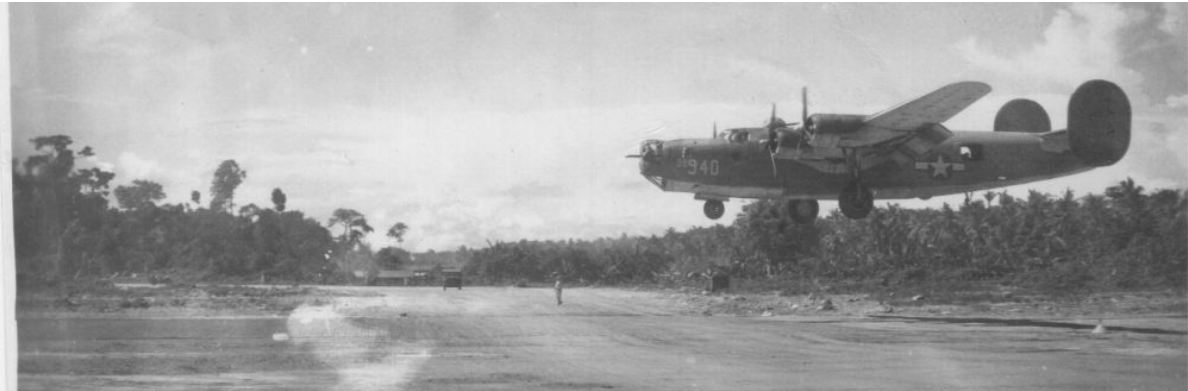
PB4Y-1 belonging to VB 116 takes off from a Naval Advance Base in the Pacific.

At 10:26 pm, Lieutenant R. C. Anderson attempted to take off his overloaded PB4Y-1, Buno 38766, ex USAAF B-24 serial number 44-40348, assigned to VB-116. The PB4Y-1 was carrying nine 500-lb bombs and its gross weight was 66,000 lbs. The emergency maximum gross weight of the PB4Y-1 aircraft was listed at 64,000 lbs. During the war the combat loads regularly exceeded 65,000 lbs often at 67,000 plus. With the extra weight the controls were mushy and soft. Operating PB4Y-1 aircraft in excess of their recommended gross weight had become routine and a **normal requirement** in the area to accomplish its combined mission of reconnaissance and strike. As the aircraft just lifted off, the Pilot cut throttles and aborted his take-off due to darkness, load and rolling runway. The pilot thought he was still on the runway mat, but was actually airborne. With a thirty degree cross-wind the plane drifted left and crashed into the parked carrier planes immediately adjacent to the runway. As the plane collided with the first row of parked airplanes, it carried away wing tips off the folded wings, canopies and came to rest in the parking area fifty-yards past the end of runway and twenty yards to the left. The PB4Y-1 plane burned with the fire spreading to other parked aircraft. The fire then caused the low order detonation of all nine 500-lb bombs and was instrumental in extending sphere of devastation to include the loss or damage of 106 aircraft. Eighty four planes out of the 106 were destroyed or so damaged as to be unfit for further use. The type of planes destroyed included F6F-3, 16 aircraft; FM-1, 11 aircraft; SB2C-1, 12 aircraft; SB2C-3, 3 aircraft; and TBM-1, 42 aircraft. Another 22 aircraft were damaged, but repairable. Nine members of the crew were killed, but miraculously, two crewmen survived. The crew included: Pilot Lt Romone C. Anderson A-V(N) USNR/Killed, Ens. T. M. Pettit A-V(N) USNR/Killed, Ens. O. B. Tully A-V(N) USNR/(died of injuries Aug 15th, 1944), AMM1c L. Johnson USN/Seriously injury, Sealc H. A. Heper USNR/Killed, ARM1c J. W. Chalmers USNR/Killed, ARM3c A. F. Burkhartemeyer USNR/Seriously injury, AOM2c J. D. Rothwell USNR/Killed, Sealc A. A. Van Winkle USNR/Killed, Sealc E. Petri USNR/Killed, and AOM3c G. A. Ehinger USNR/Killed.

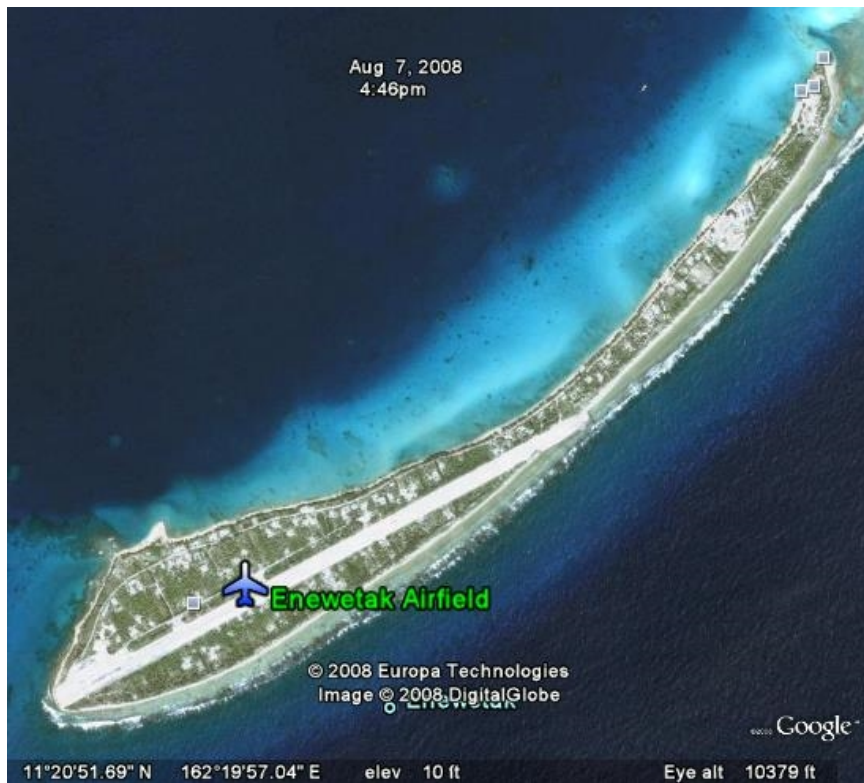
Recent photo of Enewetak Airfield

Eniwetok Atoll would serve as a base for future operations against Japanese-held Truk and the Caroline Islands. Eniwetok atoll also provided airfields for the subsequent invasion of the Marianas. After the war, Eniwetok atoll was the site of the first hydrogen bomb test on November 18, 1952. Today the airfield still remains, but is no longer an active airfield. This story is dedicated to all those who served in Navy PB4Y-1 aircraft.
