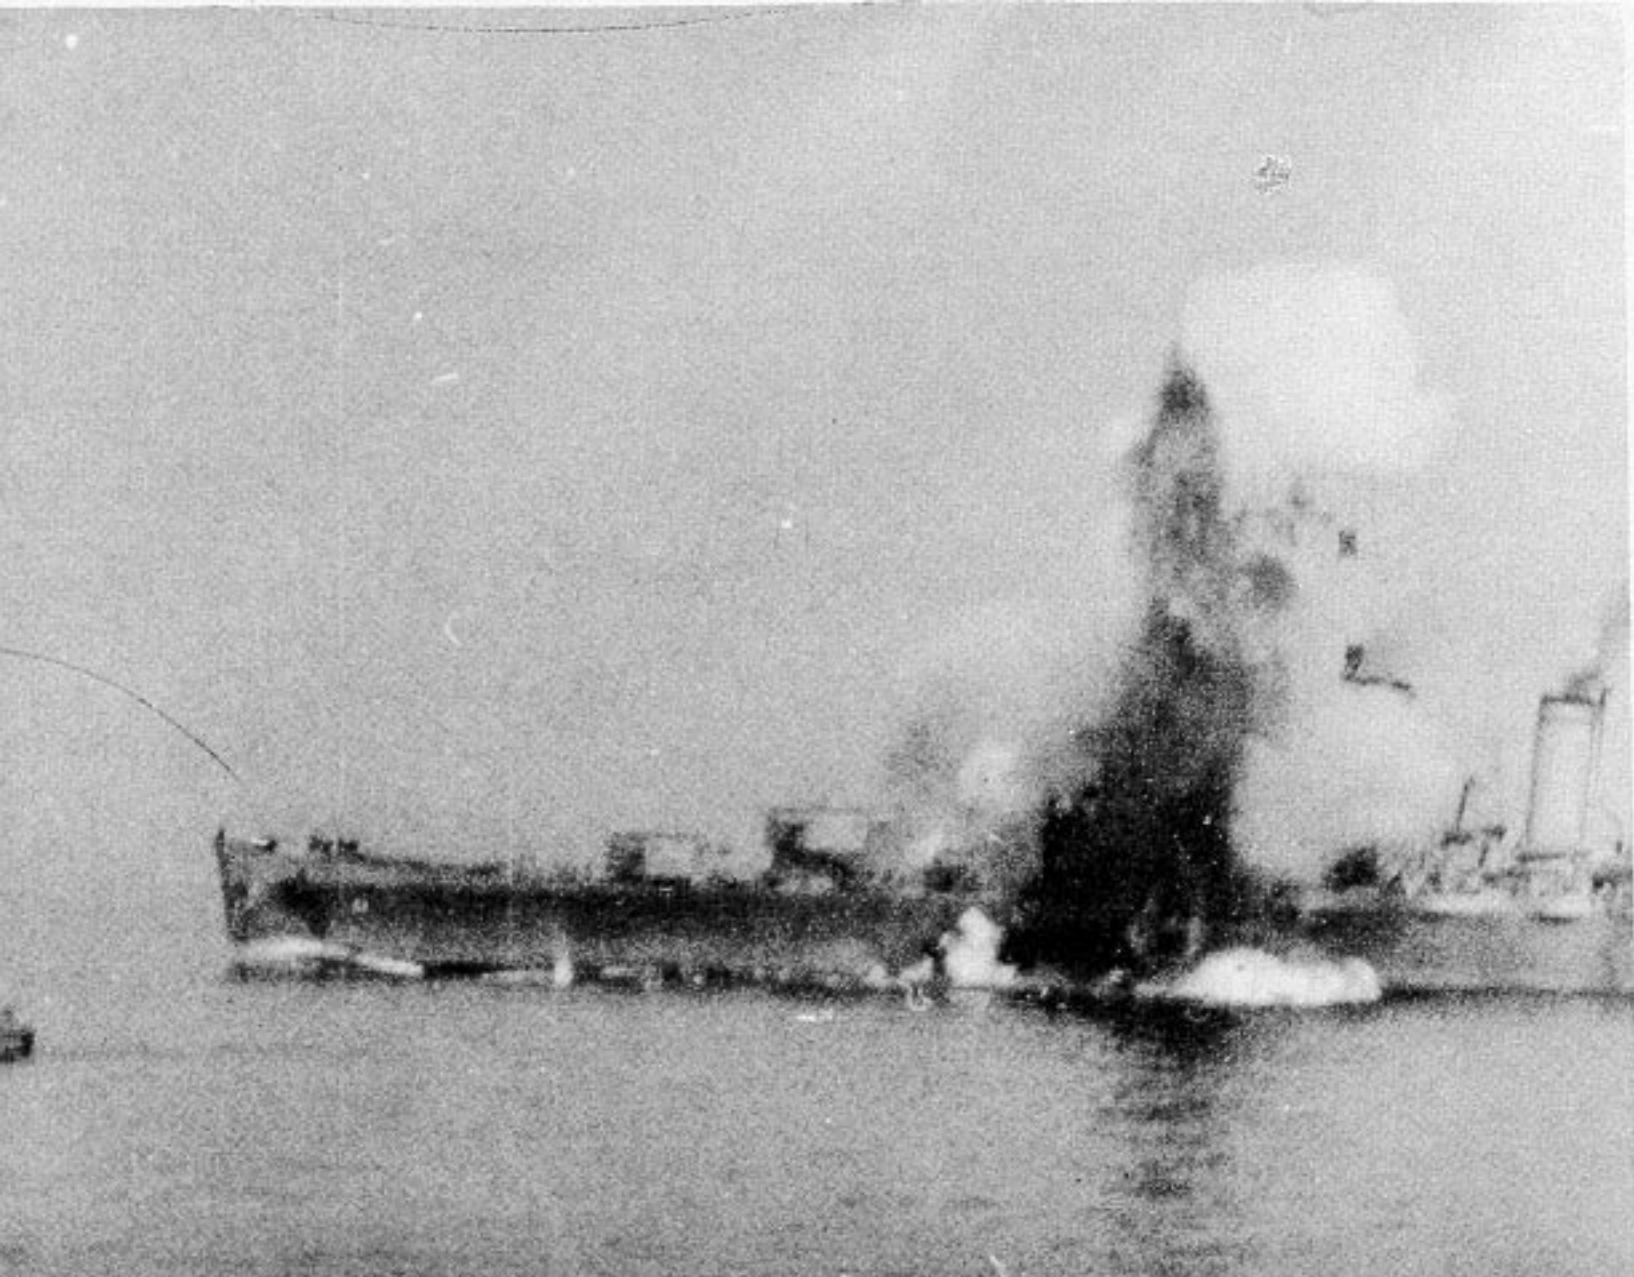
Photo 1: SAVANNAH a few seconds after detonation of bomb. Note that plume is largely of gas, smoke and vapor. A violent turbulence in the water can be seen abreast No. 3 turret - 11 September, 1943.

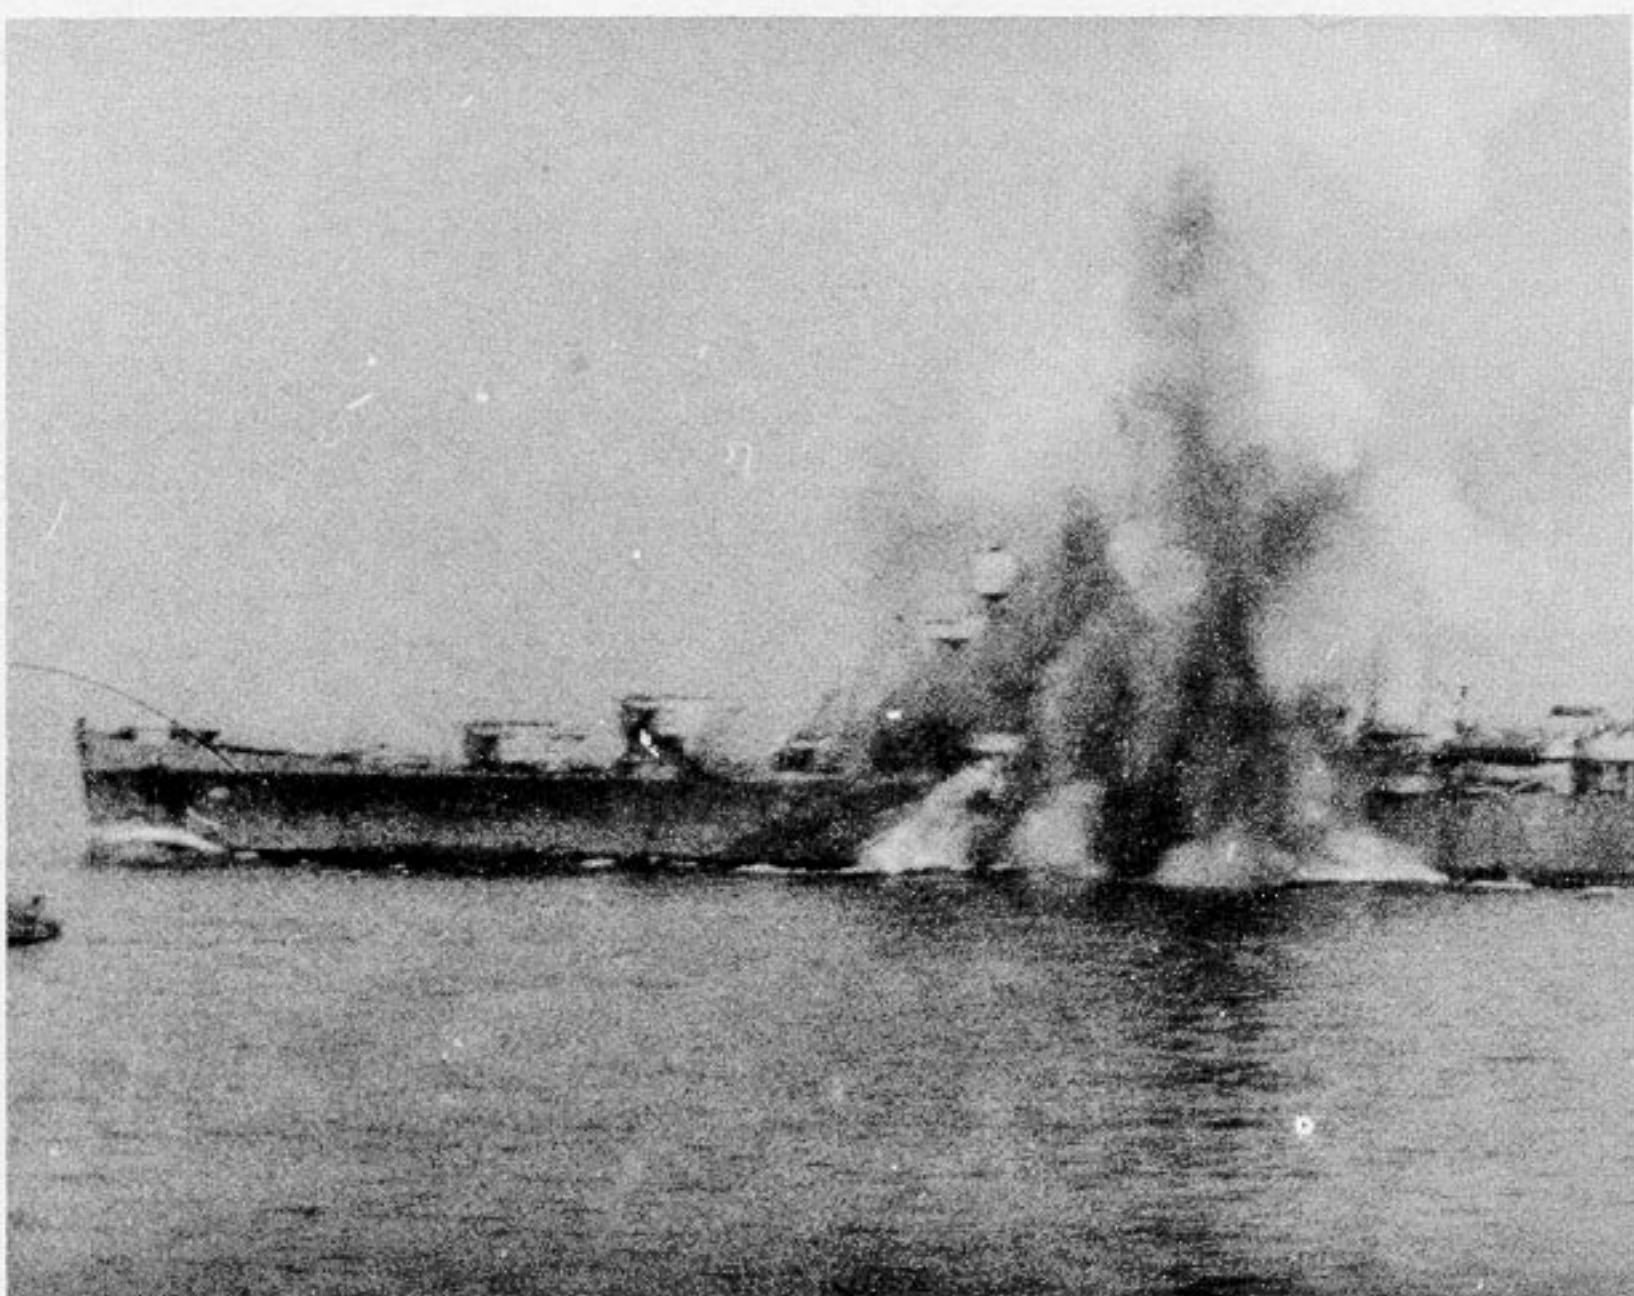
Photo 2: SAVANNAH two seconds after photo 1.
